Arboricultural Inventory and Report

For: UBC Properties Trust

Site Location: BCR Lots 5 and 6, UBC

Date: February 24, 2022

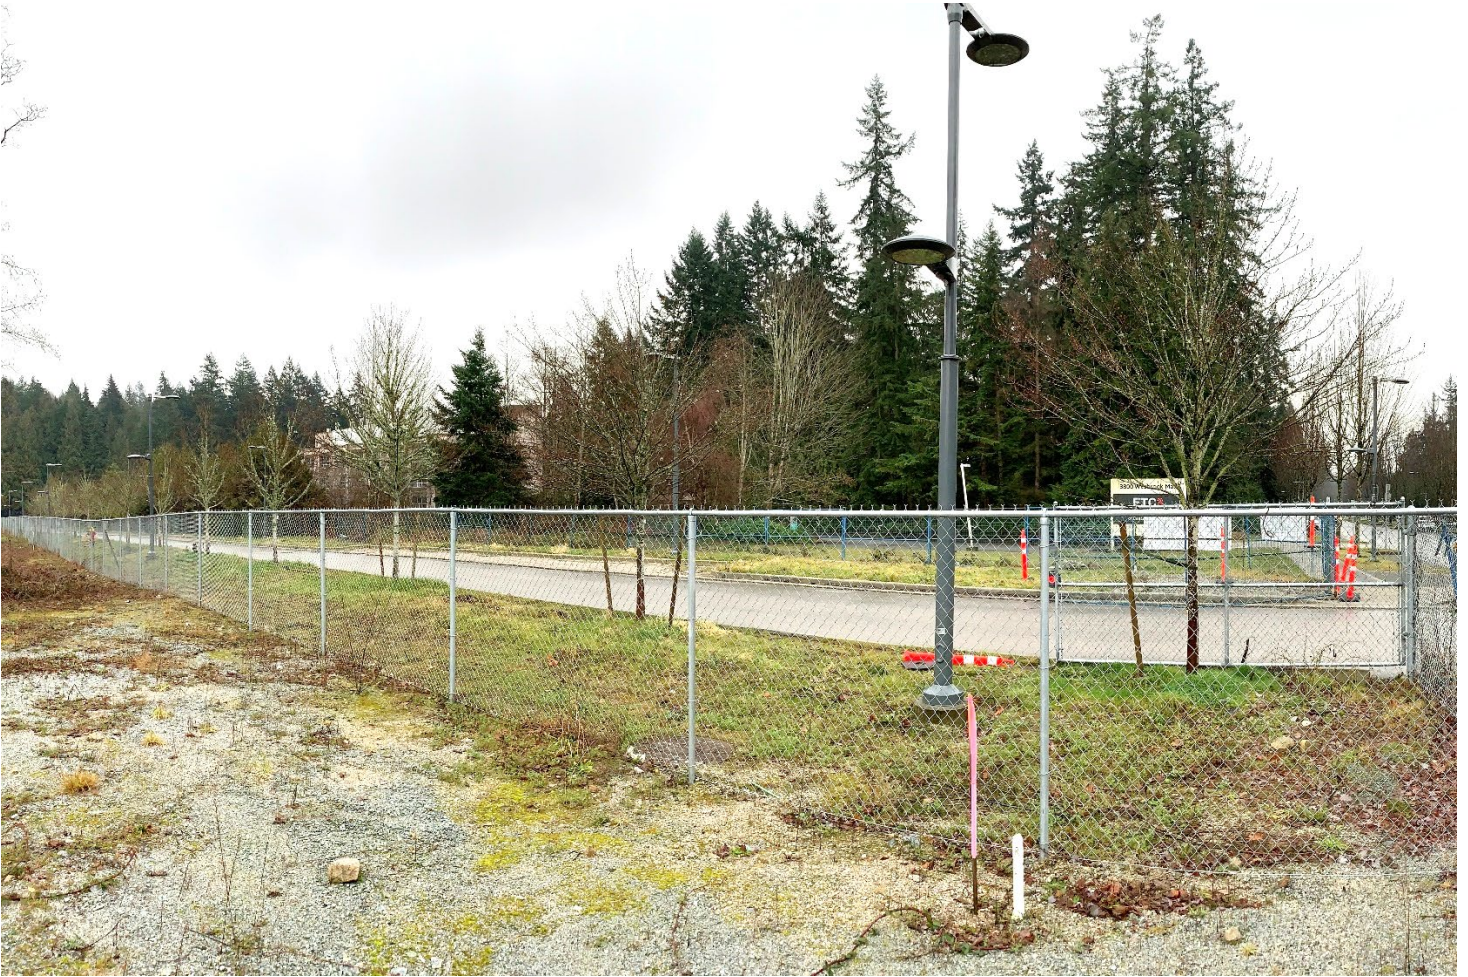
Photo 1. Overview of trees (from right to left) UBC07 to UBC21.

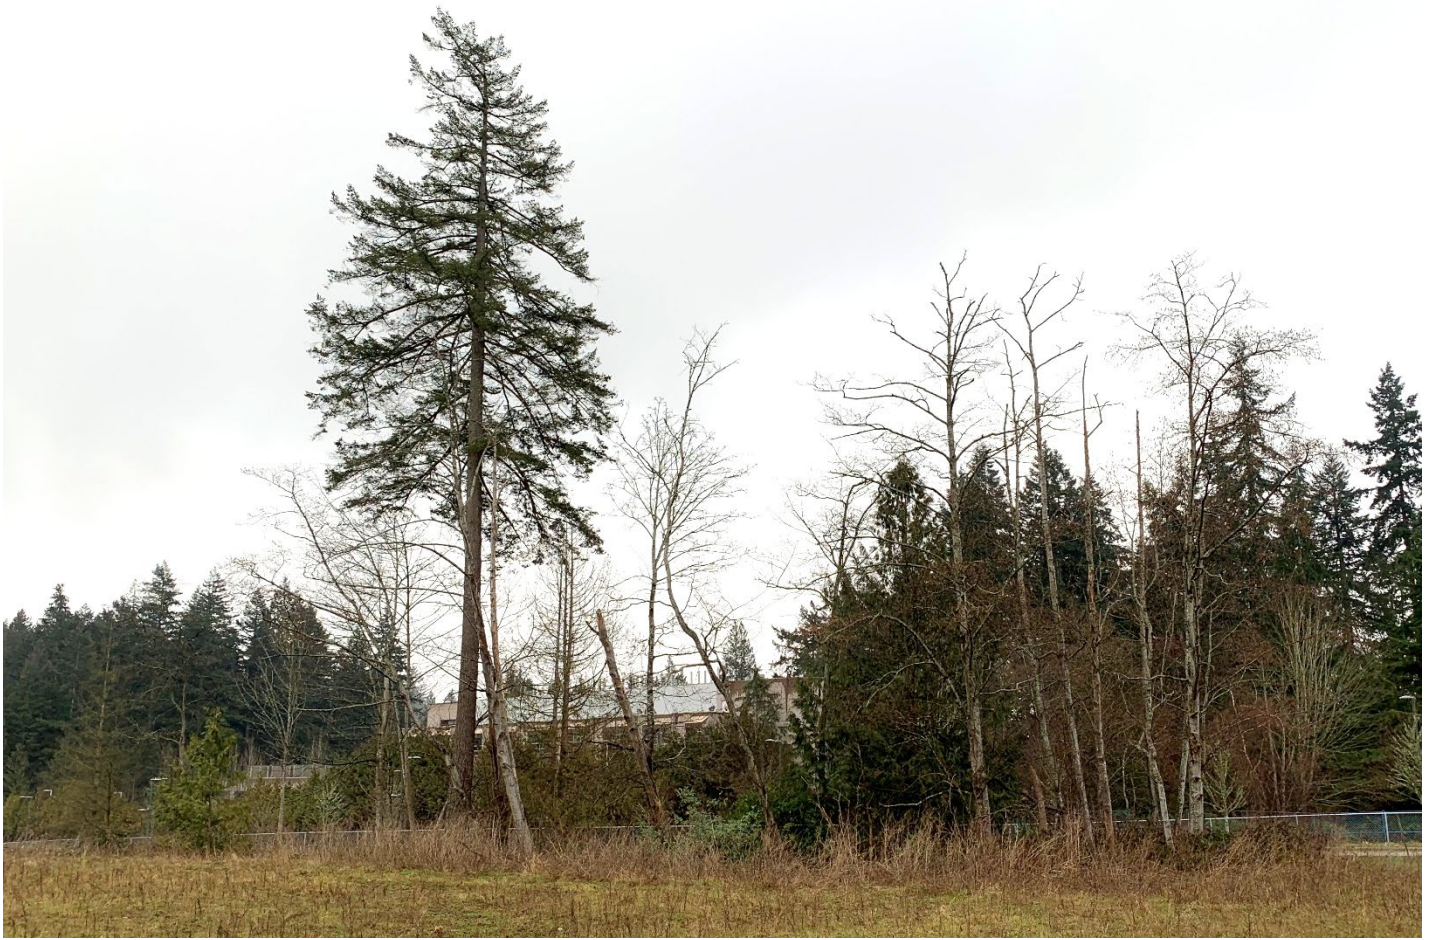
Photo 2. Overview of on-site stand.

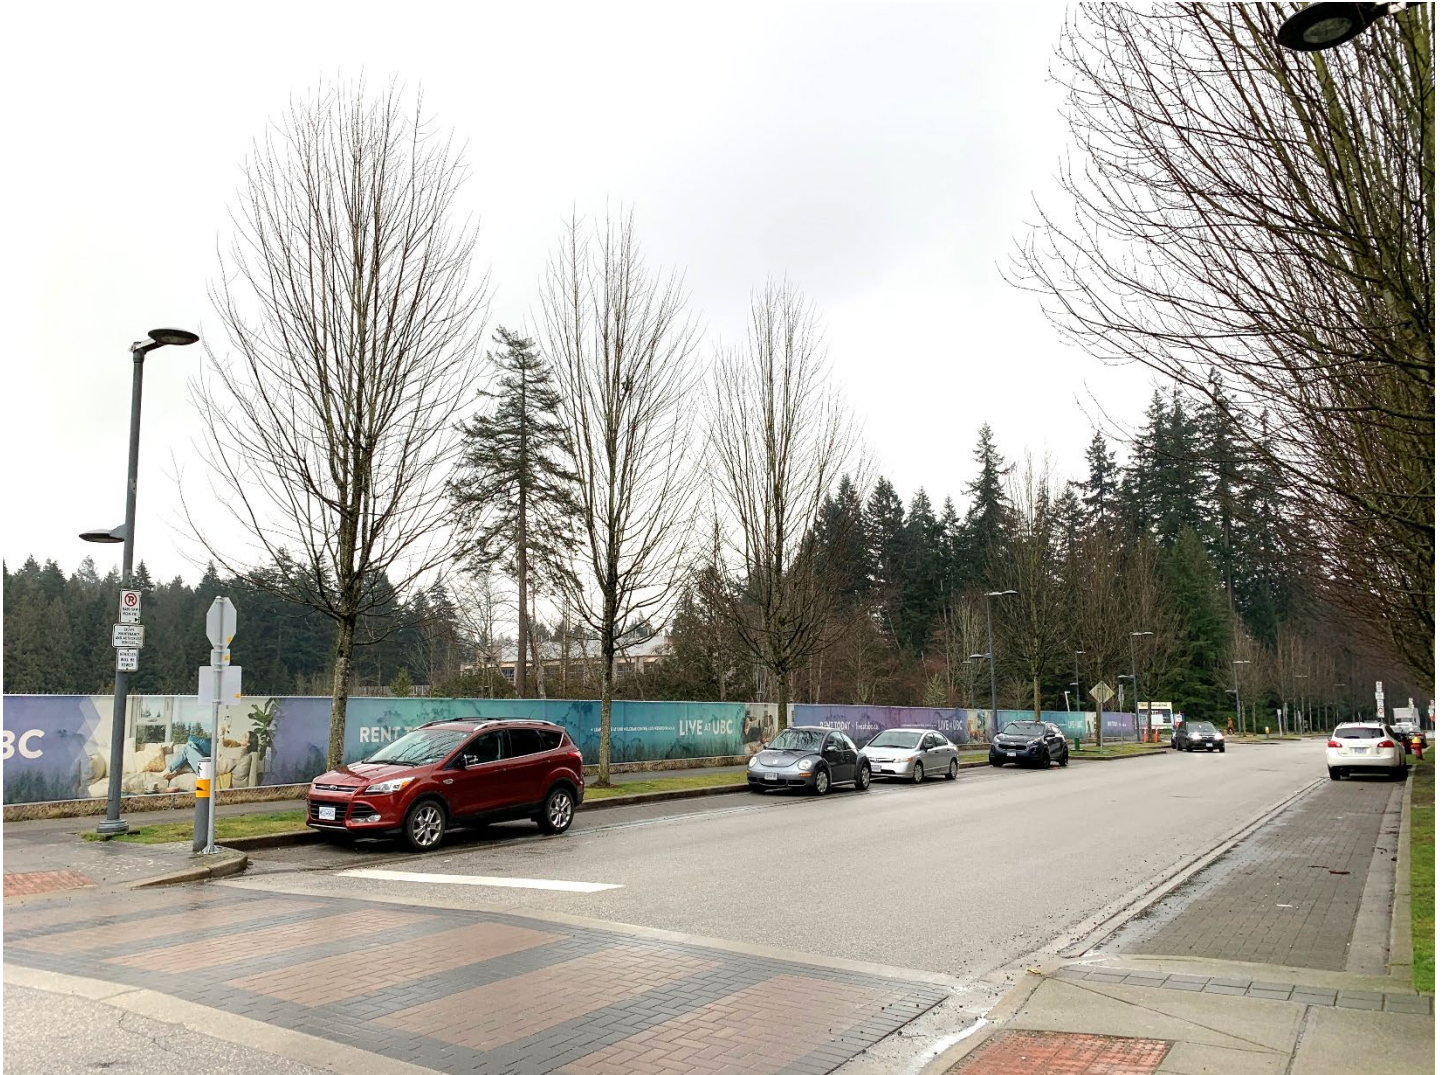
Photo 3. Overview of trees (from left to right) UBC01 to UBC06.
