Arboricultural Report and Inventory

University of British Columbia Properties Trust

UBC Pacific Residences

Date: June 4th, 2019

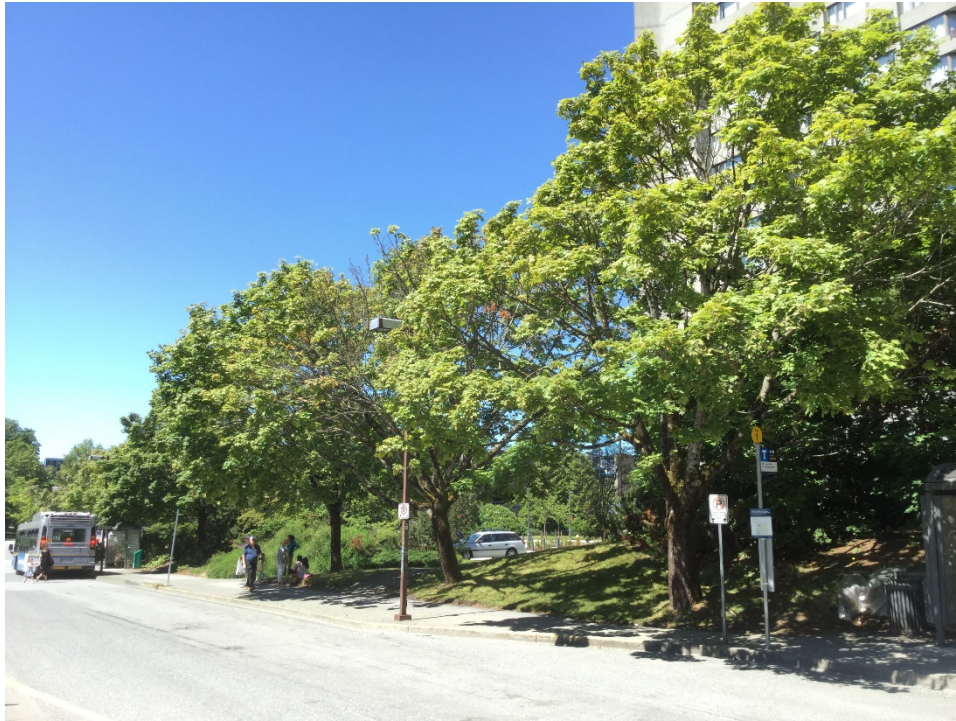
Photo 1. The subject site viewed along Student Union Boulevard

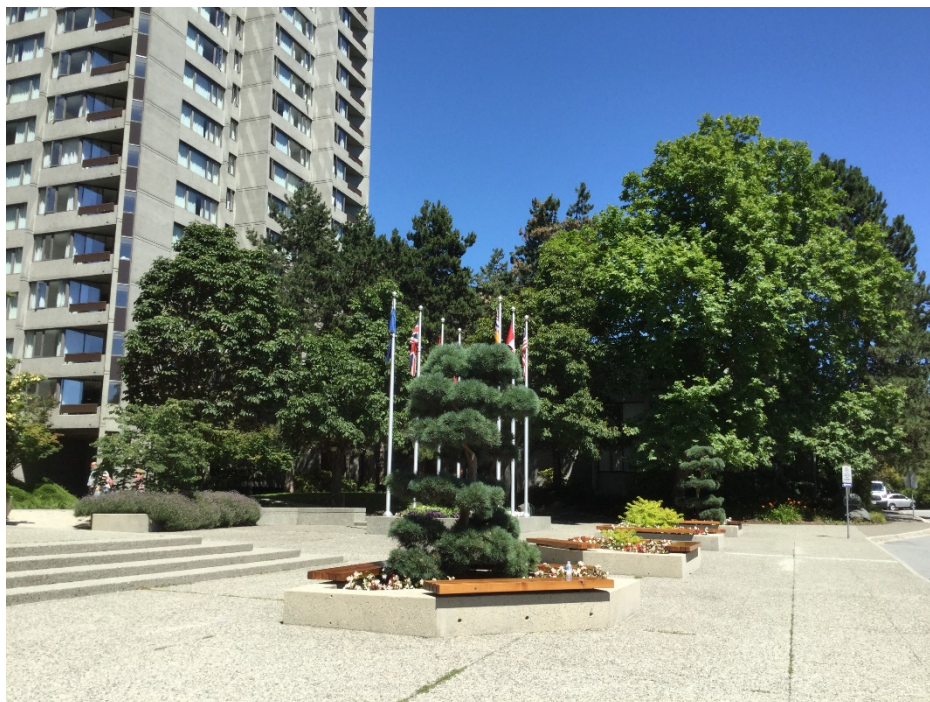
Photo 2. The plaza currently fronting Gage Residences and conference center.

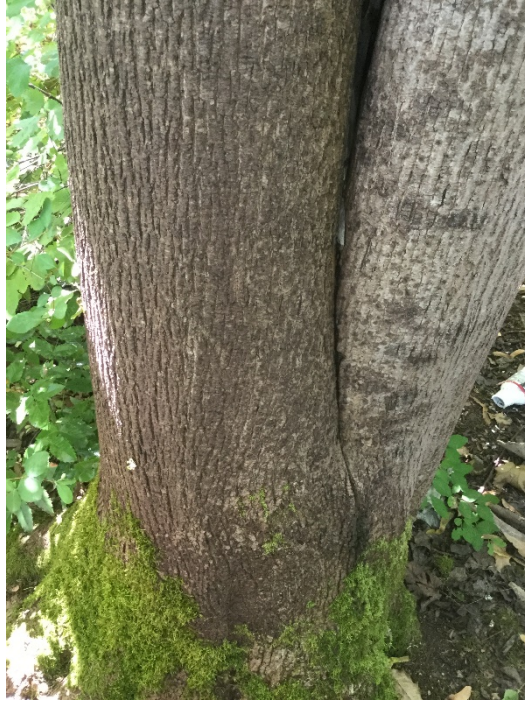
One tree, number 9874, was assessed to pose a high-risk to targets present at the time of assessment (Photo 3). We recommend that this tree is removed as soon as possible, regardless of the proposed development process.

9874	On-Site	Maple (A. macrophyllum)	63	16	Poor	In semi-natural area. Codominant stems from acute union with inclusion. Seam forming below. East stem probable to fail with high likelihood to hit parked cars.	Low	Remove	Within building envelope.	3.8
9876	On-Site	Maple (A. platanoides)	19	9	Poor	In landscape strip. Substantial crown dieback. Low vigour.	Low	Remove	Within building envelope.	2
9878	On-Site	Maple (A. platanoides)	19	9	Poor	In landscape strip. Substantial crown dieback. Low vigour.	Low	Remove	Within building envelope.	2
9880	On-Site	Maple (A. platanoides)	21	9	Poor	In landscape strip. Minor crown dieback. Low vigour.	Low	Remove	Within building envelope.	2
9881	On-Site	Maple (A. platanoides)	33	18	Moderate	In landscape strip. Minor crown dieback. Moderate vigour.	Medium	Remove	Within building envelope.	2
9884	On-Site	Maple (A. platanoides)	30	11	Poor	Grows in semi-natural area. Minor phototropic lean south east and one-sided crown. Moderate vigour.	Low	Remove	Within building envelope.	2

Photo 3. Poor union at the base of tree 9874.

Tree		Target	Likelihood			Consequences	Risk Rating	Action	Residual Risk
Number	Part to Fail		Failure	Impact	Failure & Impact				
9874	Half or whole tree	Parked vehicles	Probable	Medium	Somewhat likely	Significant	High	Remove tree. It is within building envelope and proposed for removal.	Nil
