Arborist Report

University of British Columbia Properties Trust

Beaty Biodiversity Addition

Date: June 20, 2022

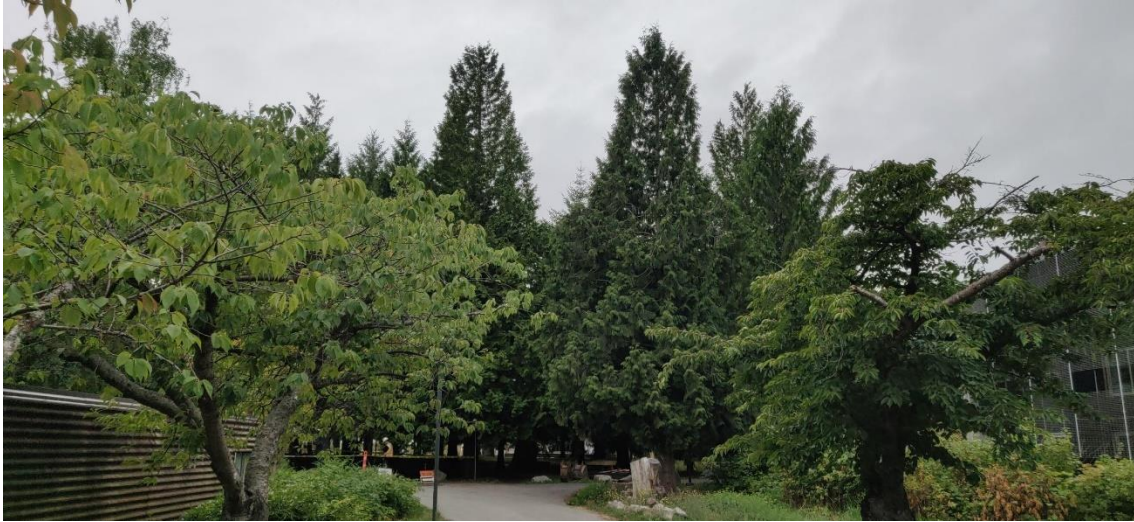
Photo 1. Facing west at grove of conifers. Cherries in foreground.

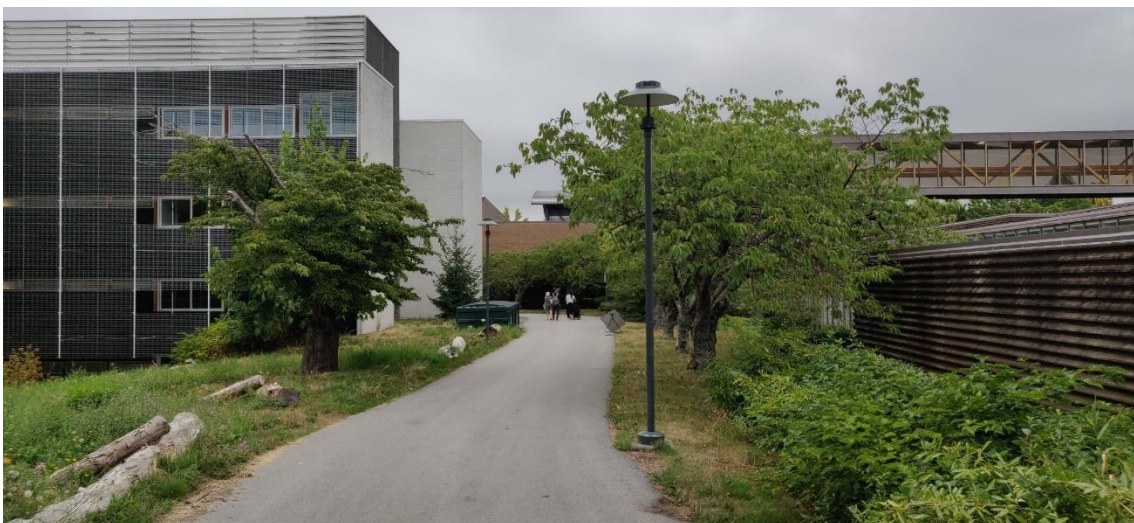
Photo 2. Cherry trees.

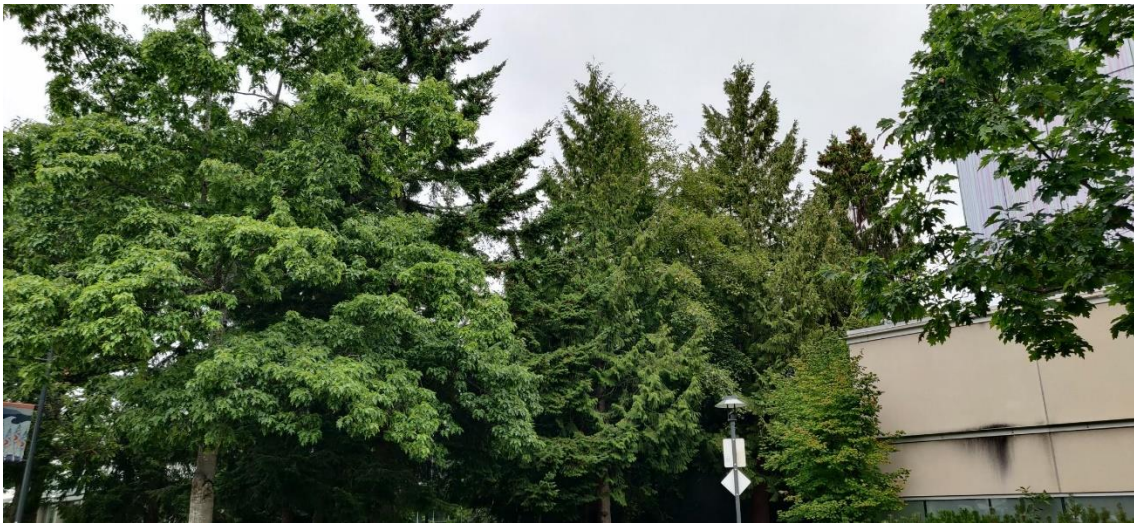
Photo 3. East edge of grove.

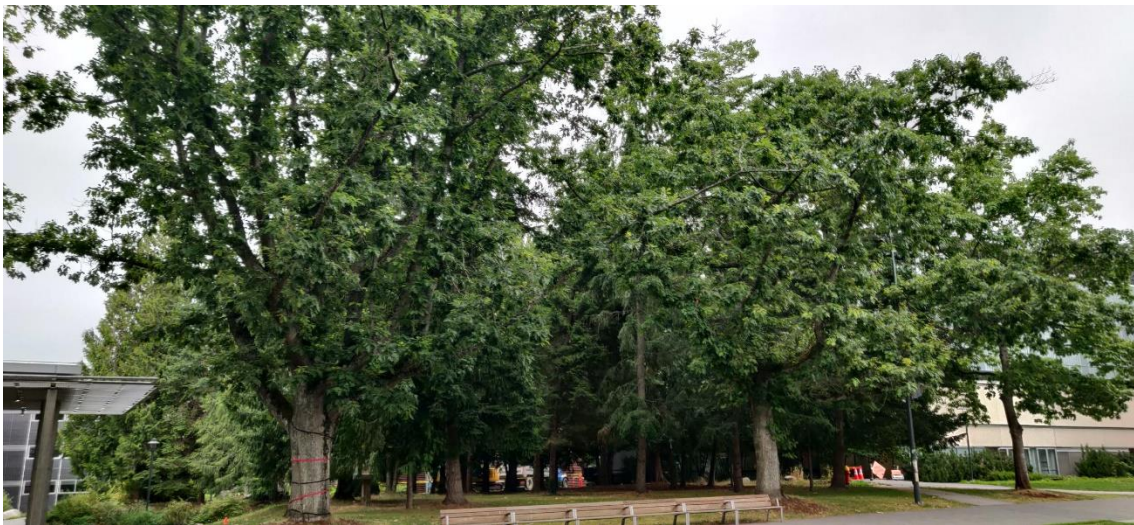
Photo 4. Facing east at grove. Note the large Oaks in foreground are well outside of the development scope.
