Development Permit Report

TRIUMF

Institute for Advanced Medical Isotopes

PHASE I ENVIRONMENTAL SITE ASSESSMENT

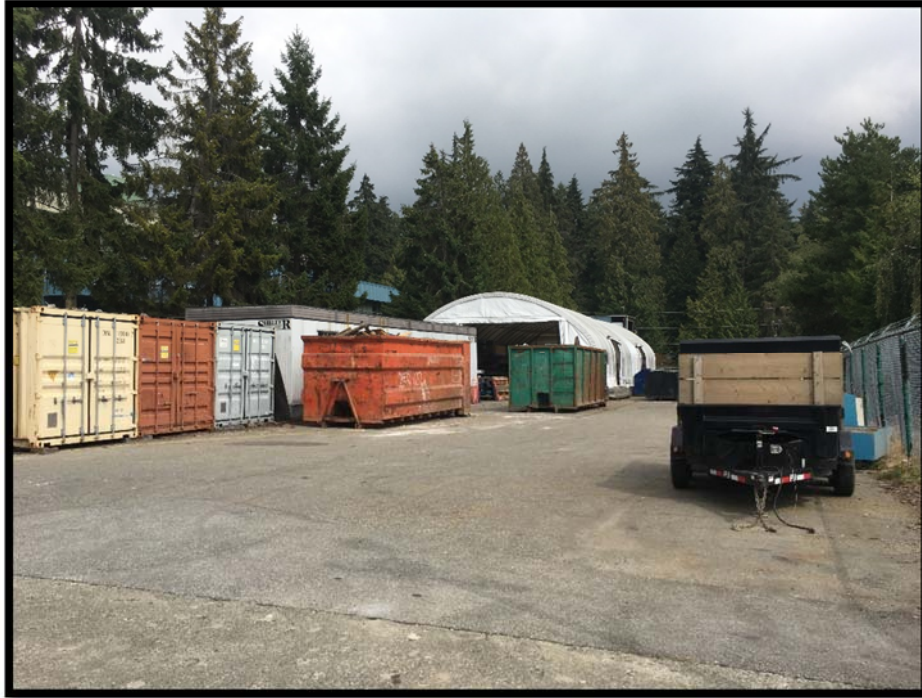
Photograph 1: View of the northern portion of the Site, looking east near the western Site boundary.

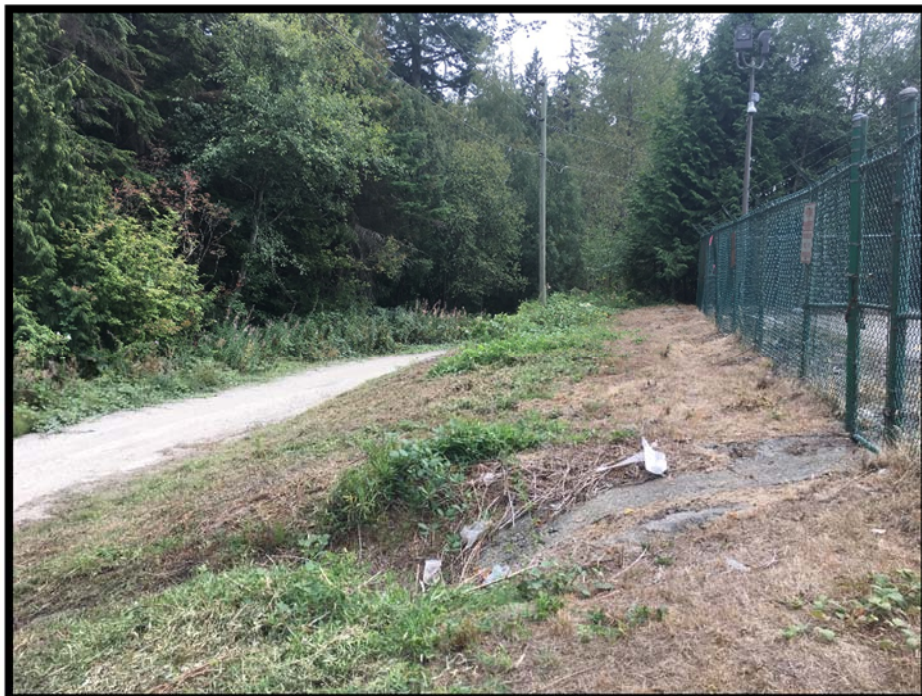
Photograph 4: A slope near the roadway at the eastern portion of the Site, which indicates that fill materials have been brought onto the Site.

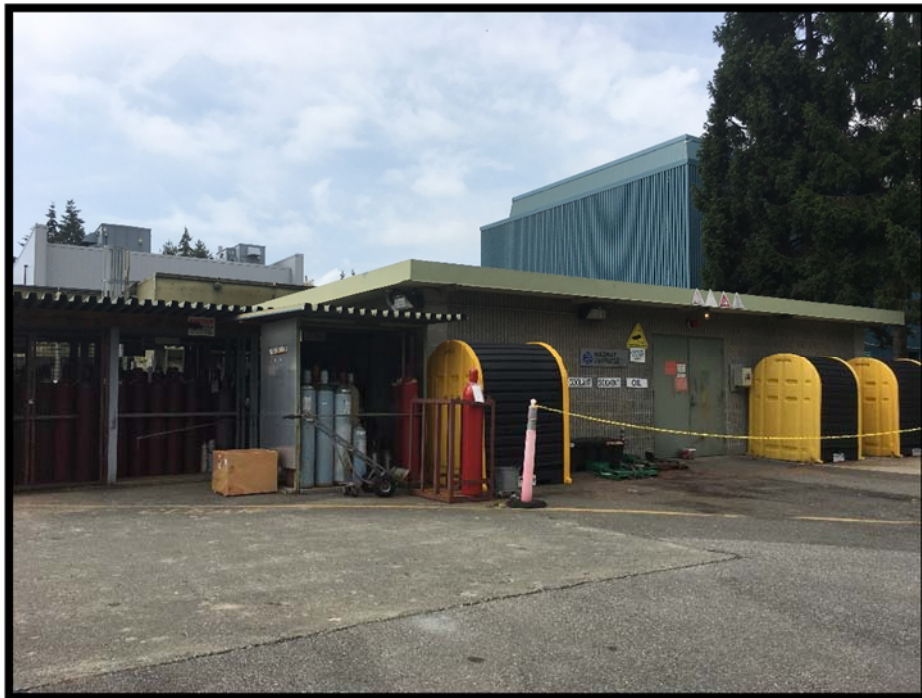
Photograph 8: View of the hazardous materials storage building located to the west of the Site.

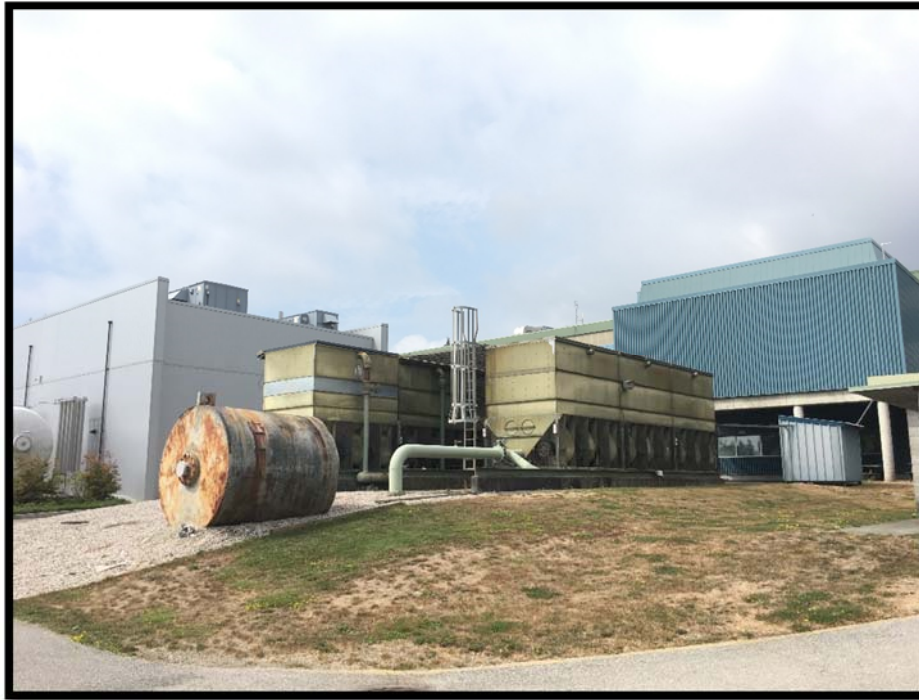
Photograph 9: View of the chiller system located to the west of the Site.

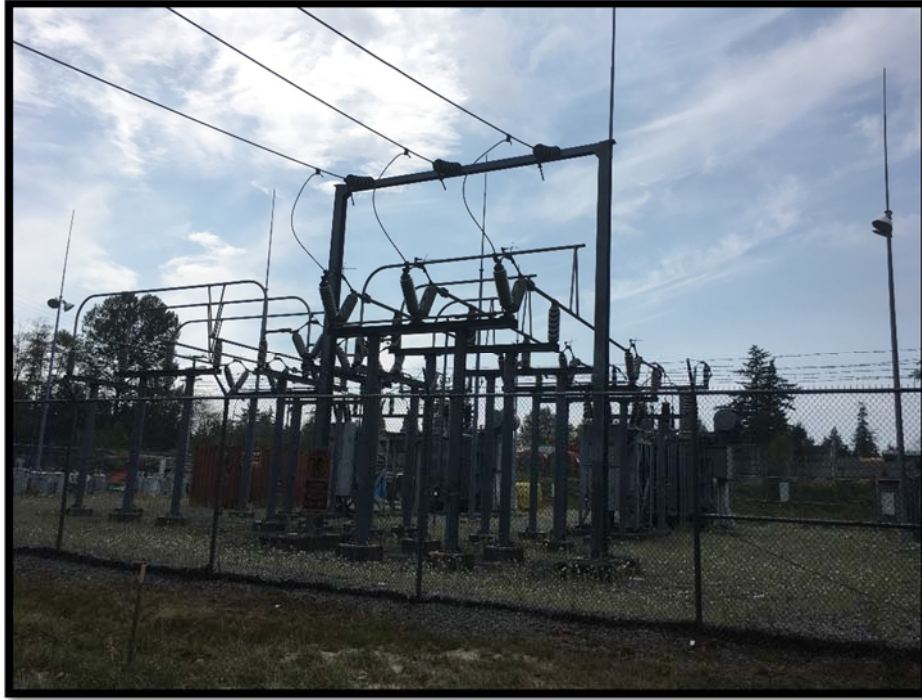
Photograph 11: View of the South Campus Substation located immediately to the southwest of the Site.
