# ACADIA MODULAR CHILDCARE

## University of British Columbia

UBC STUDENT HOUSING & HOSPITALITY SERVICES  
UBC CHILDCARE SERVICES  
ACADIA PARK

Acadia Modular  
Childcare

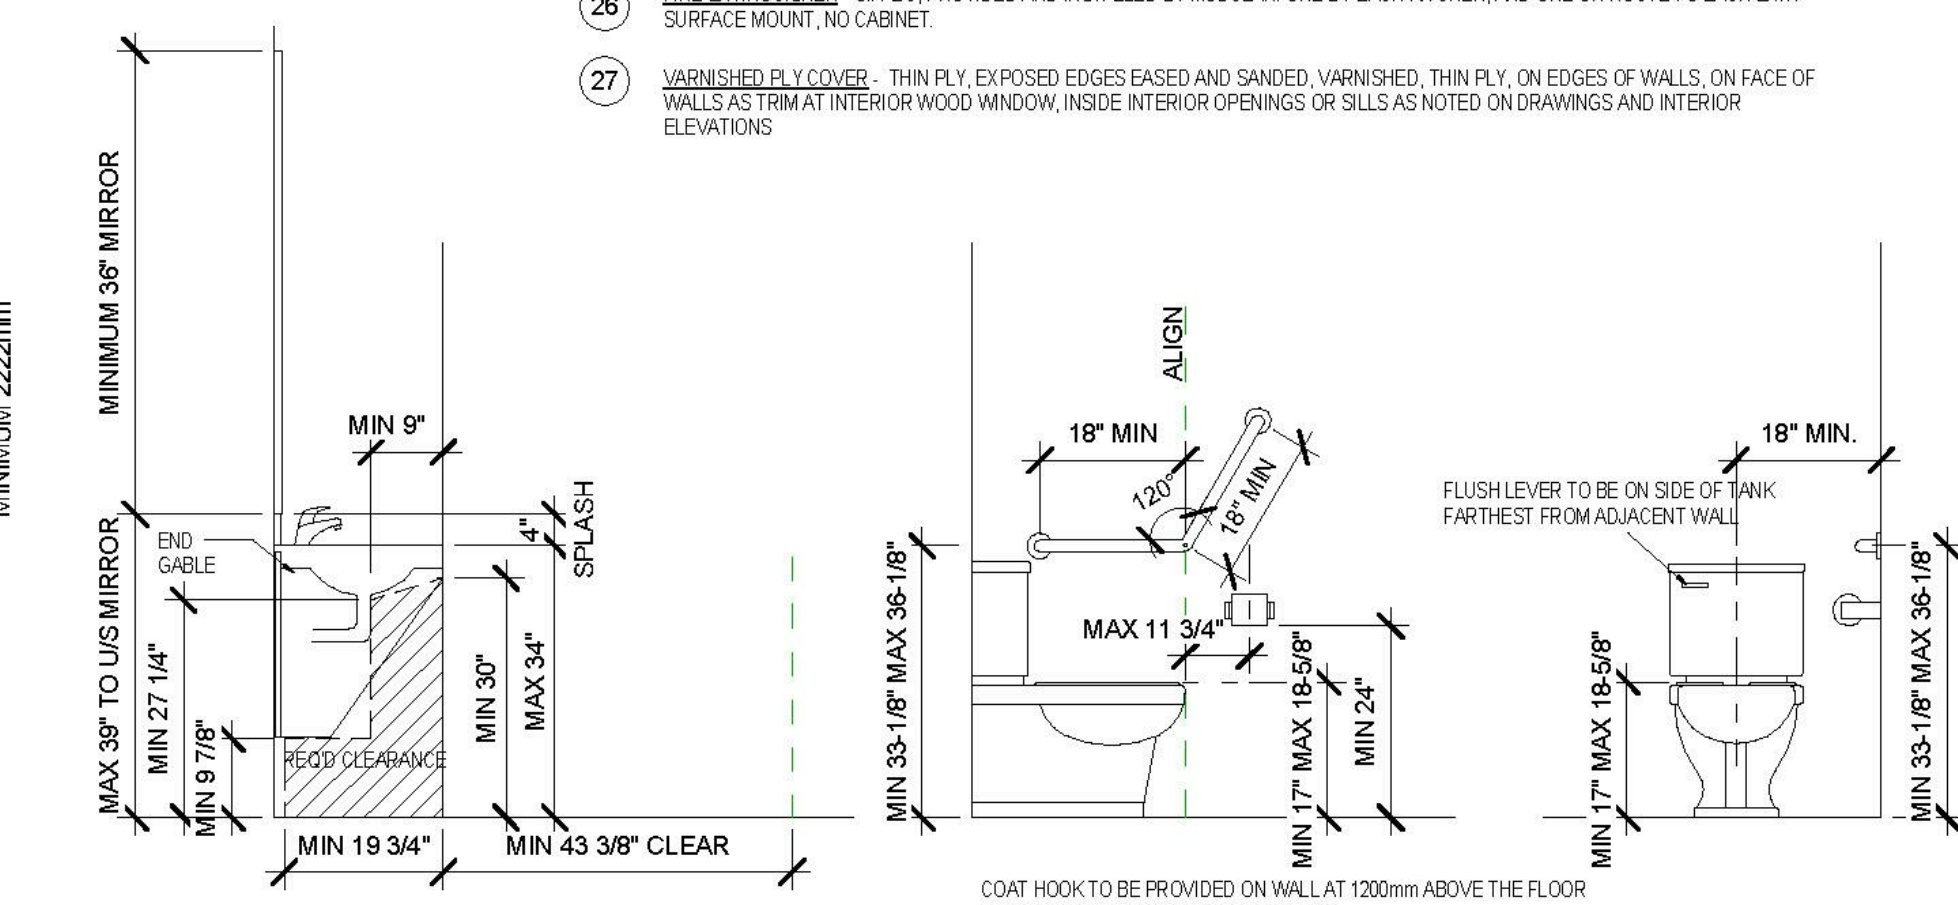
2 WASHROOM ELEVATIONS

- WALL WAINSCOT - MIN. 36" HIGH WAINSCOT OPTIONS. VARNISHED BIRCH DOOR SKIN, VERT GRADE PLAM ON MDF, 1/2" BIRCH VENEER FLY, TOP EDGE TRIM VARNISH HARDWOOD, ALUM. AT WASHROOMS USE VERT GRADE PLAM ON THIN PLY OR MDF BACKER BOARD.
- EMERGENCY PLAN HOLDER, PROVIDED BY OWNER. MOUNT BY MODULAR.
- FIRE EXTINGUISHER - 5# ABC, PROVIDED AND INSTALLED BY MODULAR. ONE BY EACH KITCHEN AND ONE ON ROUTE TO EACH EXIT. SURFACE MOUNT, NO CABINET.
- VARNISHED PLY COVER - THIN PLY, EXPOSED EDGES EASED AND SANDED, VARNISHED, THIN PLY, ON EDGES OF WALLS, ON FACE OF WALLS AS TRIM AT INTERIOR WOOD WINDOW, INSIDE INTERIOR OPENINGS OR SILLS AS NOTED ON DRAWINGS AND INTERIOR ELEVATIONS.

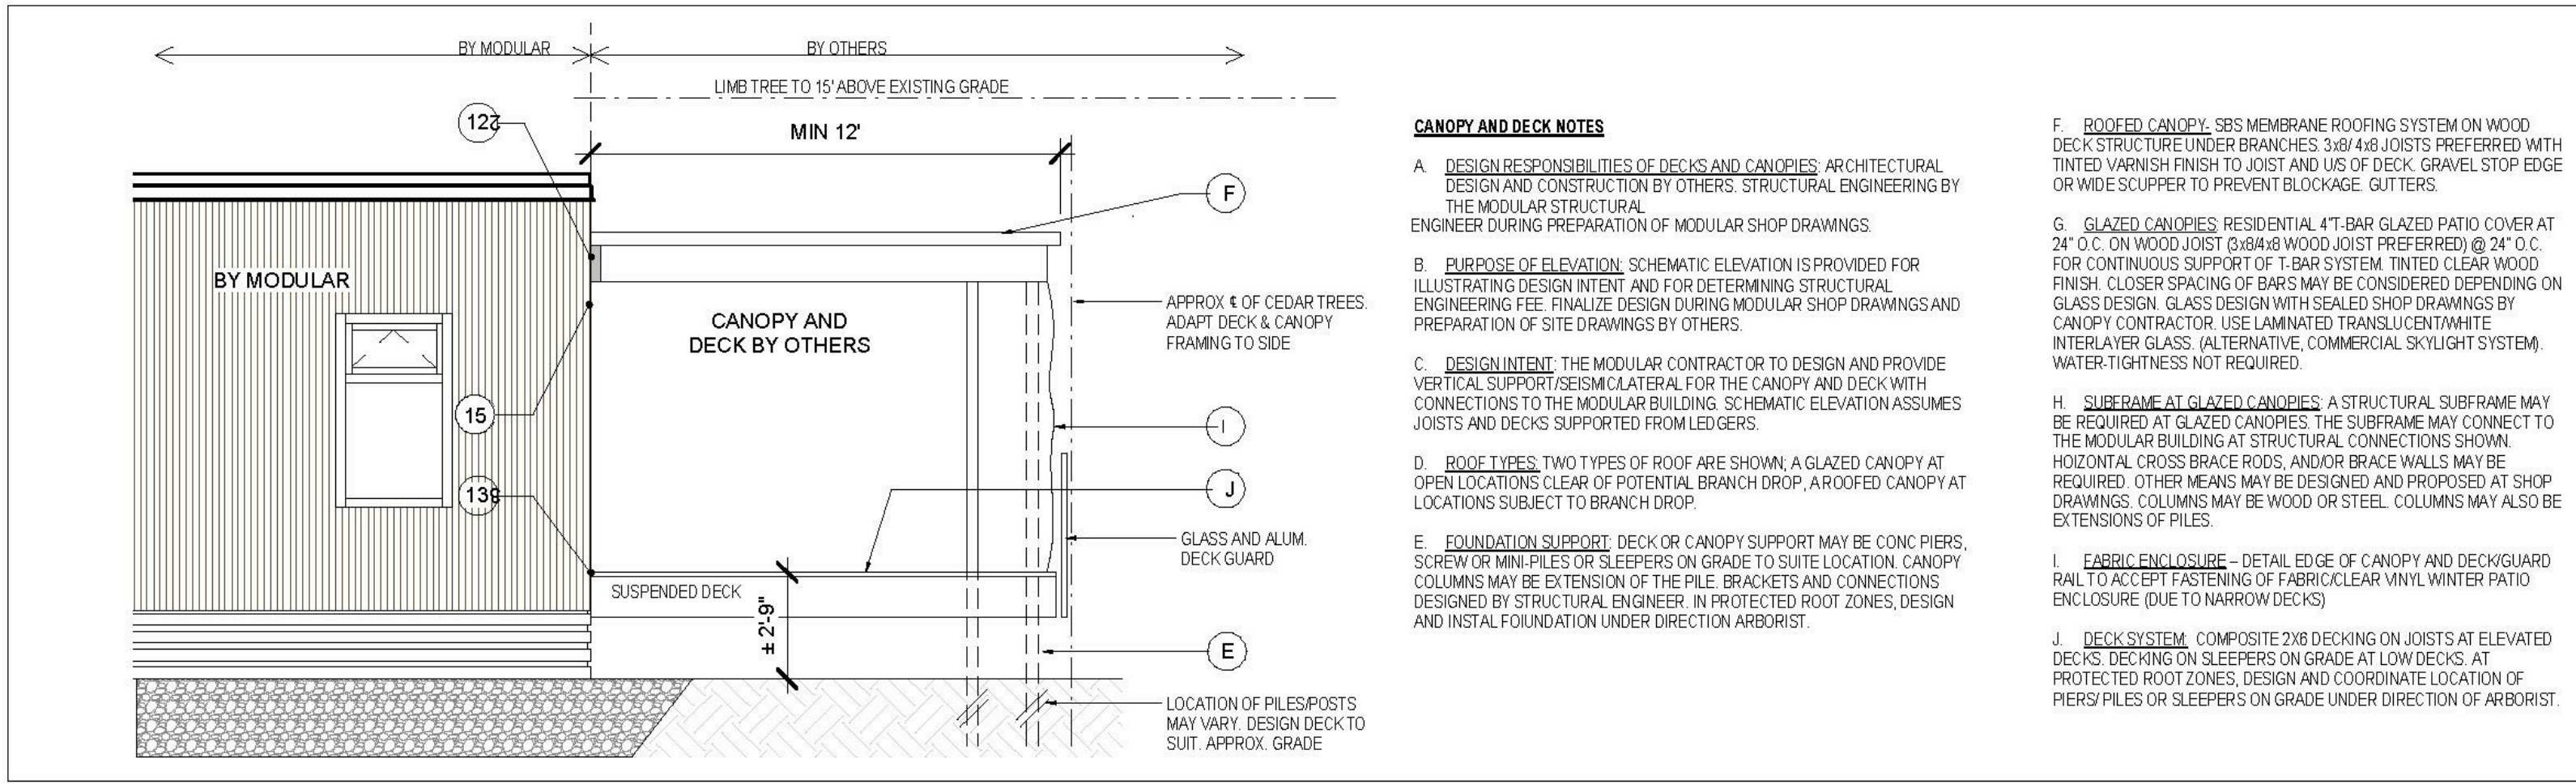
5 WOOD DECK TO CANOPY - BY OTHERS (WEST)

E. FOUNDATION SUPPORT: DECK OR CANOPY SUPPORT MAY BE CONIC PIERS, SCREW OR MINI-PILES OR SLEEPERS ON GRADE TO SUIT LOCATION. CANOPY COLUMNS MAY BE EXTENSION OF THE PILE BRACKETS AND CONNECTIONS DESIGNED BY STRUCTURAL ENGINEER. IN PROTECTED ROOT ZONES, DESIGN AND INSTALL FOUNDATION UNDER DIRECTION ARBORIST.

I. FABRIC ENCLOSURE - DETAIL EDGE OF CANOPY AND DECK GUARD RAIL TO ACCEPT FASTENING OF FABRIC/CLEAR VINYL WINTER PATIO ENCLOSURE (DUE TO NARROW DECKS).

J. DECK SYSTEM: COMPOSITE 2x8 DECKING ON JOISTS AT ELEVATED DECKS. DECKING ON SLEEPERS ON GRADE AT LOW DECKS. AT PROTECTED ROOT ZONES, DESIGN AND COORDINATE LOCATION OF PIERS/PILES OR SLEEPERS ON GRADE UNDER DIRECTION OF ARBORIST.

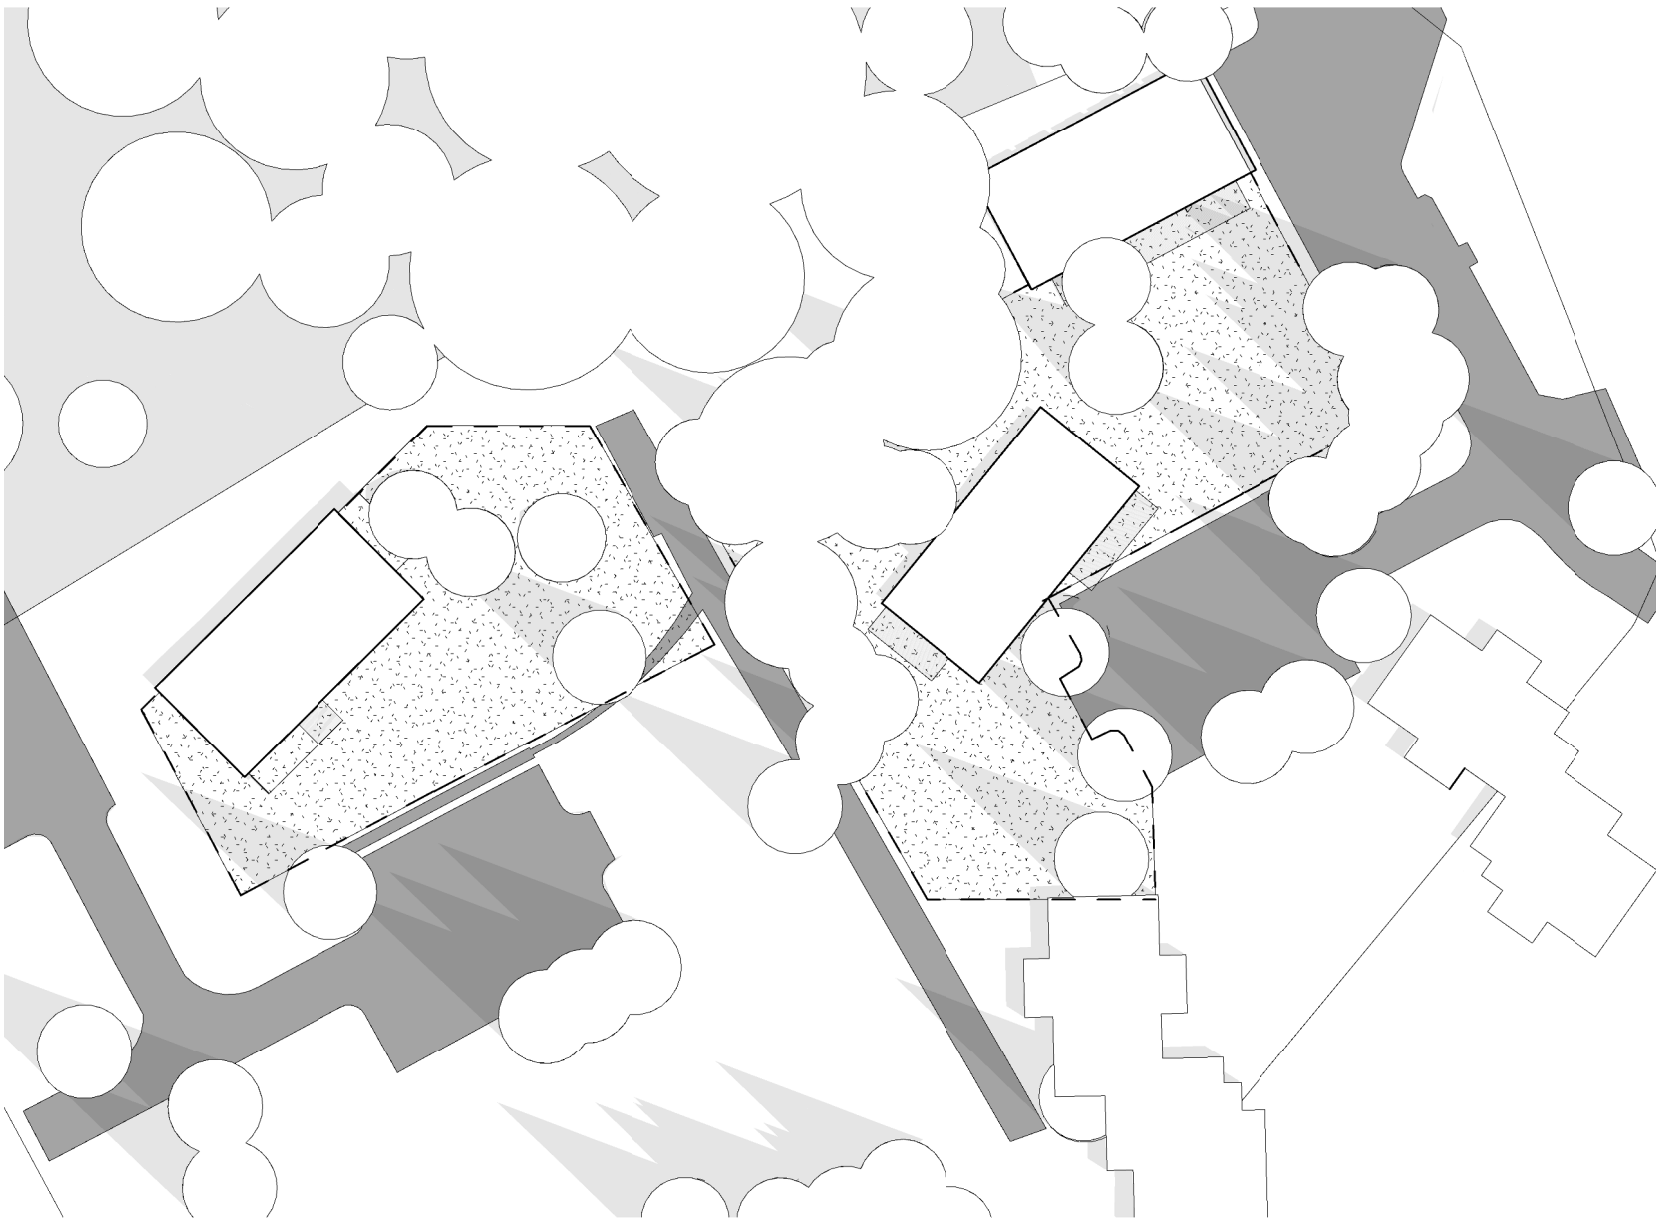
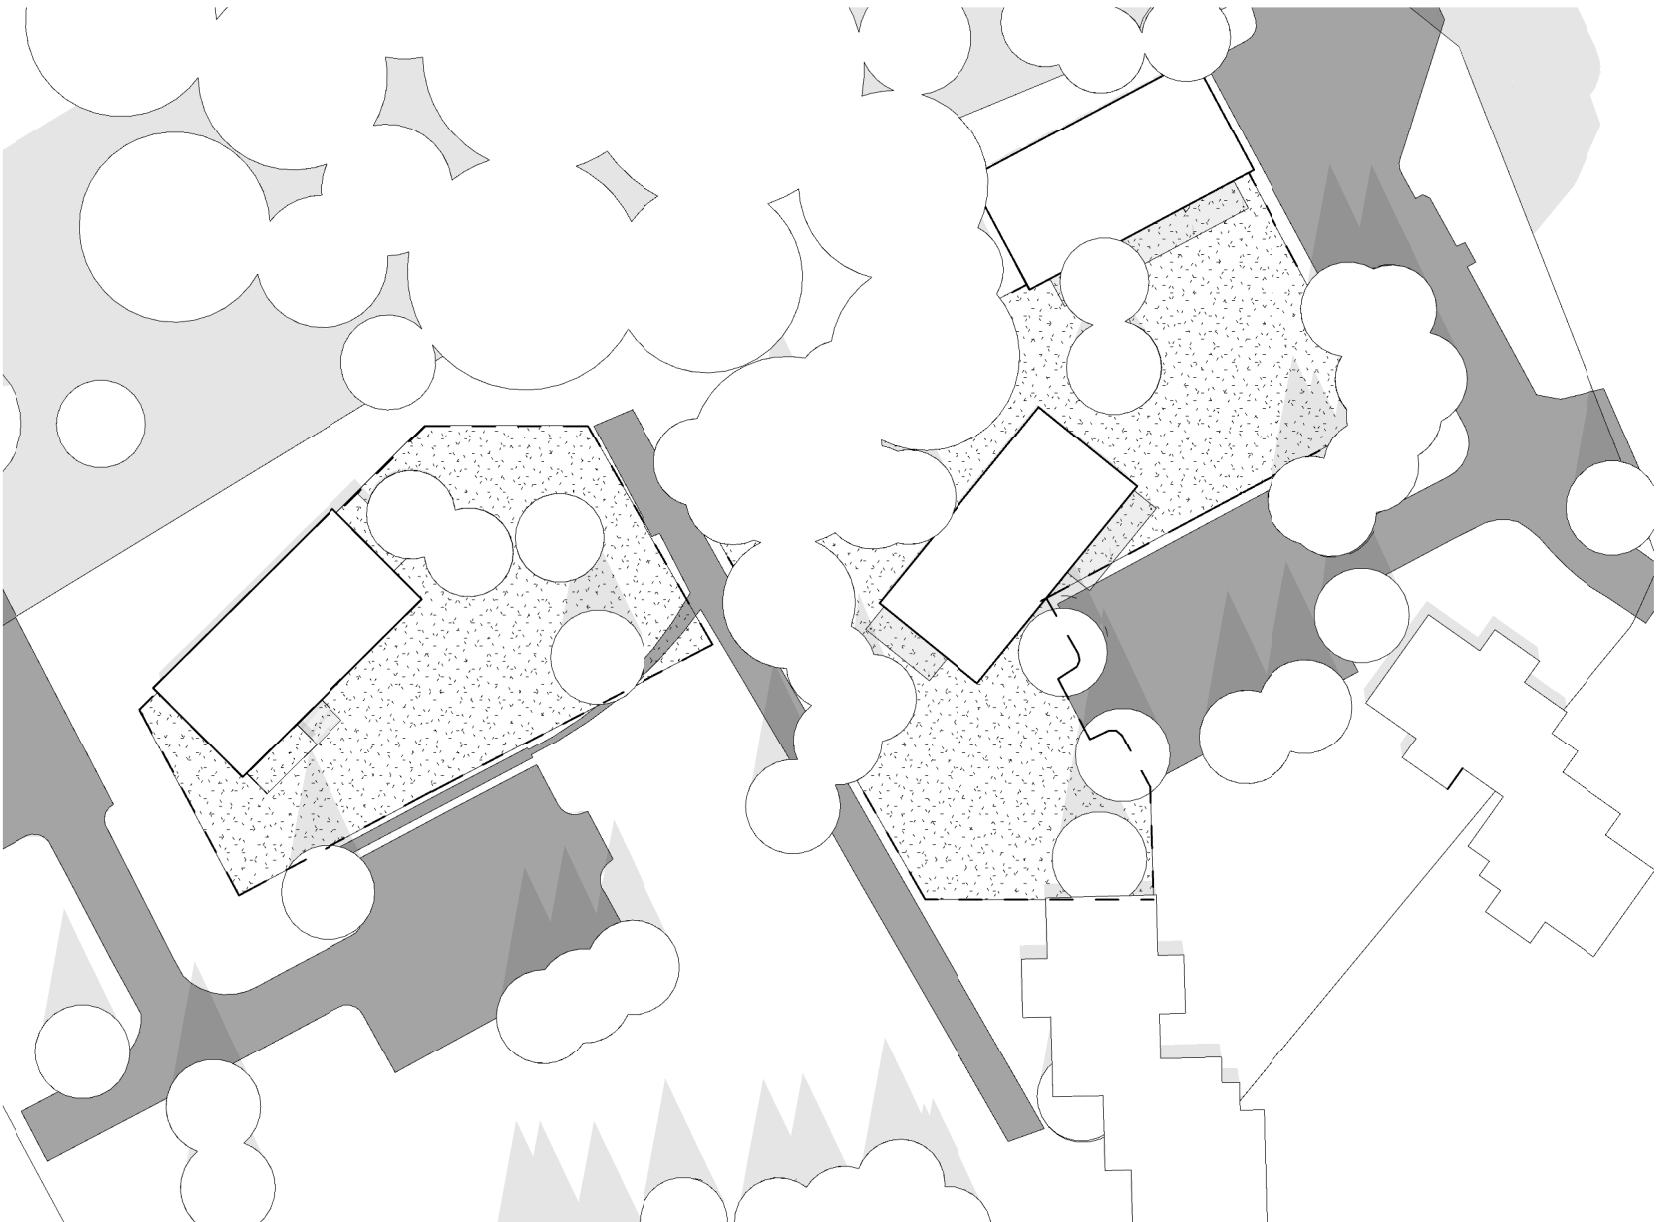
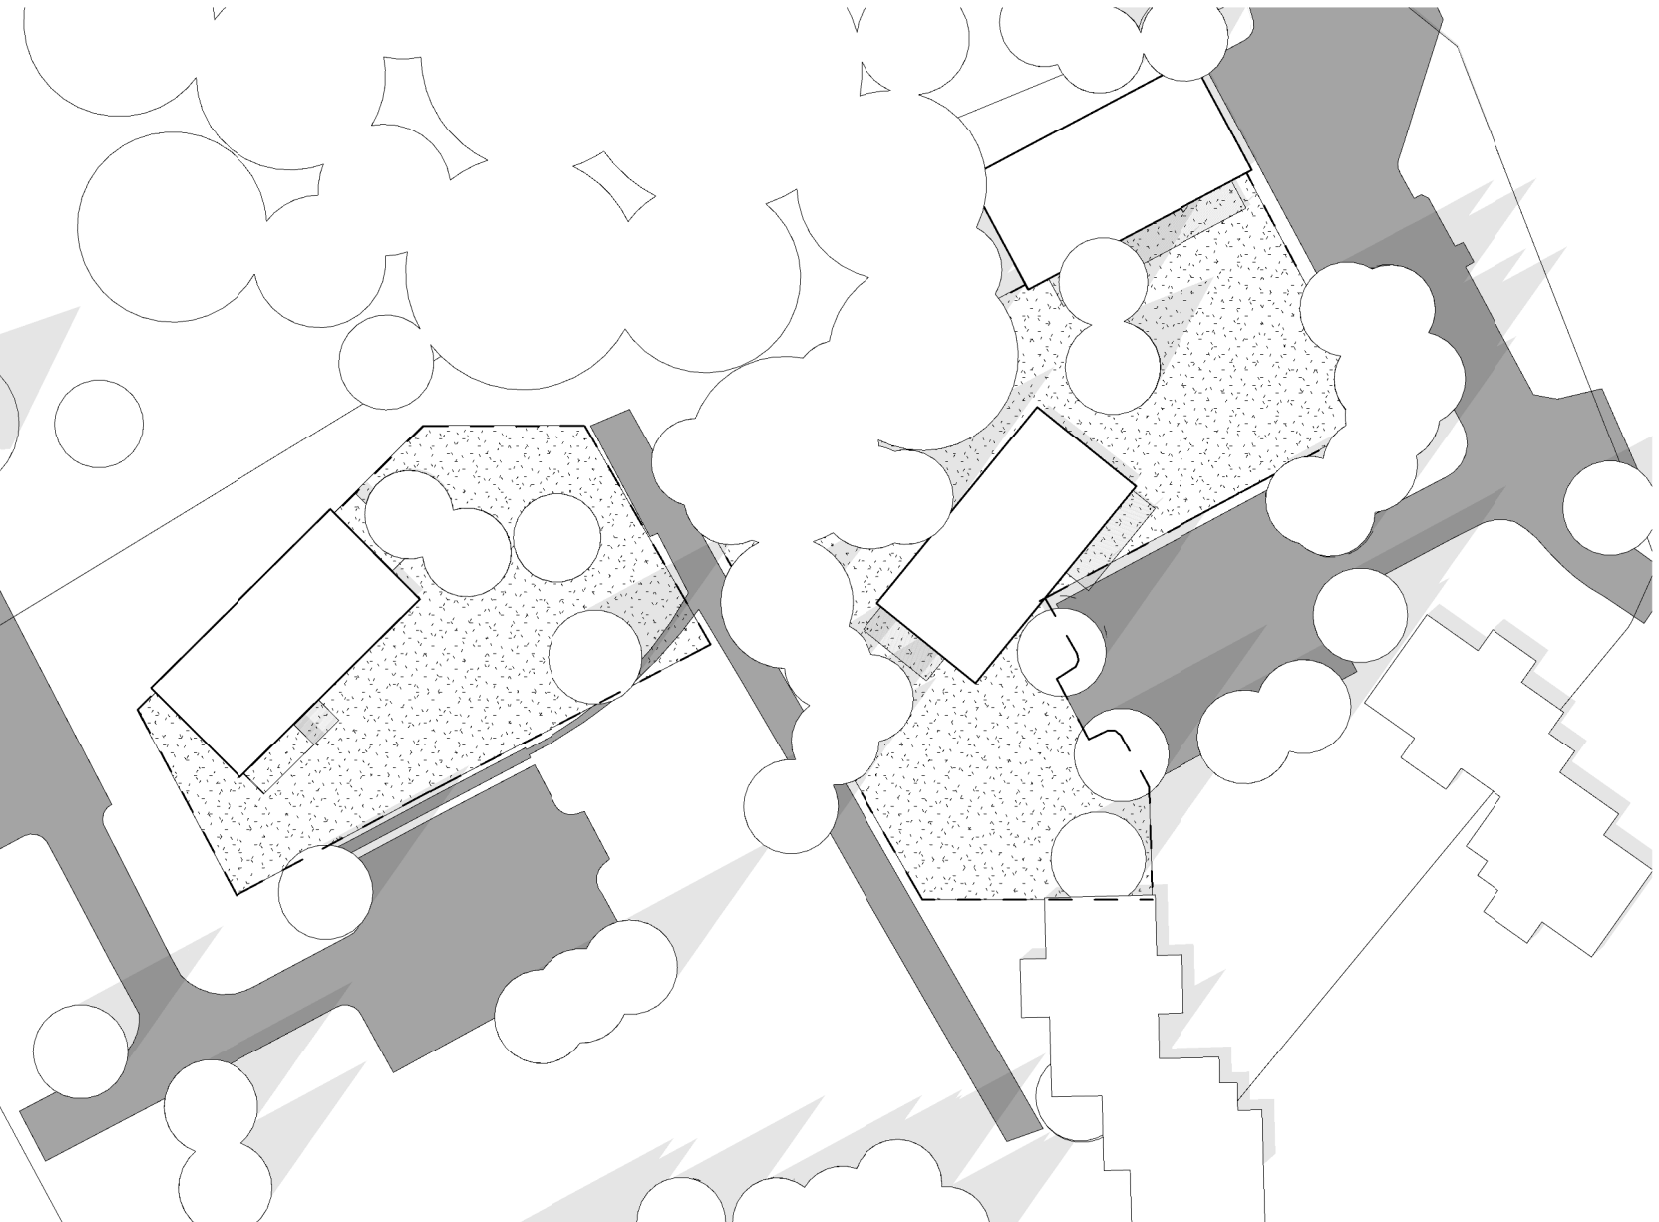
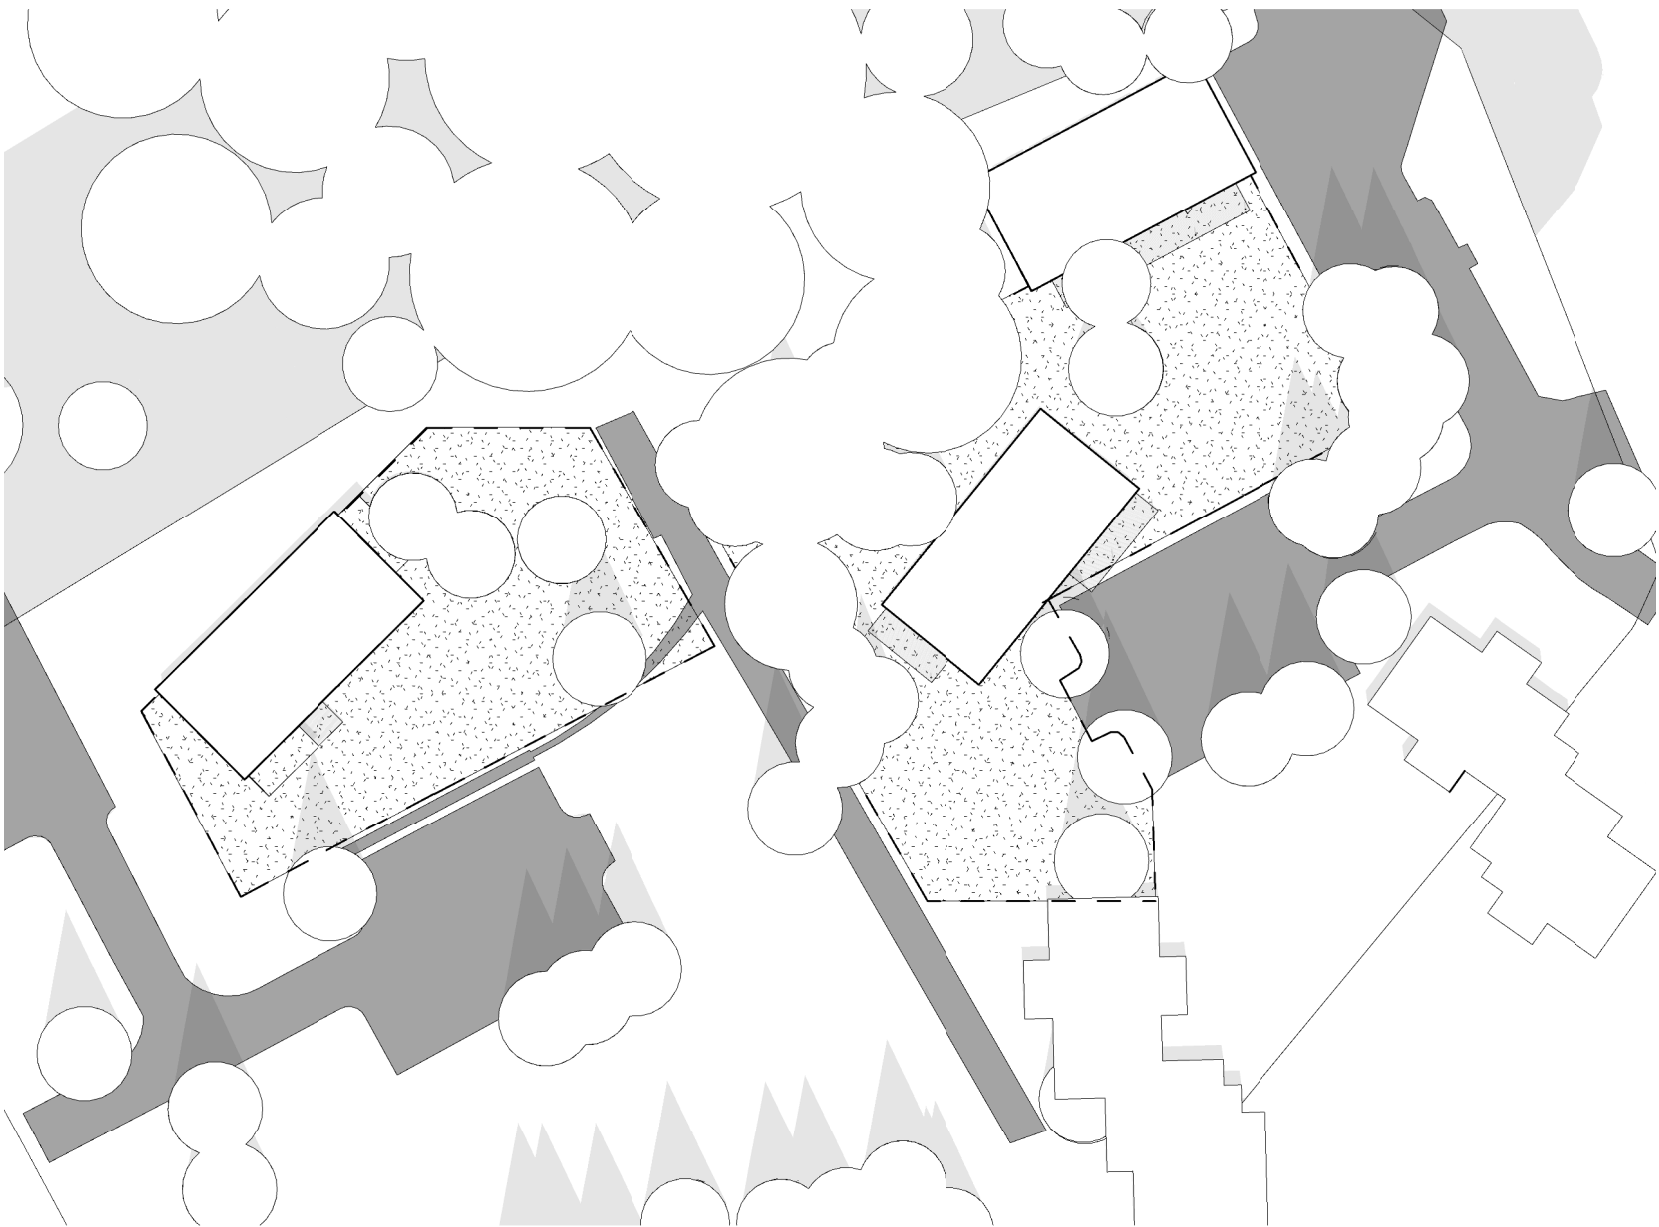
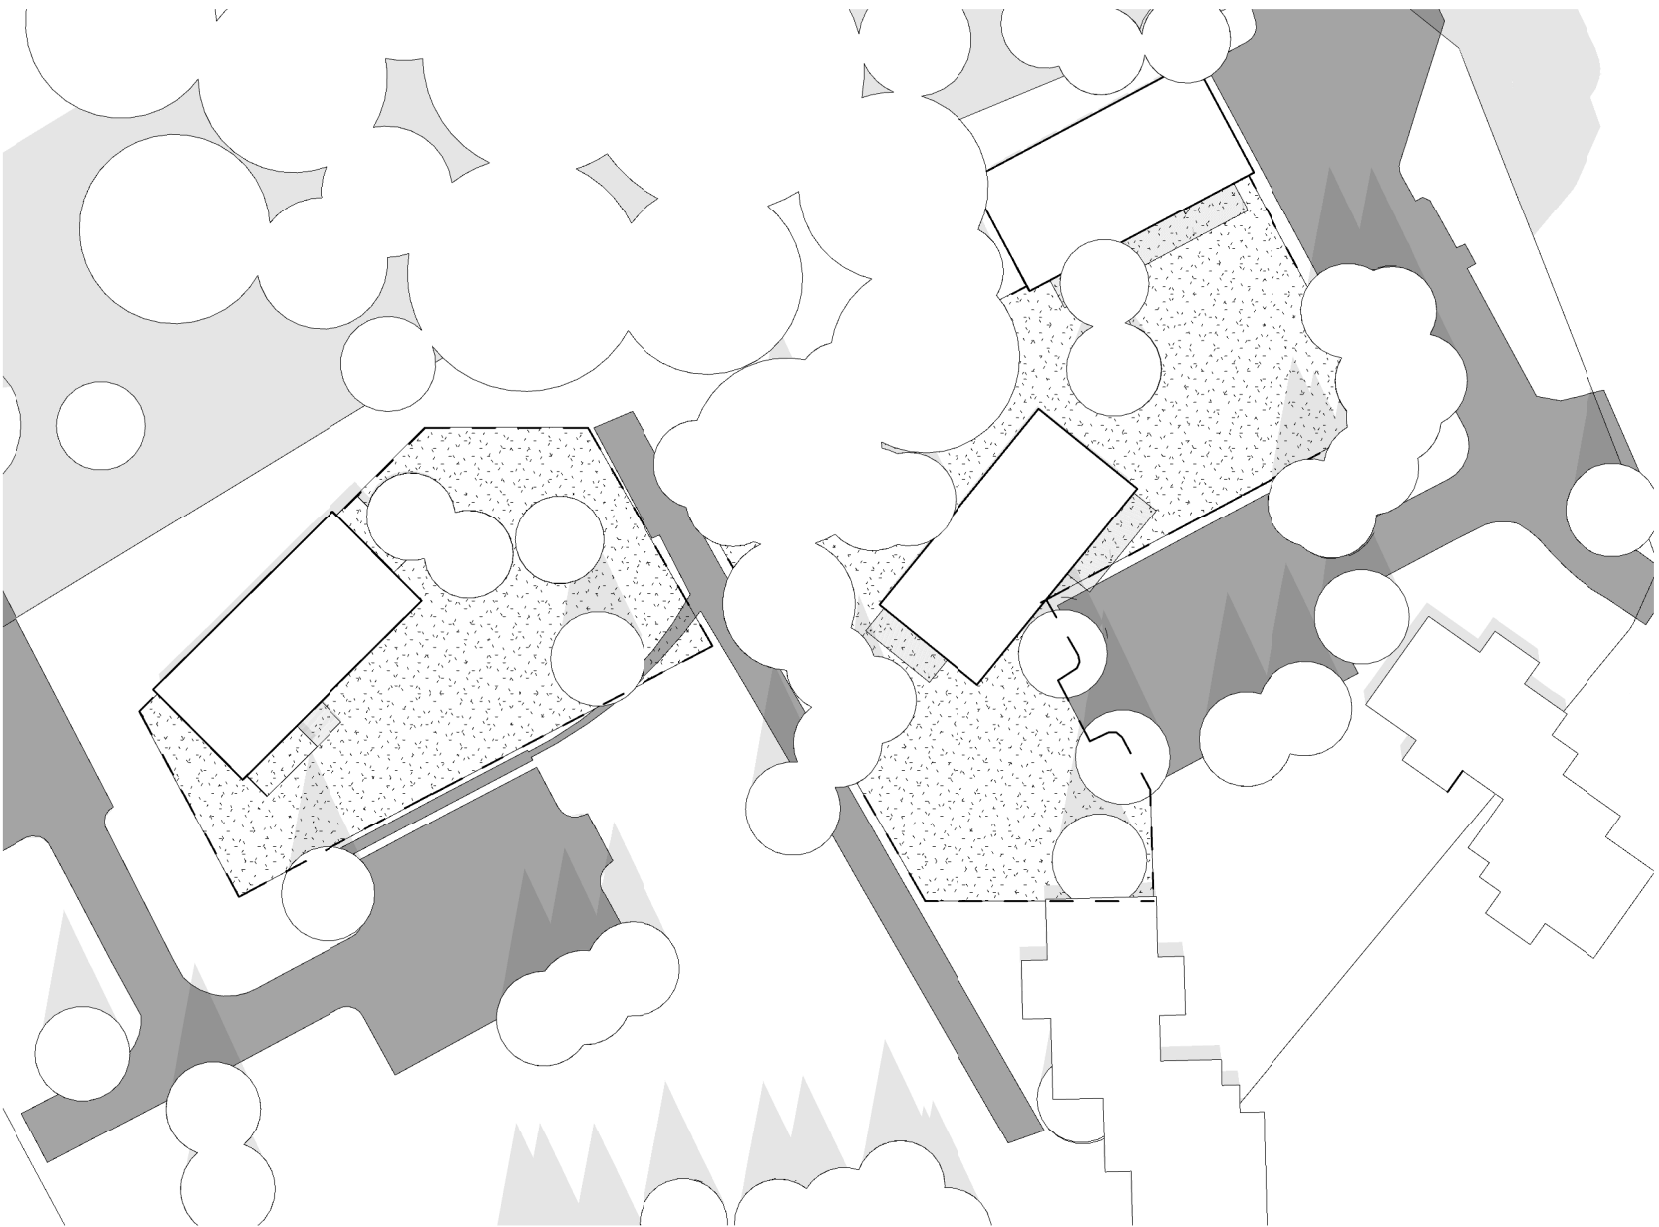
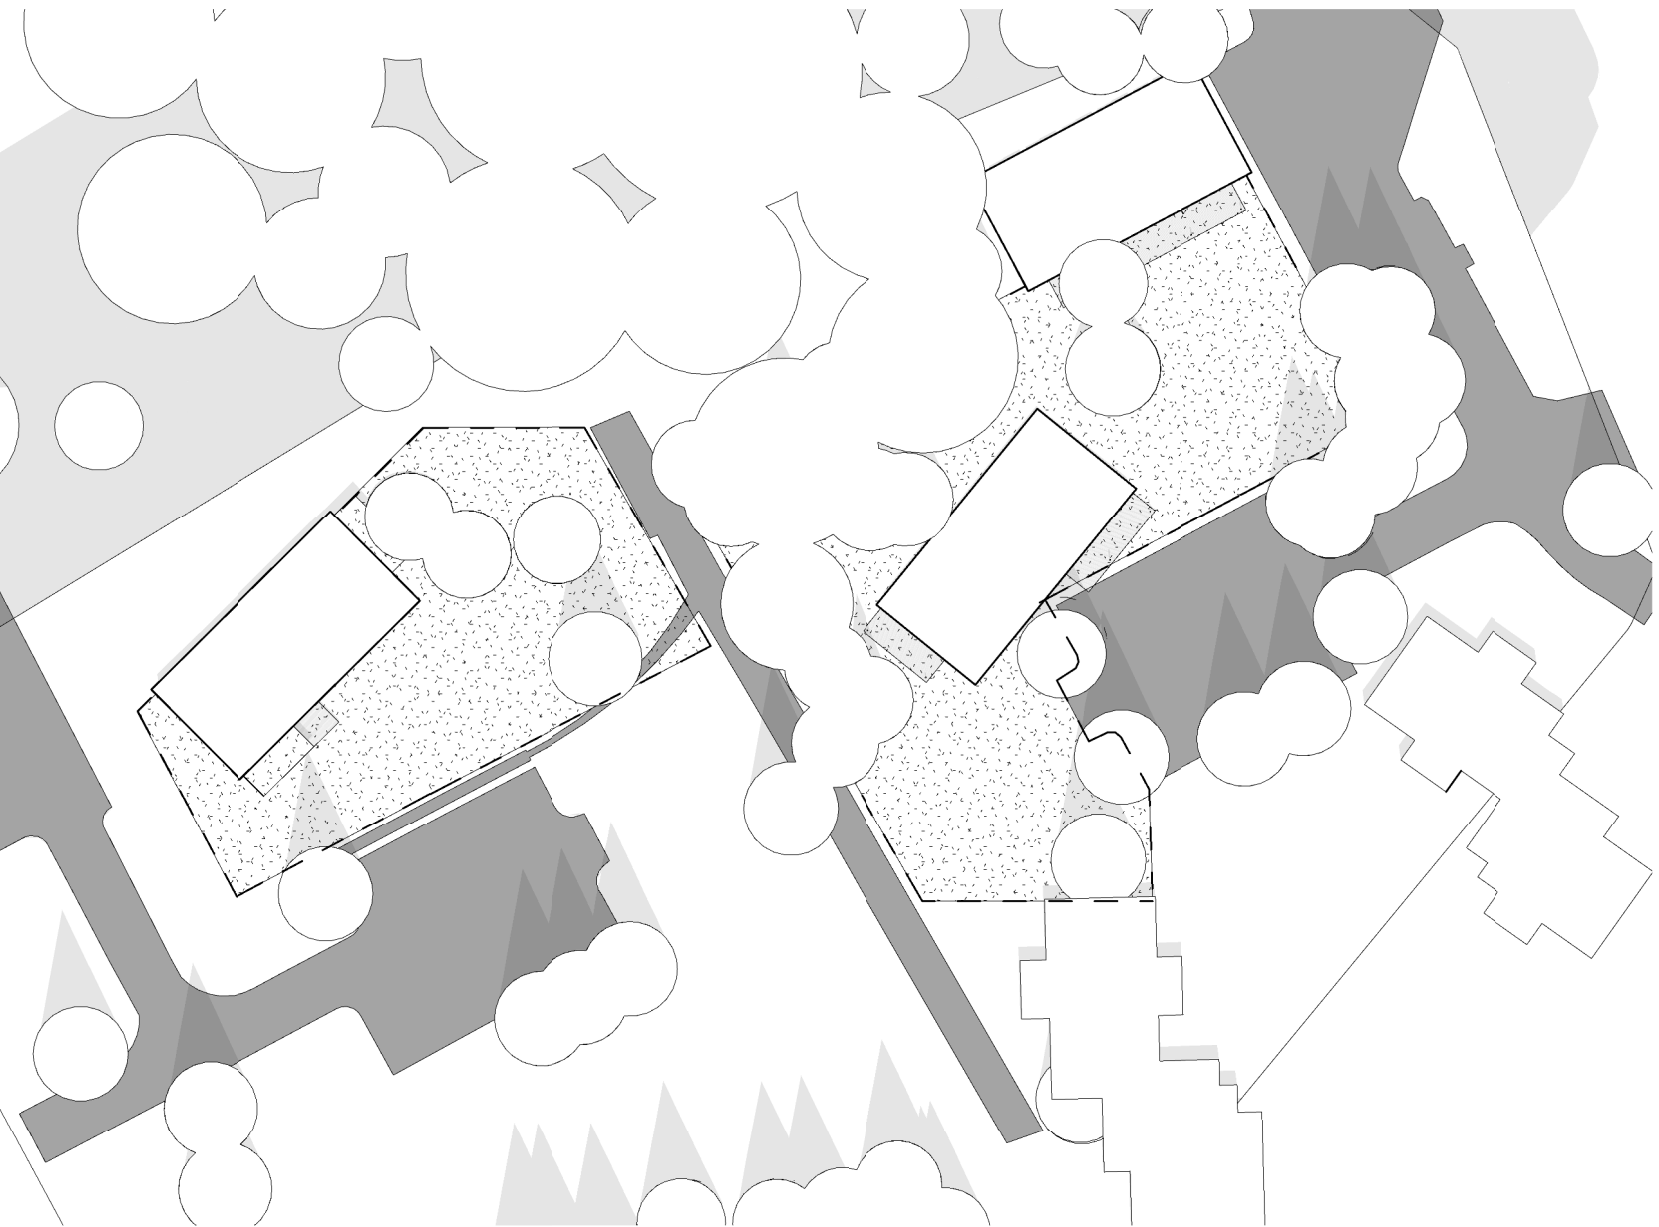
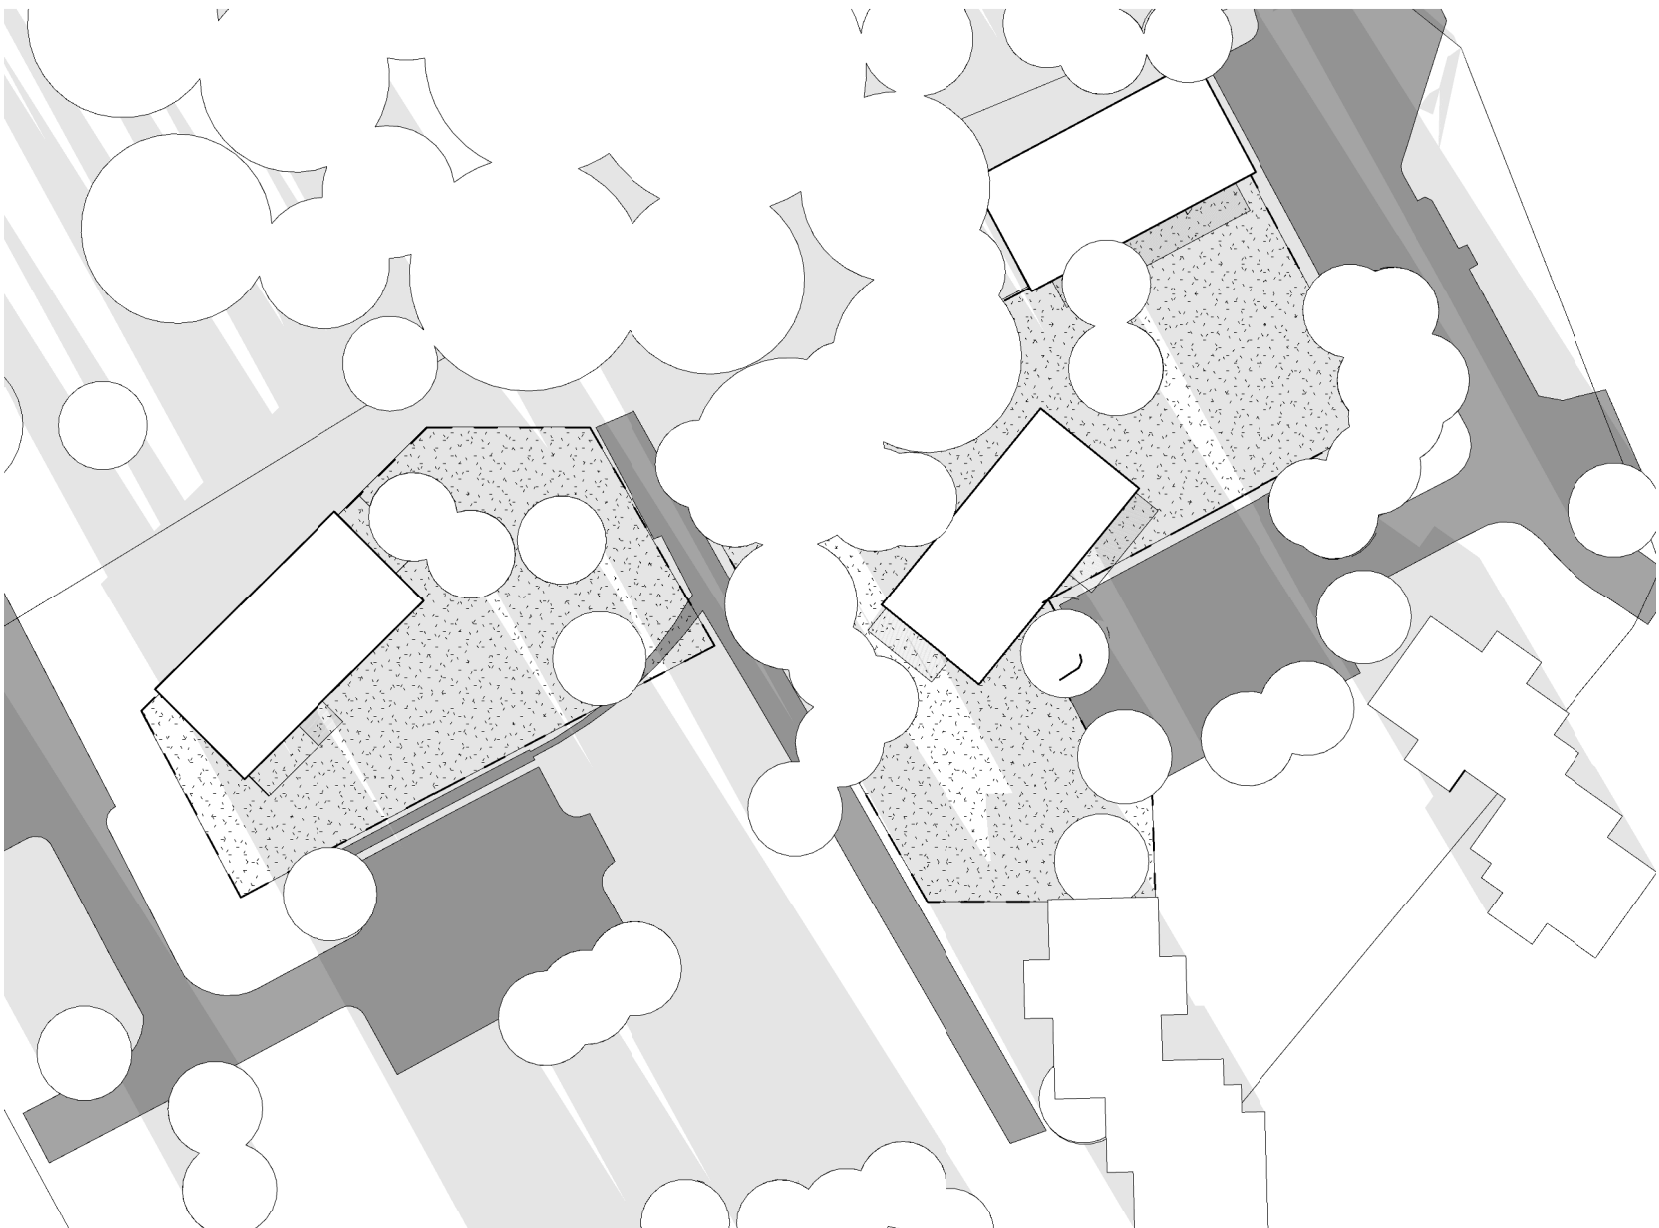
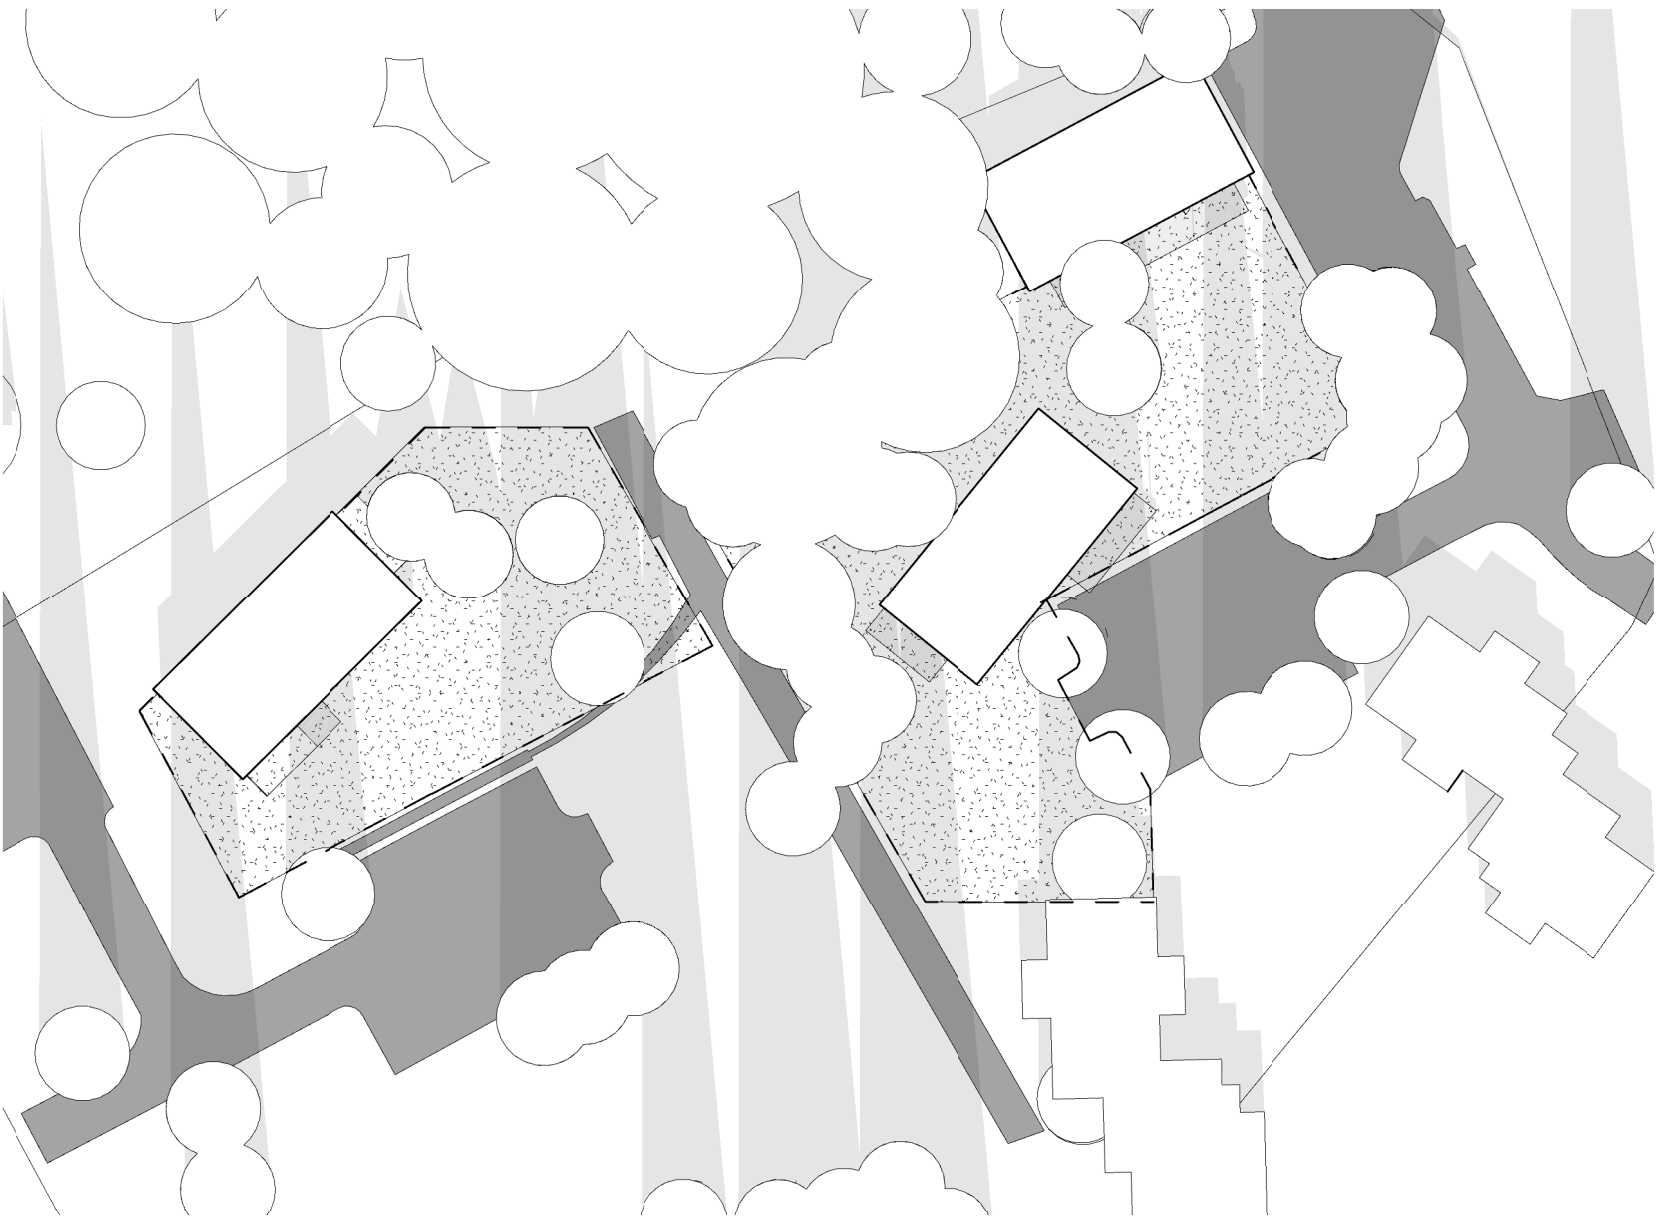
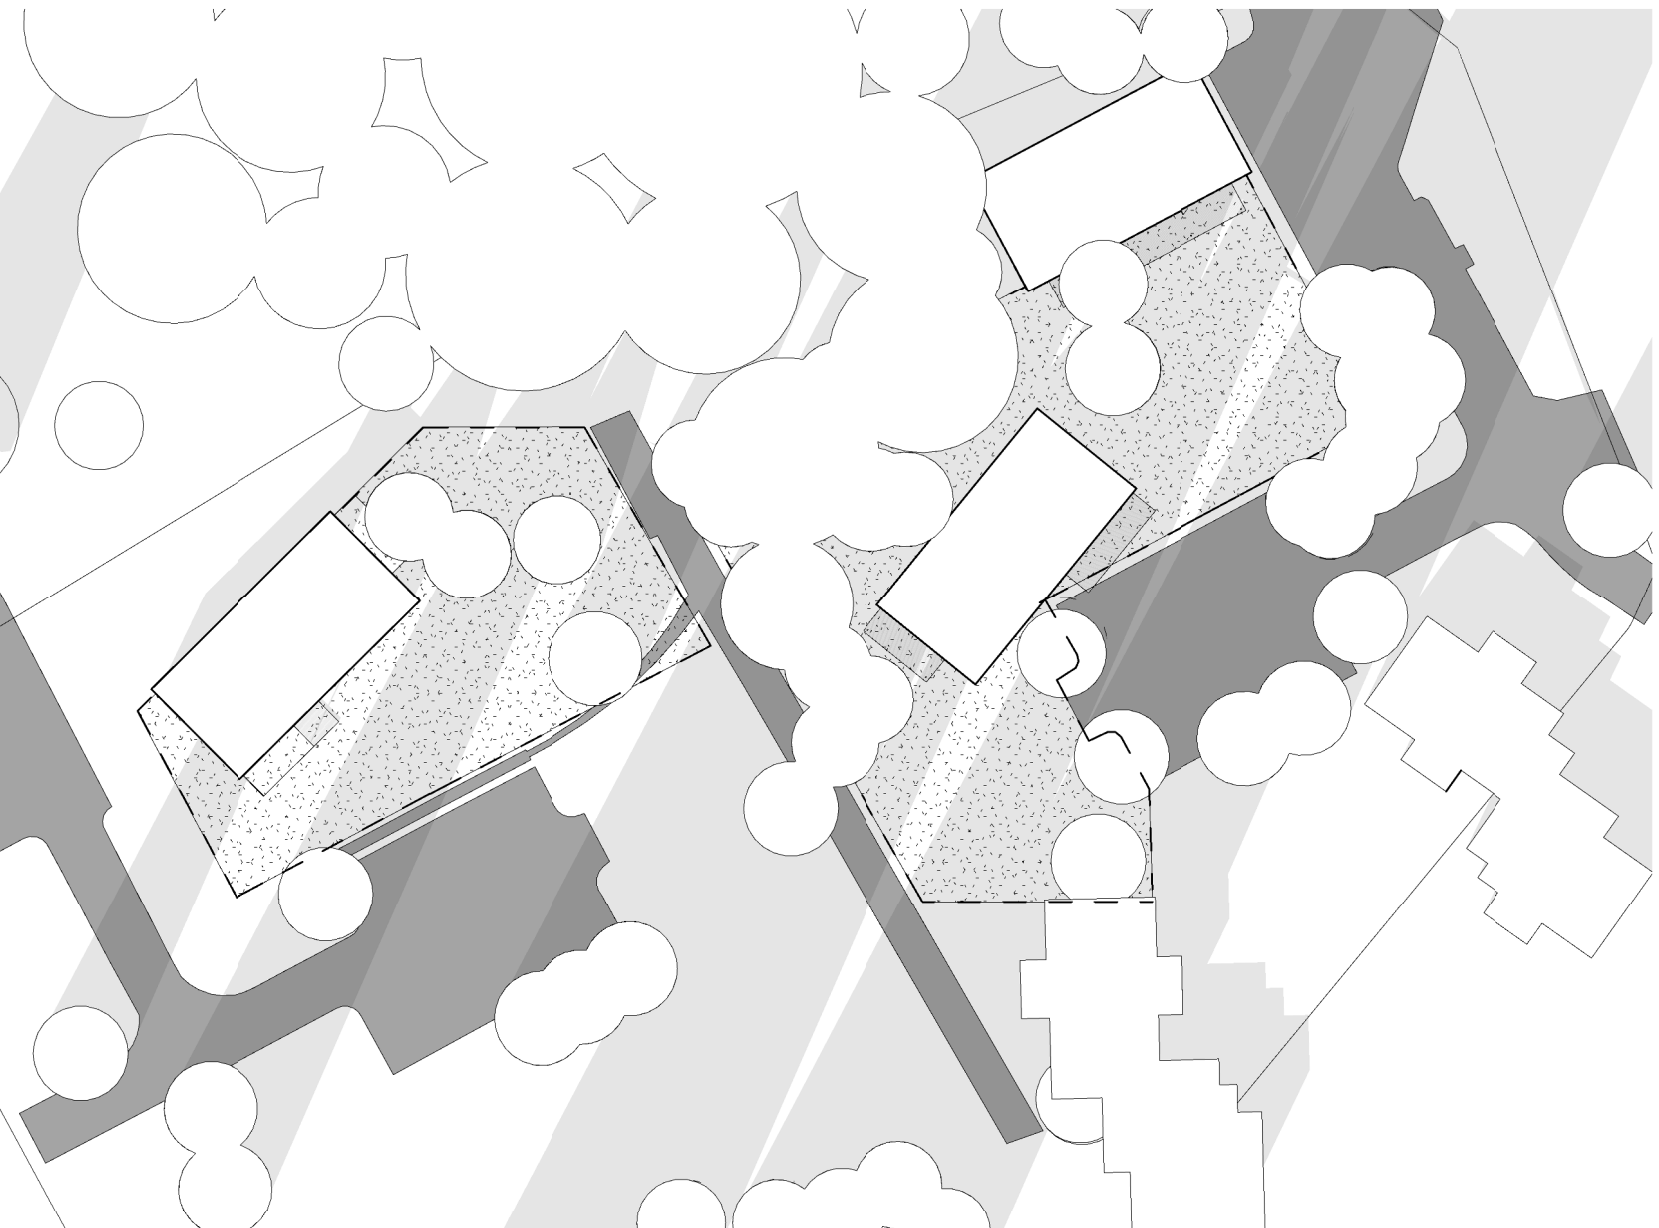
Shadow Studies

1 Jun 21 10 am

2 Jun 21 12pm

3 Jun 21 2 pm

4 Aug 01 10 am

5 Aug 01 12pm

6 Aug 01 2pm

7 Dec 22 10 am

8 Dec 22 12 am

9 Dec 22 2 pm
