# ACADIA MODULAR CHILDCARE

## University of British Columbia

UBC STUDENT HOUSING & HOSPITALITY SERVICES  
UBC CHILDCARE SERVICES  
ACADIA PARK

Acadia Modular  
Childcare

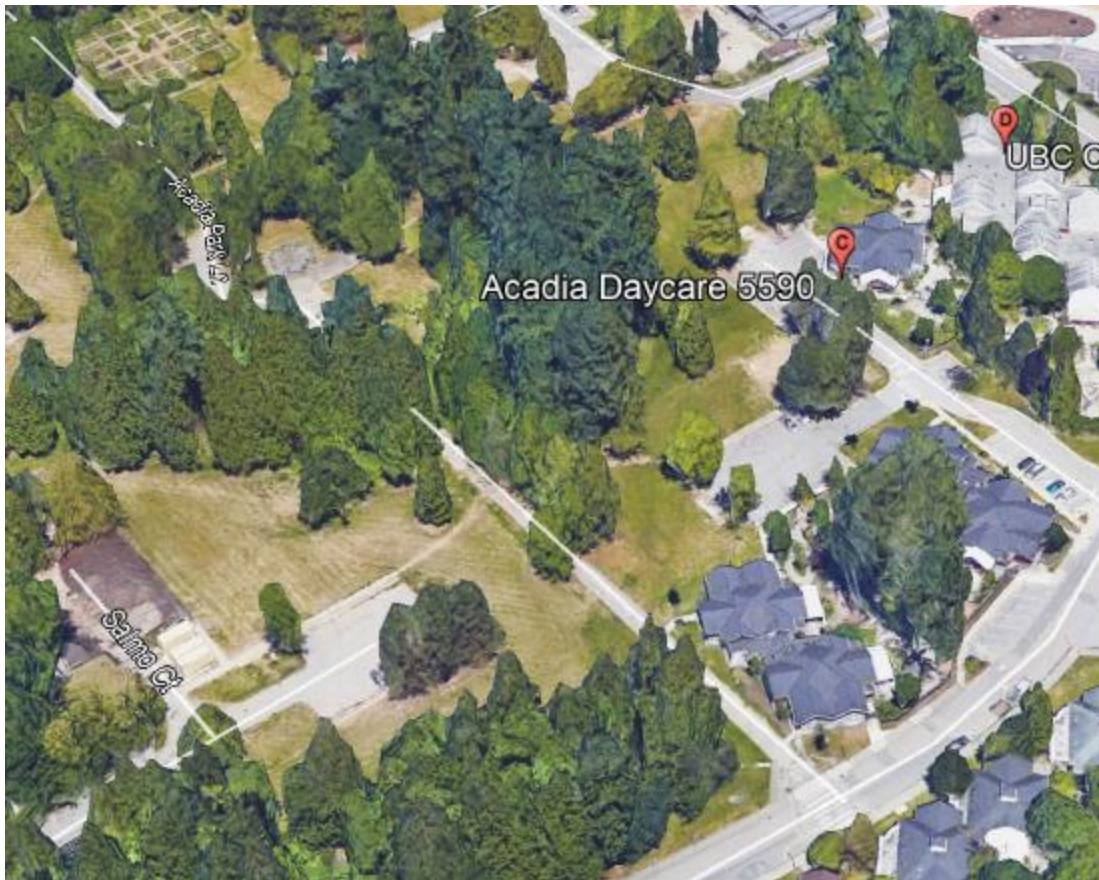
Figure 1. The three daycare sites are to be situated in areas near the middle of the photo (Air photo from Google Earth 2018).

Figure 1. The three daycare sites are to be situated in areas near the middle of the photo (Air photo from Google Earth 2018. ....	5
Figure 2. Tree protection and removal plan .....	7

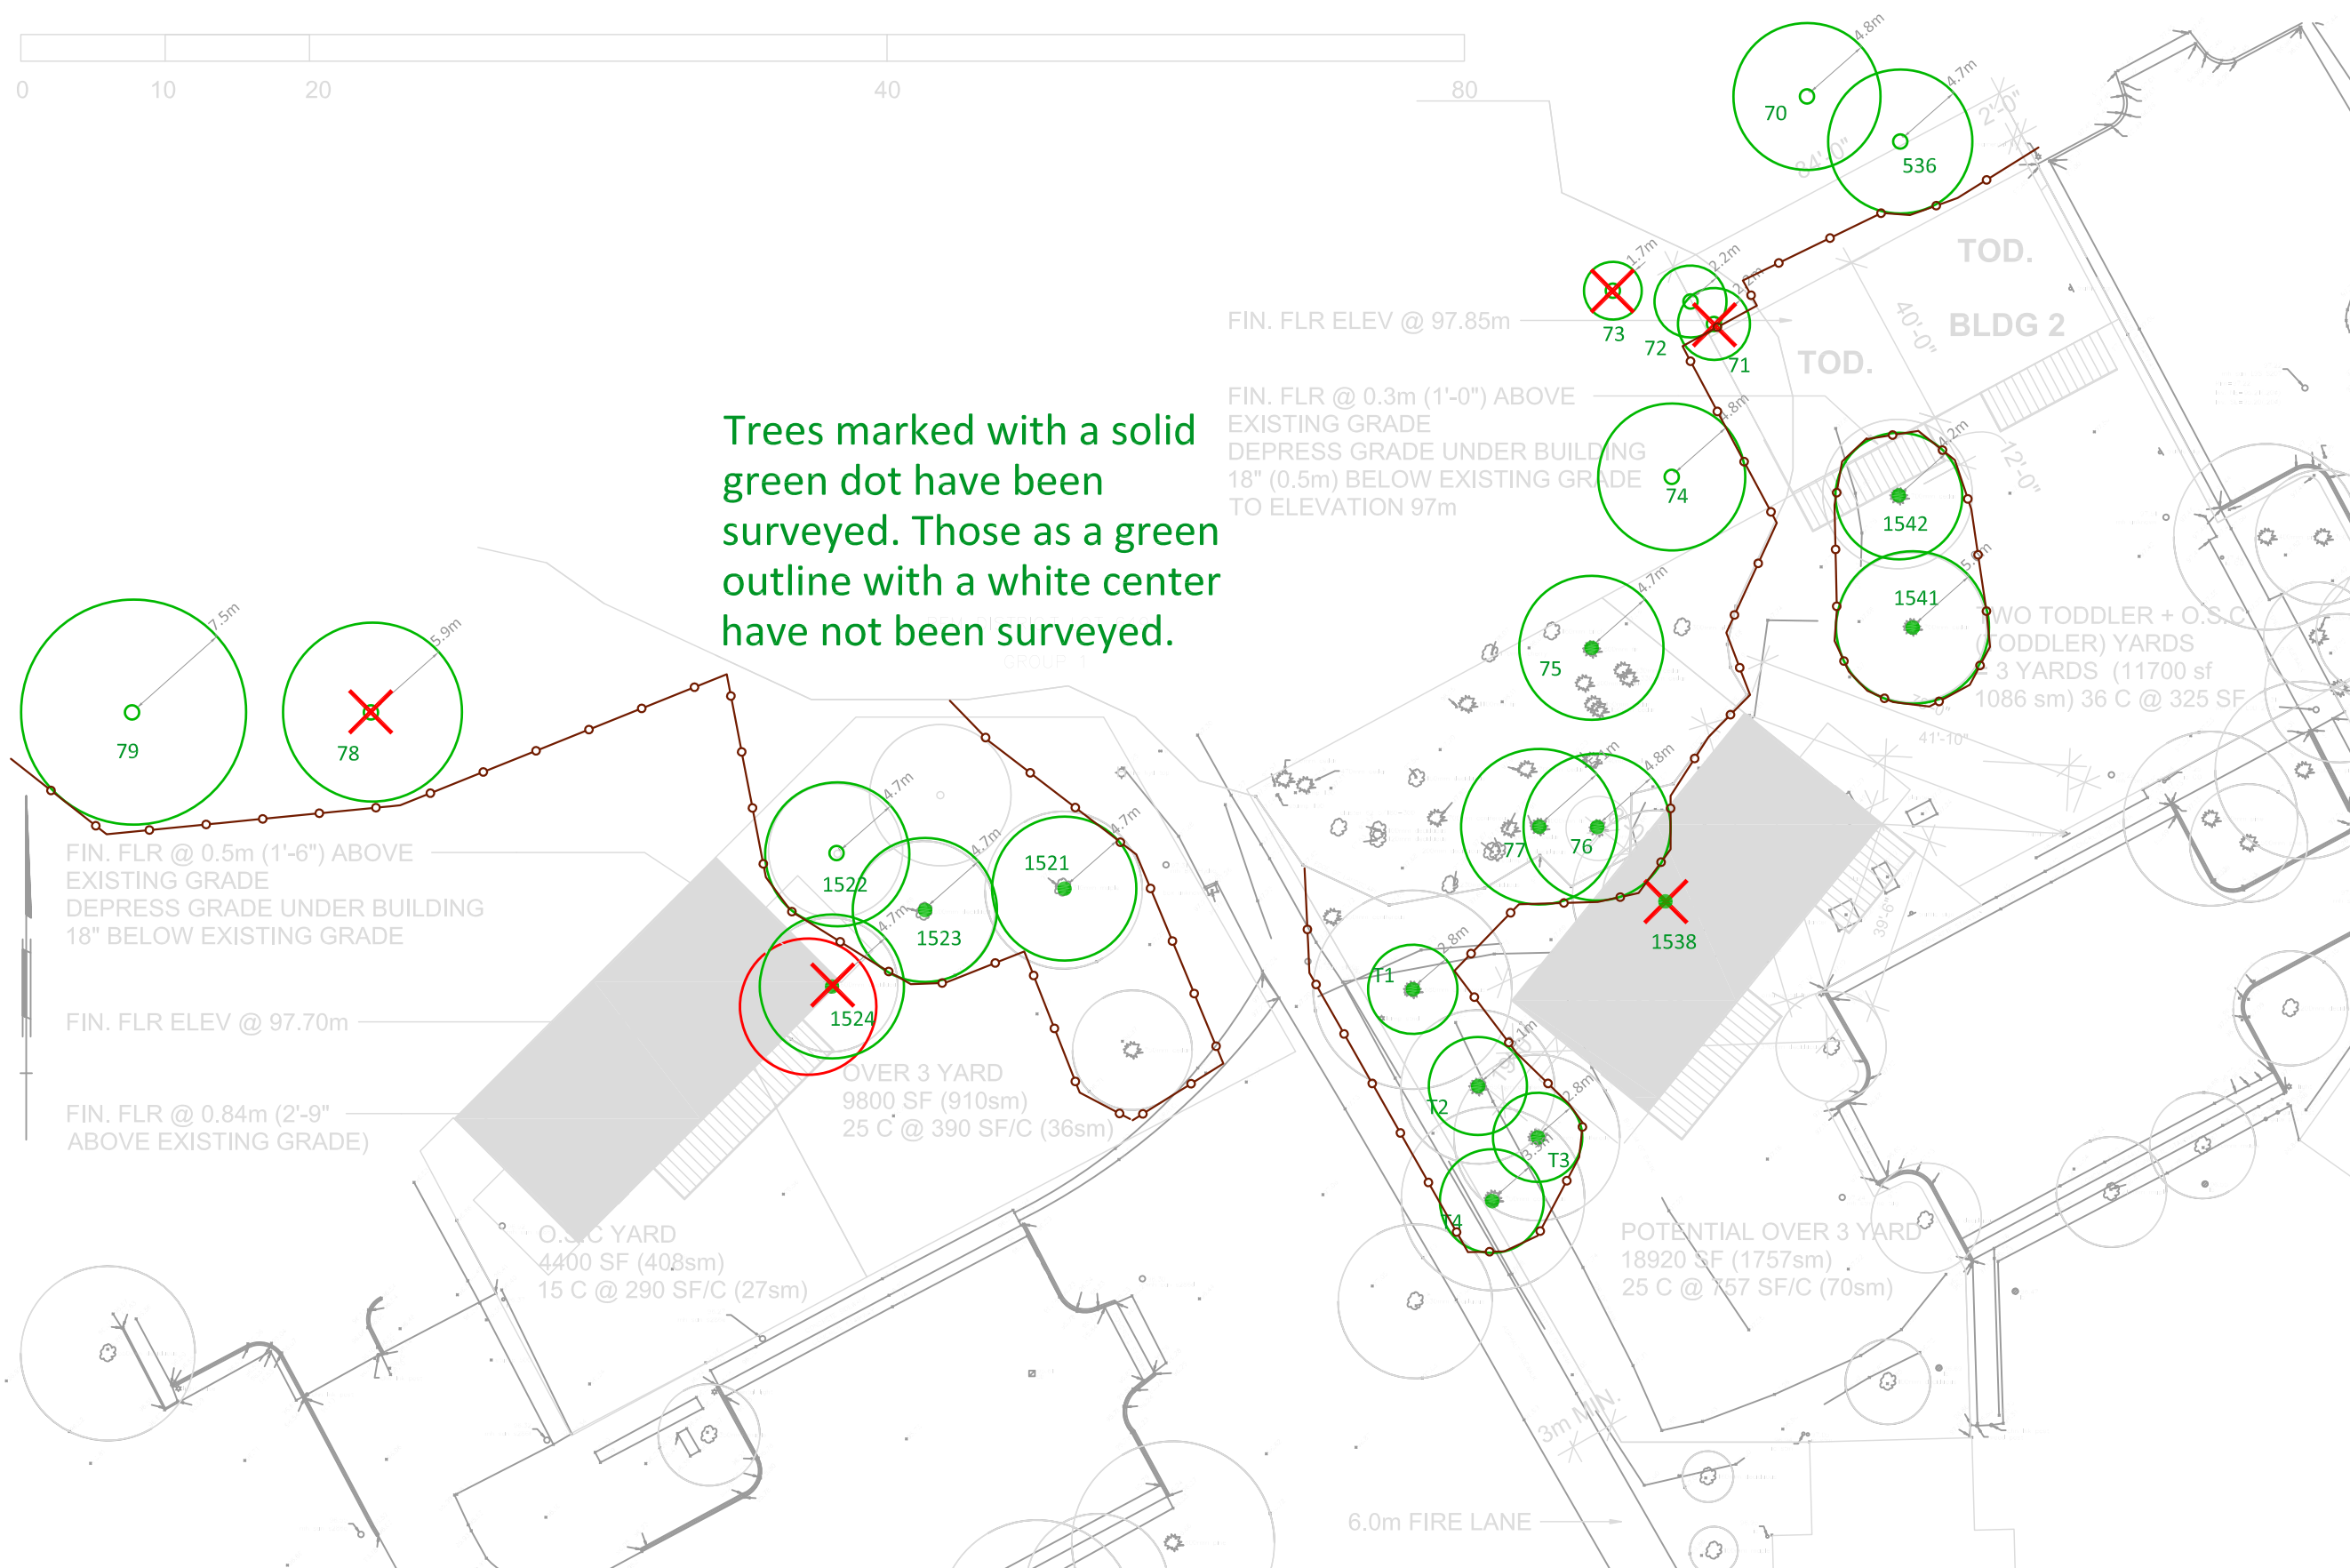
Trees marked with a solid green dot have been surveyed. Those as a green outline with a white center have not been surveyed.

The complete tree inventory below contains information on tree attributes and recommendations for removal or retention. Tree ownership in this inventory table is not definitive, its determination here is based on information available from the legal site survey, GPS locations, and field assessment during site visits. Critical Root Zones are measured from the outer edge of a tree's stem and are generally used to delineate the Tree Protection Zone. If using these measurements for mapping the tree protection zone, ½ the tree's diameter must be added to the distance to accommodate a survey point at the tree's center. Where Tree Protection Zones are proposed to vary from the CRZ, comments will be included in the Retention/TPZ comments and shown on the Tree Retention and Removal Plan. Trees T1-T4 have not been tagged in the field.

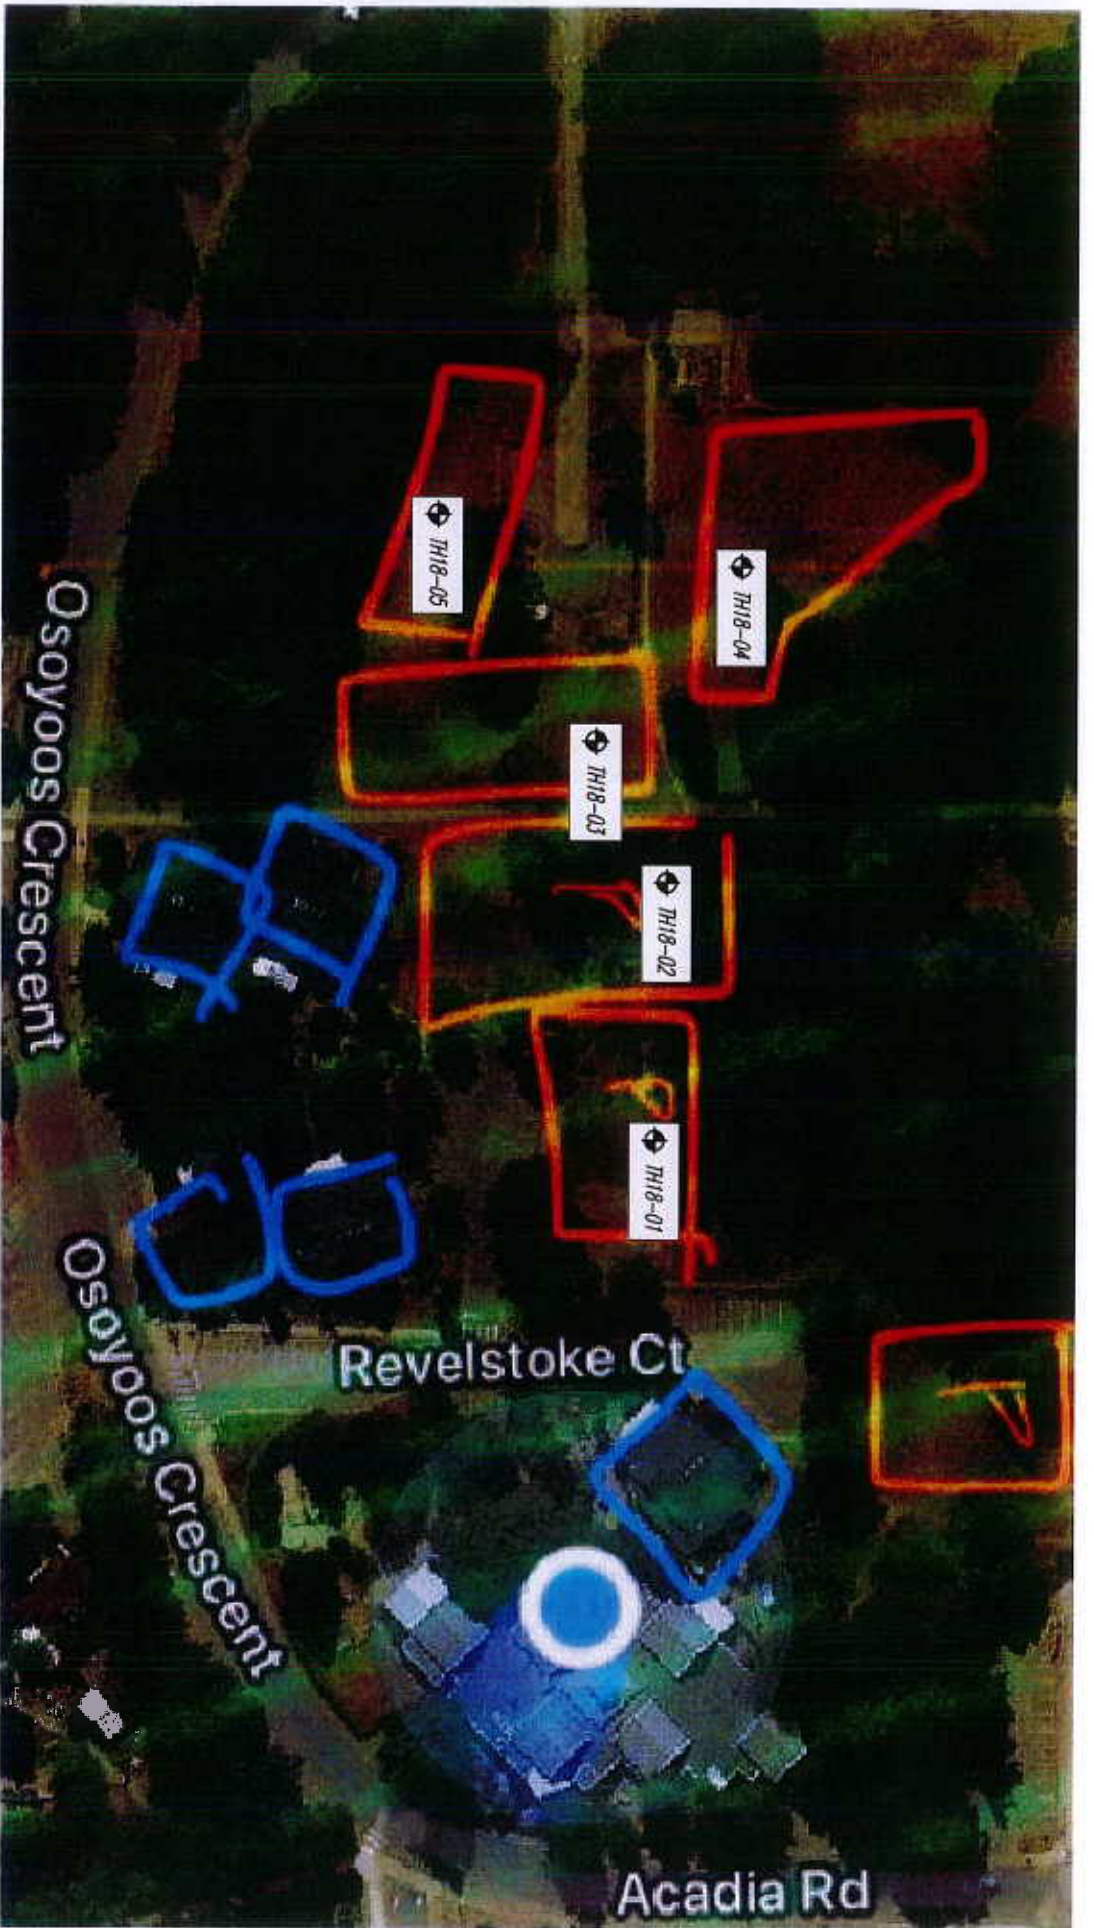
### **Test Hole Logs**

TH18-# - TEST HOLE (TH) LOCATIONS
