DEVELOPMENT PERMIT APPLICATION MUSEUM OF ANTHROPOLOGY at the UNIVERSITY OF BRITISH COLUMBIA

VEGETATION, SITE AND SITE ELEMENT PROTECTION, PRESERVATION, RESTORATION AND REHABILITATION GREAT HALL AND SKYLIGHT UPGRADES

GREAT HALL SEISMIC UPGRADE

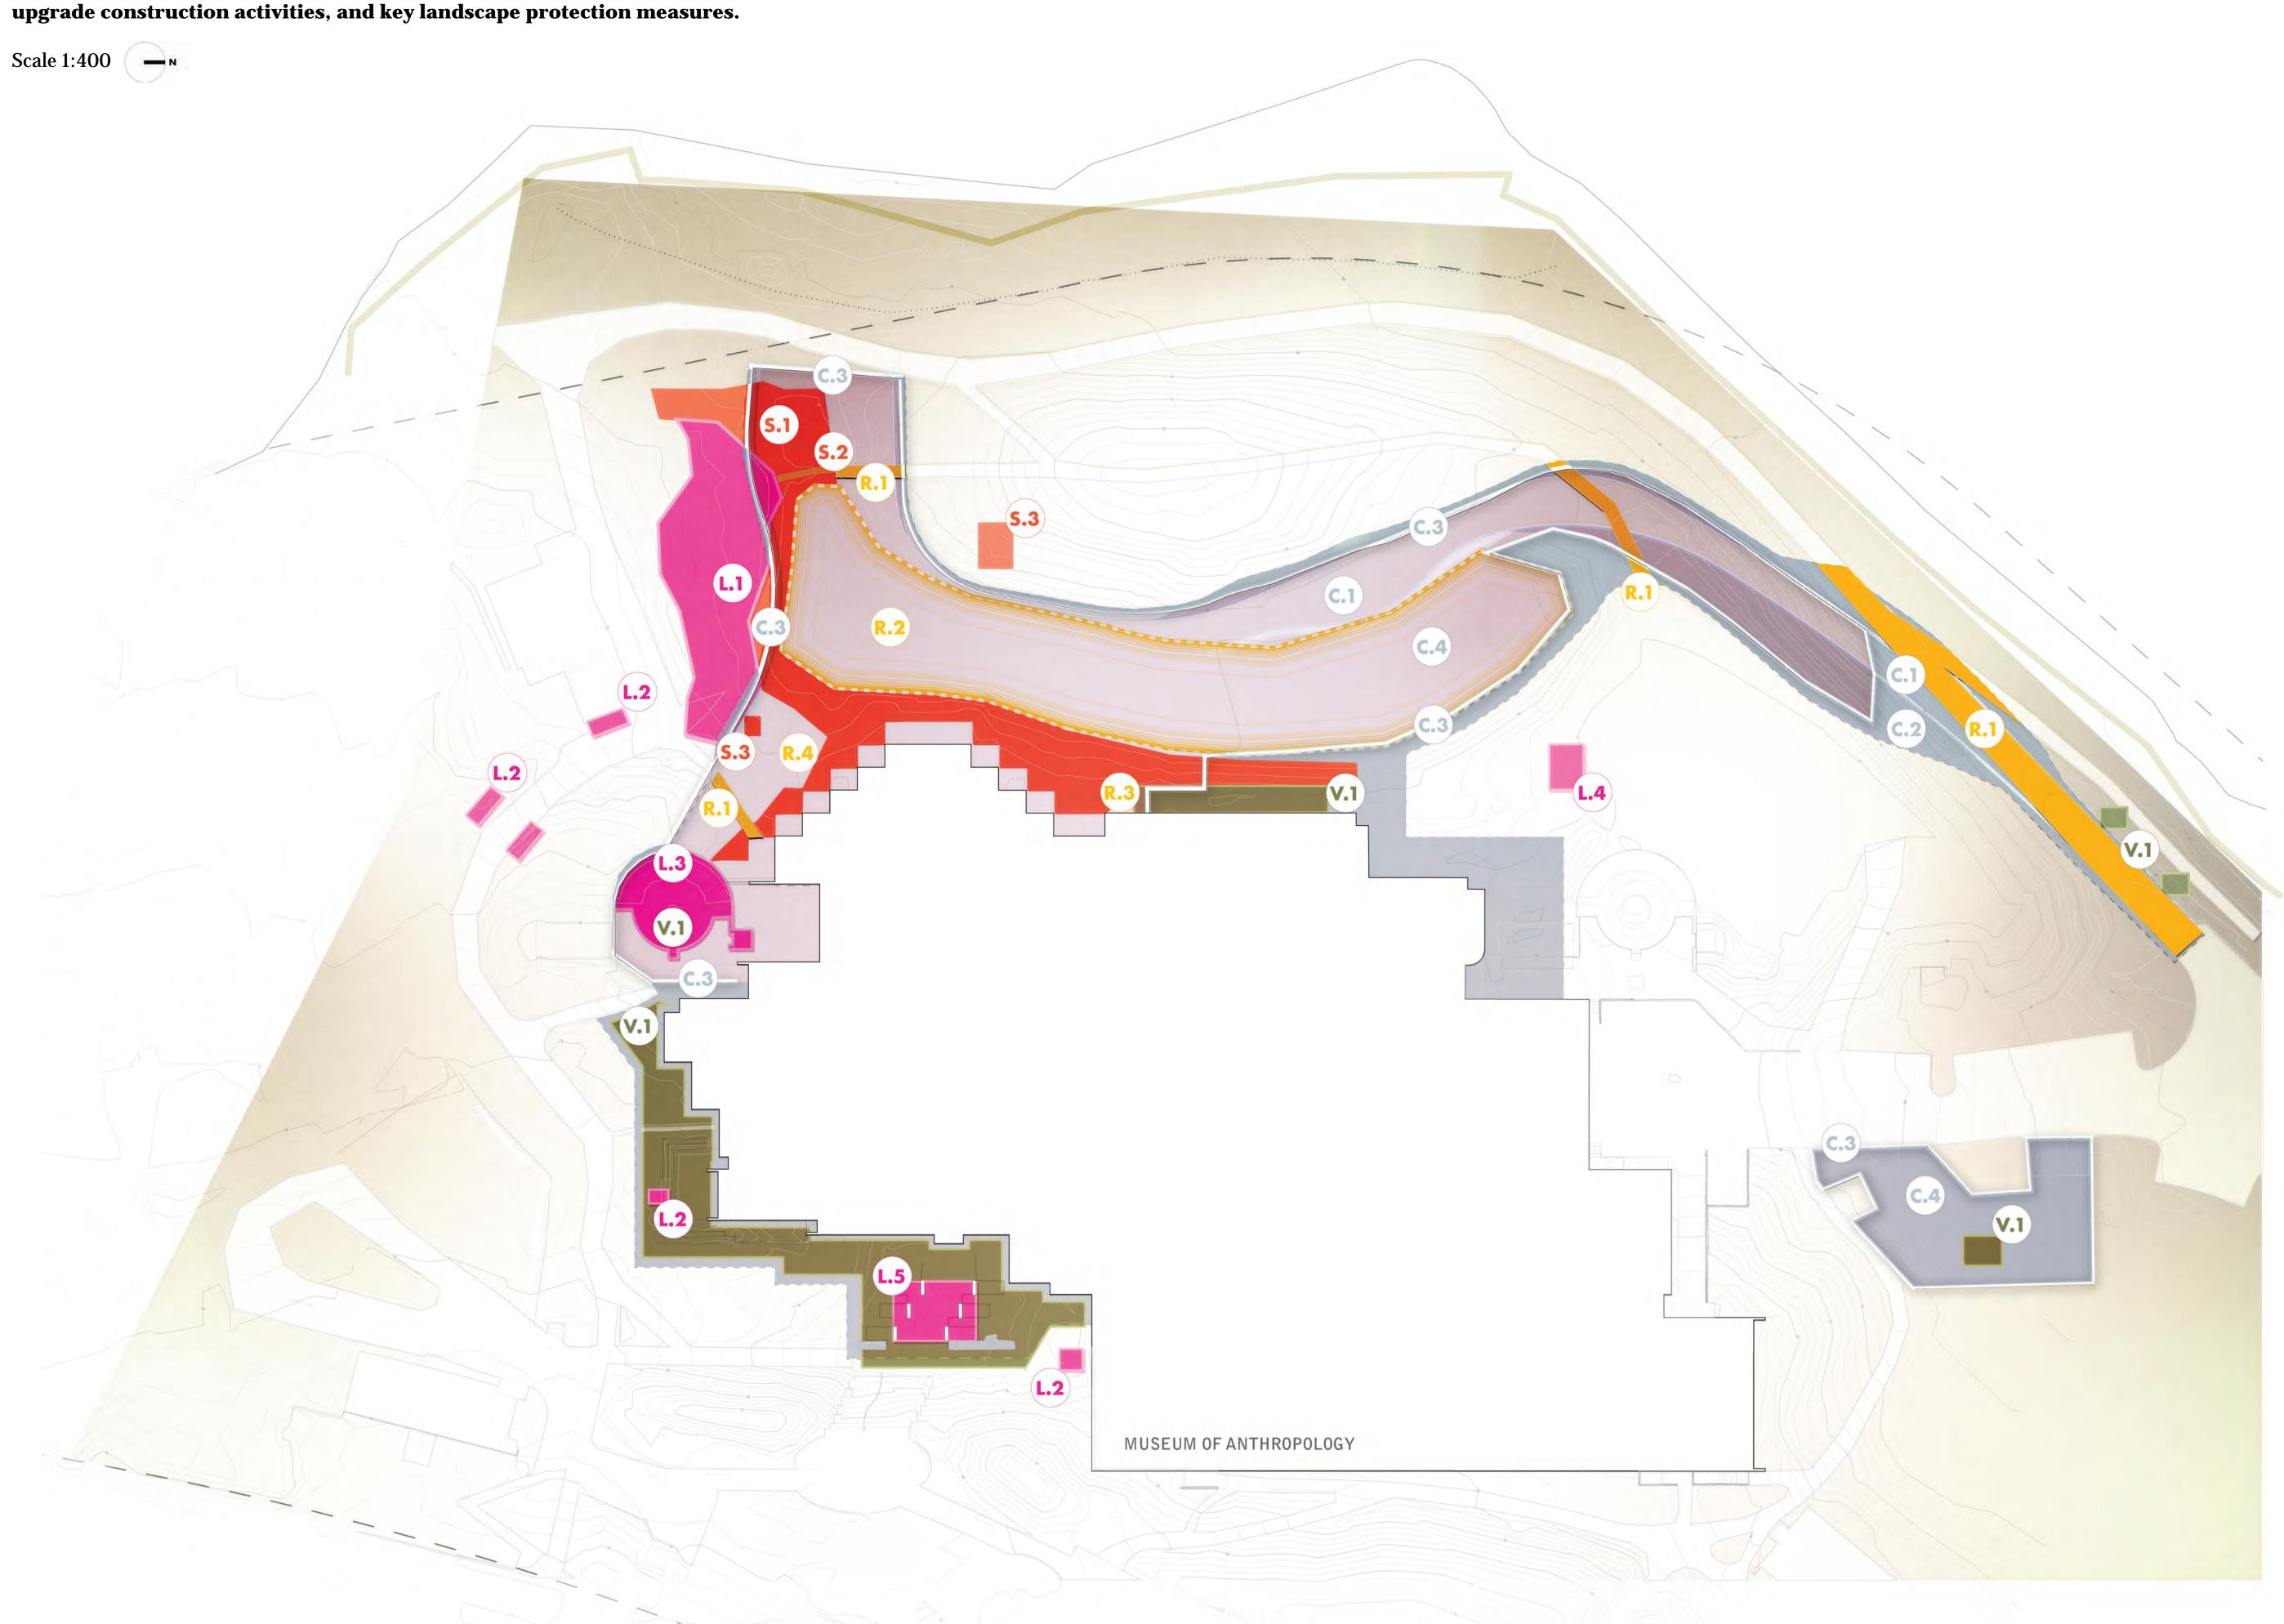
Protecting an Iconic Landscape Critical Areas to be Protected During Construction

Plan showing site area potentially impacted by Great Hall seismic and envelope upgrade construction activities, and key landscape protection measures.

Proposed Areas where Construction will Impact the Landscape. Protection and restoration will be undertaken.

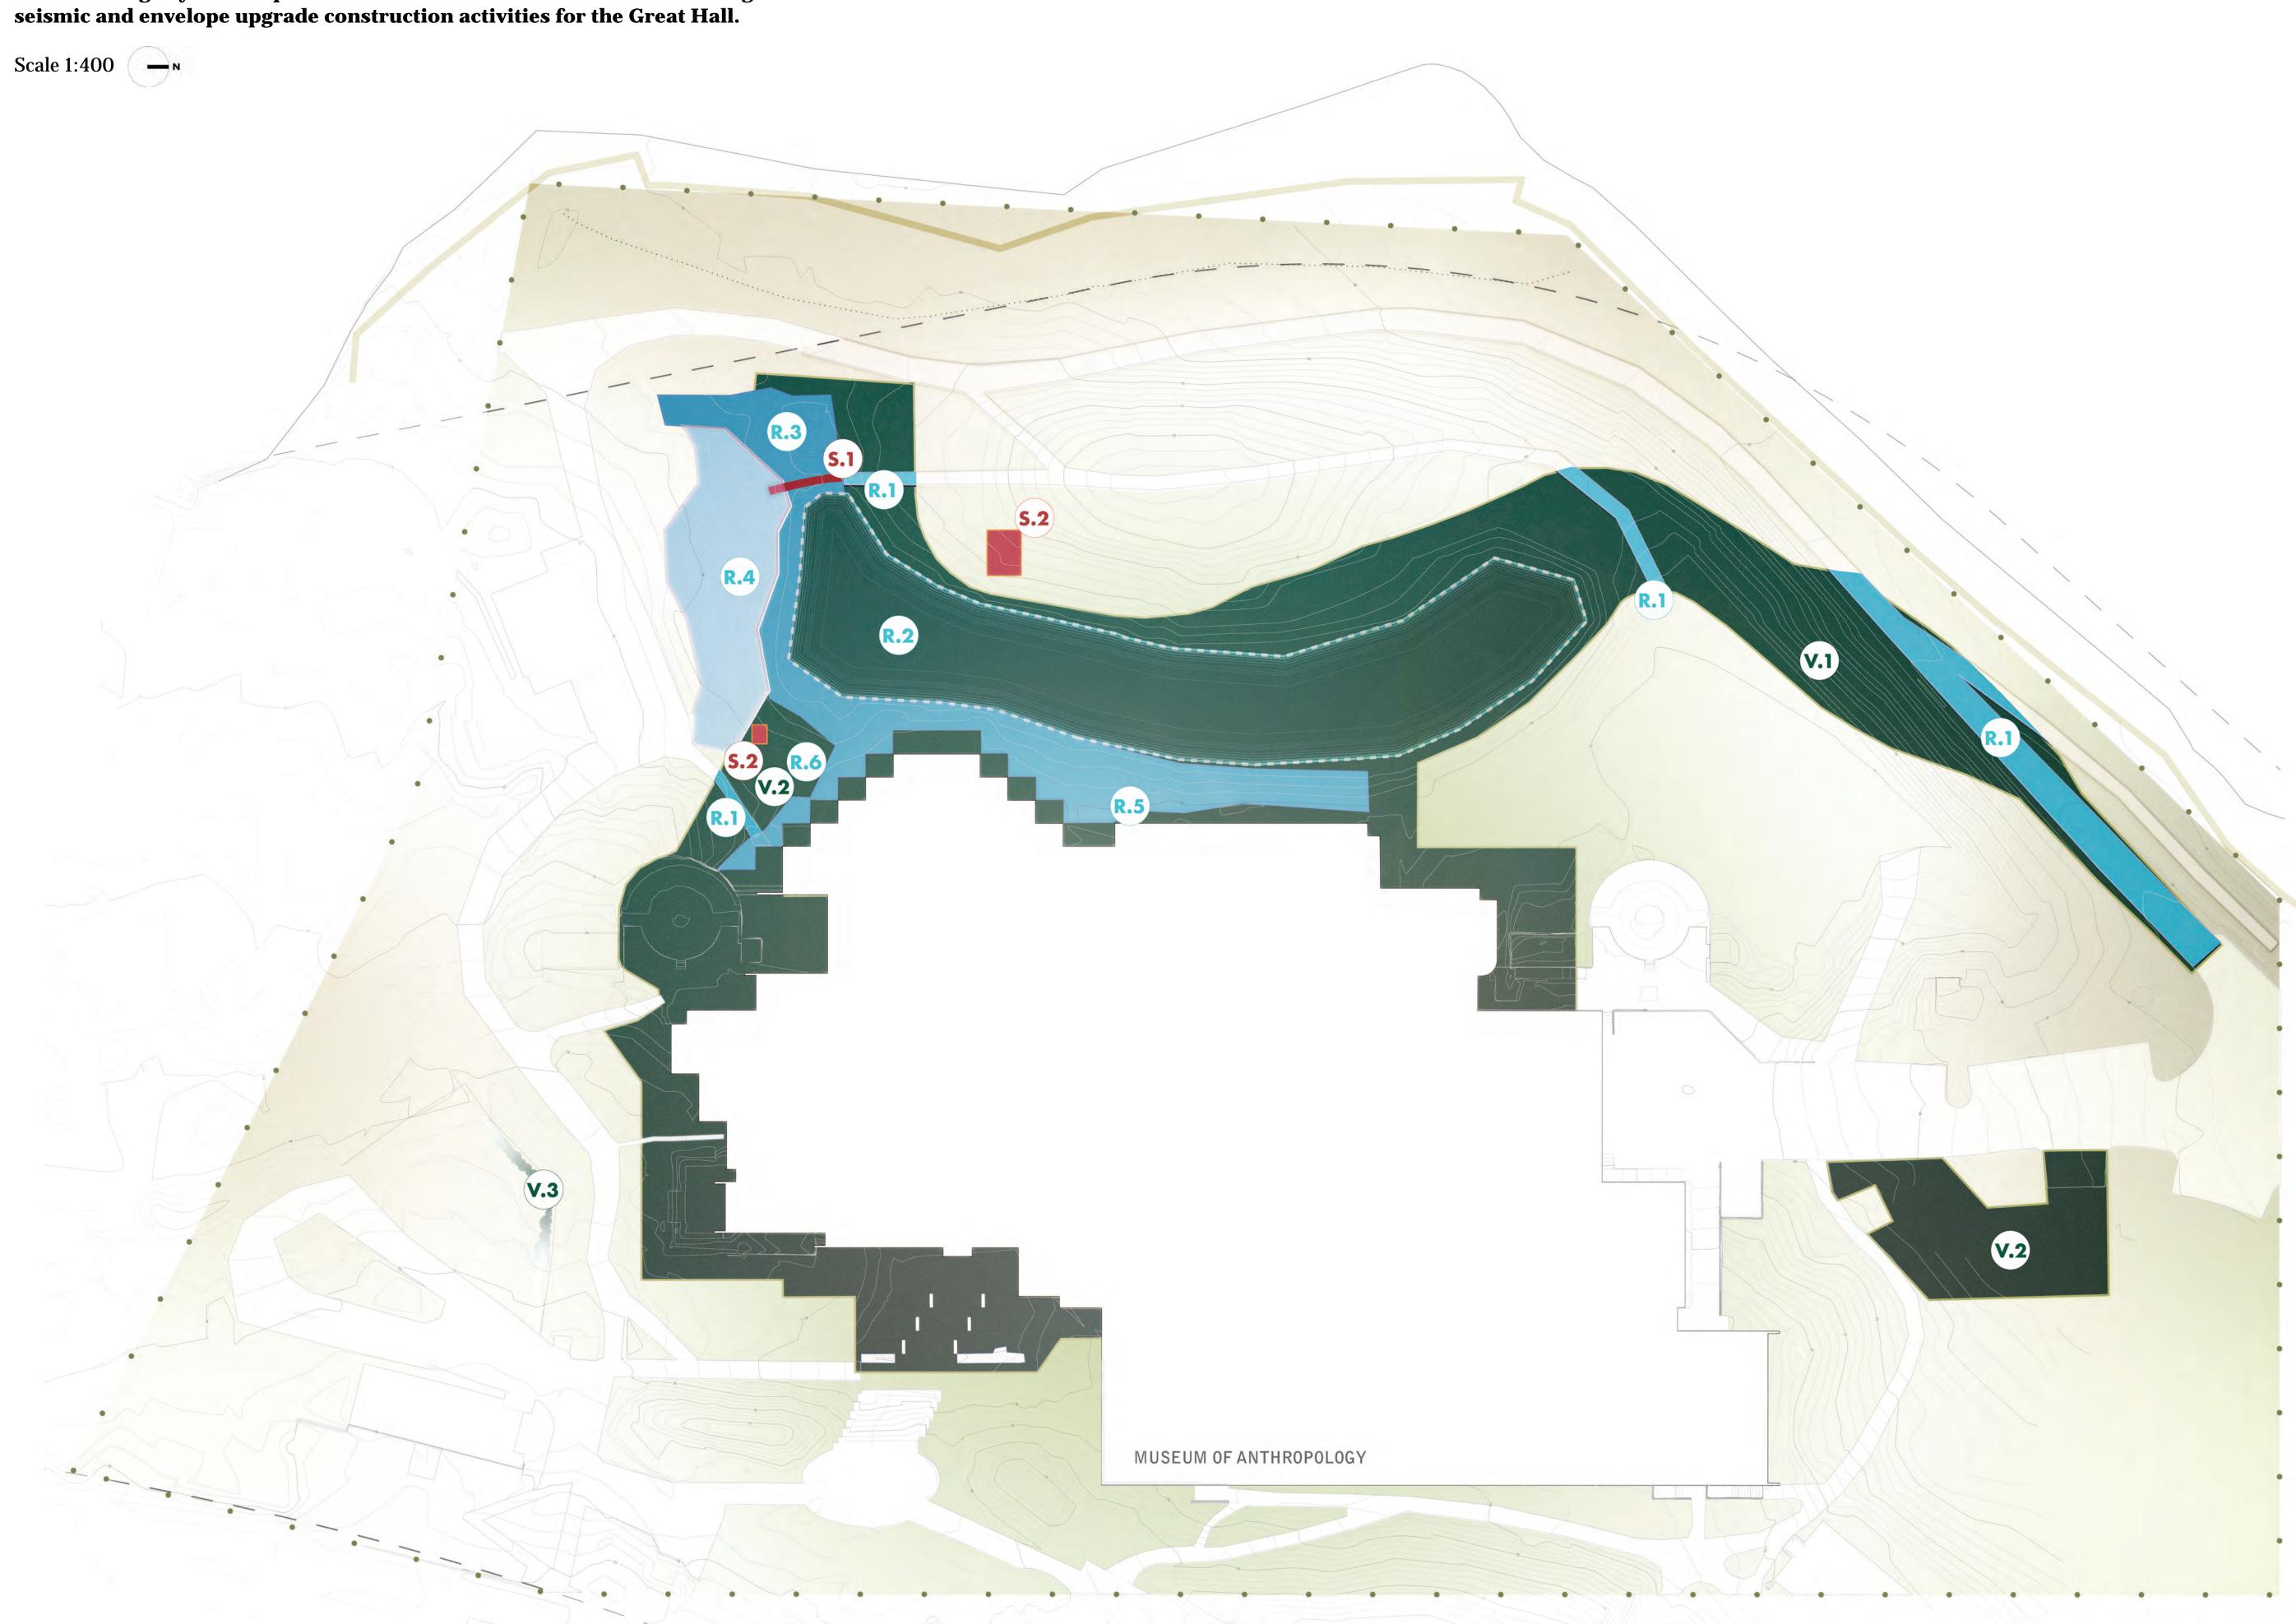
Restoring an Iconic Landscape Critical Areas to be Restored After Construction

Plan showing key landscape restoration work to be undertaken following

V.3 ECO-CULTURAL RESTORATION OF VEGETATION Fence and existing planting will be removed. Replace with eco-cultural indigenous planting developed with partners.

> All vegetation will be restored and rehabilitated within the areas impacted by construction activities, including areas where protective fencing was erected. All grading and materials will be restored to pre-existing conditions.

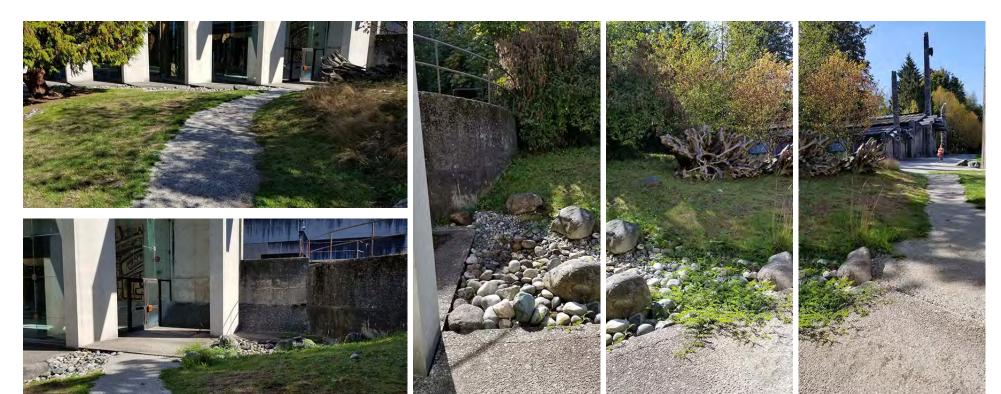
View G1 Sheet L3 (G1:L3)
existing site conditions | vegetation | path | aggregate
concrete pads | cobbles | armory/gun emplacement

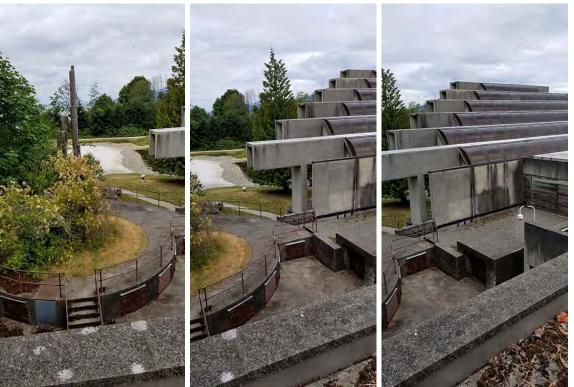
Views R1 Sheet L13 (R1:L13) (Envelope Sheets) July 26 2018 armory/gun emplacement | vegetation | site conditions

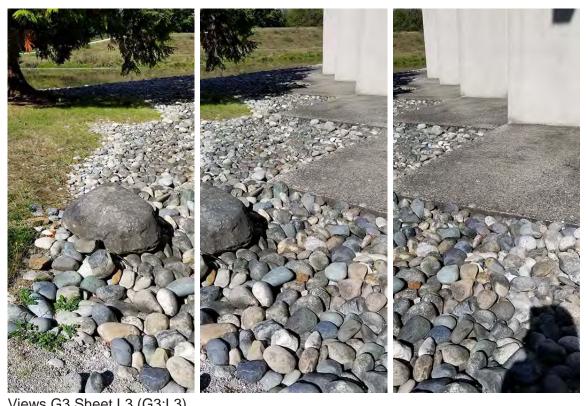
existing site conditions | aggregate concrete pads | cobbles | vegetation

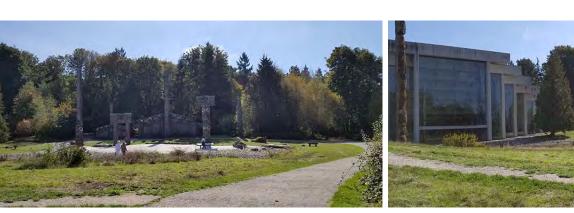
Views G8 Sheet L4 (G8:L4) existing site conditions | view toward proposed location for temporary construction vehicle turn-around, construction set up and staging | vegetation | path | site elements

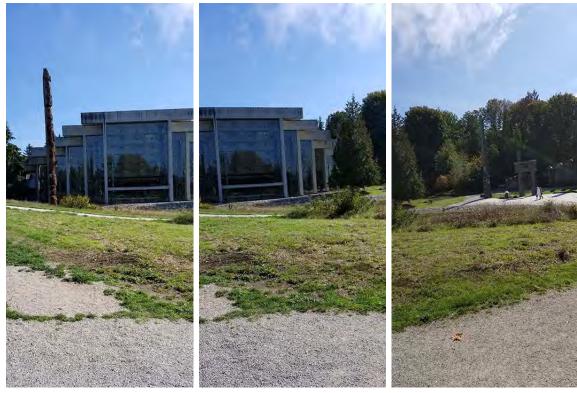
Views G9 Sheet L4 (G9:L4) existing site conditions | view toward proposed location for temporary construction vehicle turn-around, construction set up and staging | vegetation | paths | totem

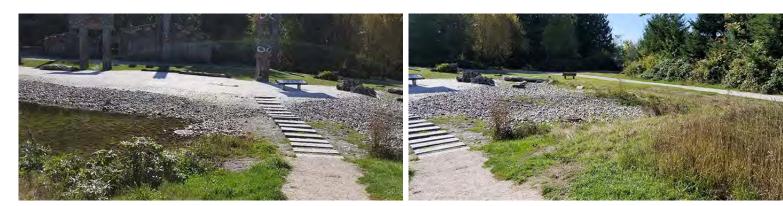
Views G10 Sheet L4 (G10:L4) existing site conditions | vegetation | overflow catch basins | cobbles | shell beach | totems | site elements | concrete unit pavers

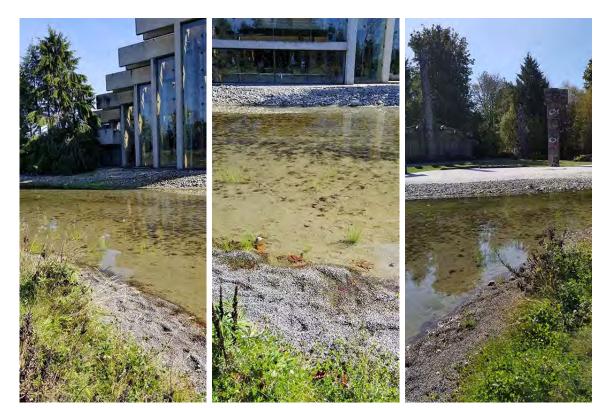
Views G11 Sheet L4 (G11:L4) existing site conditions | pea gravel at pool water's edge | vegetation | grading

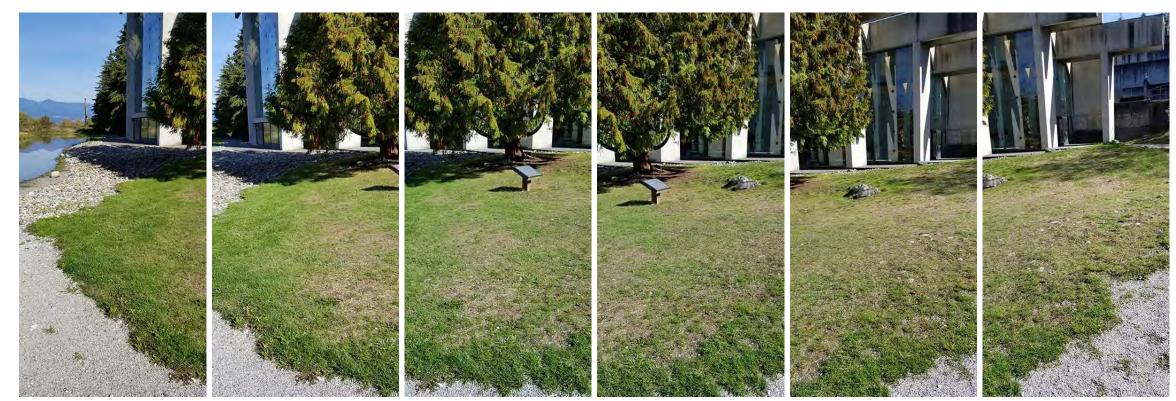
Views G12 Sheet L5 (G12:L5) existing site conditions | cedar (south-west corner of building) requiring critical root zone protection | vegetation | cobbles | site elements | grading

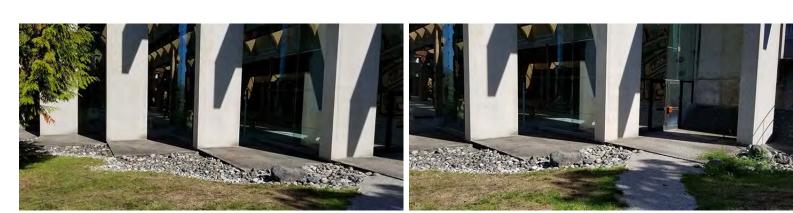
Views G14 Sheet L5 (G14:L5) existing site conditions | vegetation | aggregate concrete pads | cobbles | path | site elements

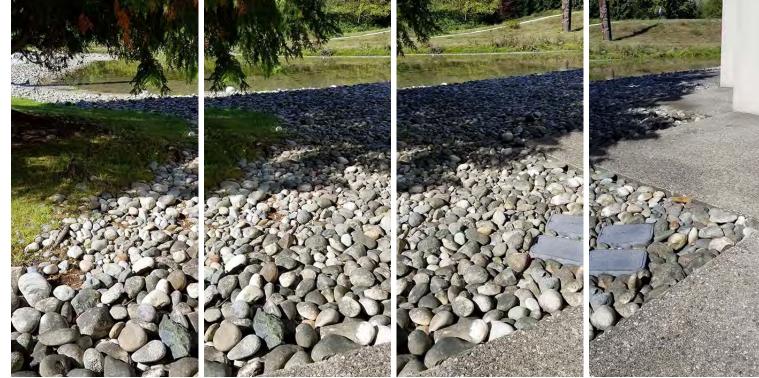
Views G16 Sheet L5 (G16:L5) existing conditions between pond and Great Hall | grading existing site conditions | cedar roots | cobbles | site utility | aggregate concrete pads between pool and aggregate concrete pads

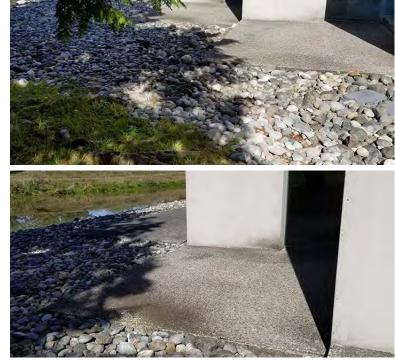
Views G18 Sheet L5 (G18:L5) existing site conditions | vegetation | cedar roots | cobbles aggregate concrete pads

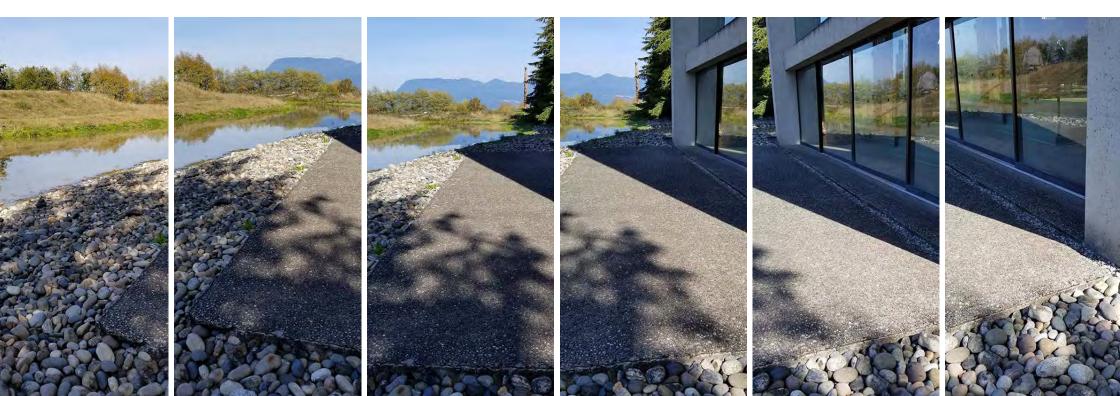
Views G19 Sheet L5 (G19:L5) existing site conditions at large aggregate concrete pad west side of Great Hall | grading | cobbles | concrete interface with glazing

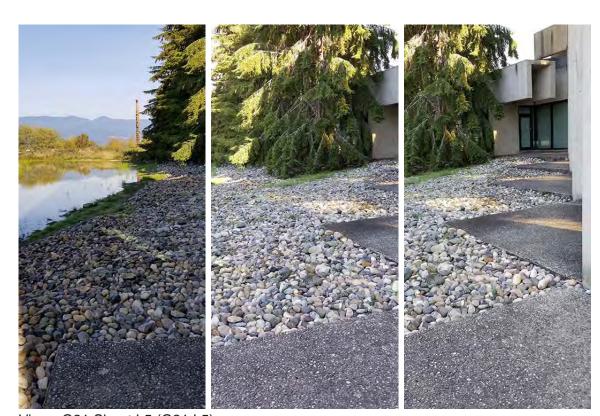
Views G21 Sheet L5 (G21:L5) existing site conditions | vegetation | cobbles | aggregate concrete pads

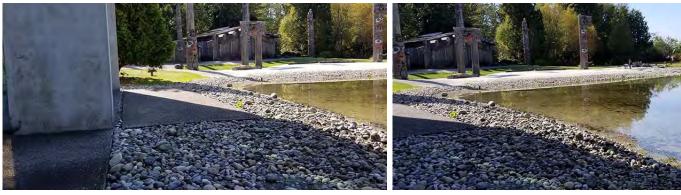
Views G23 Sheet L5 (G23:L5) existing site conditions | grading | cobbles | pea gravel at pool edge | aggregate concrete pads | vegetation

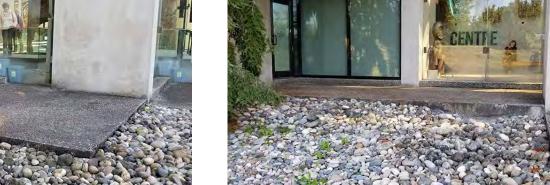
View G25 Sheet L6 (G25:L6) existing site conditions | hemlock | aggregate concrete | cobbles

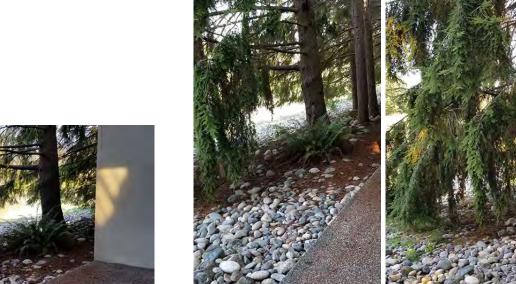
View G26 Sheet L6 (G26:L6) existing site conditions | hemlock | cobbles | aggregate concrete critical root zone in conflict with seismic upgrade excavation

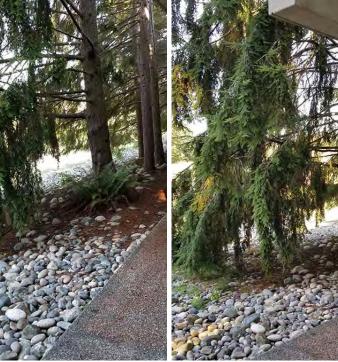
Views G26 Sheet L6 (G26:L6) existing site conditions | hemlocks | cobbles | aggregate concrete | critical root zone in conflict with seismic upgrade excavation

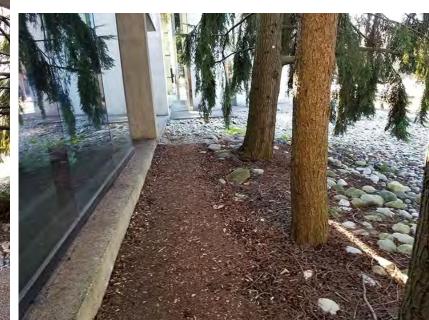
View E3 Sheet L14 (Envelope Sheets) (E3:L14) March 20 2020 proposed location of access stairwell to crawl space under Great Hall existing site conditions | hemlocks | cobbles

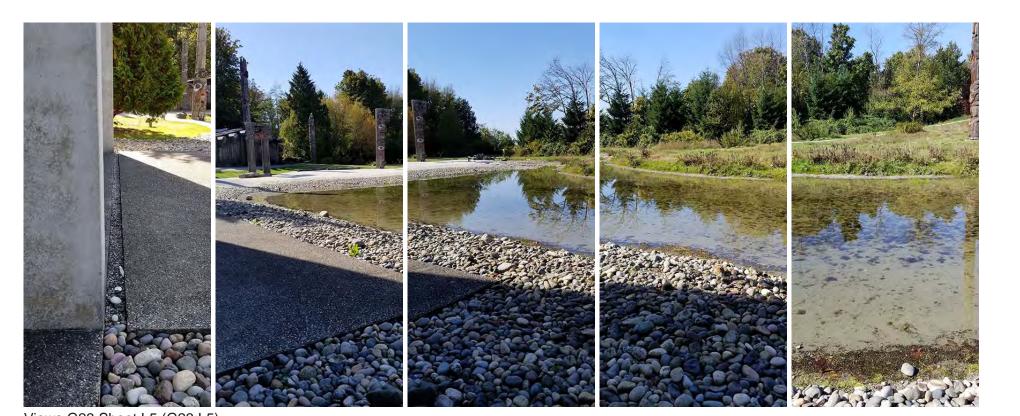
existing site conditions | aggregate concrete | cobbles | grading | pea gravel at pool water's edge | vegetation

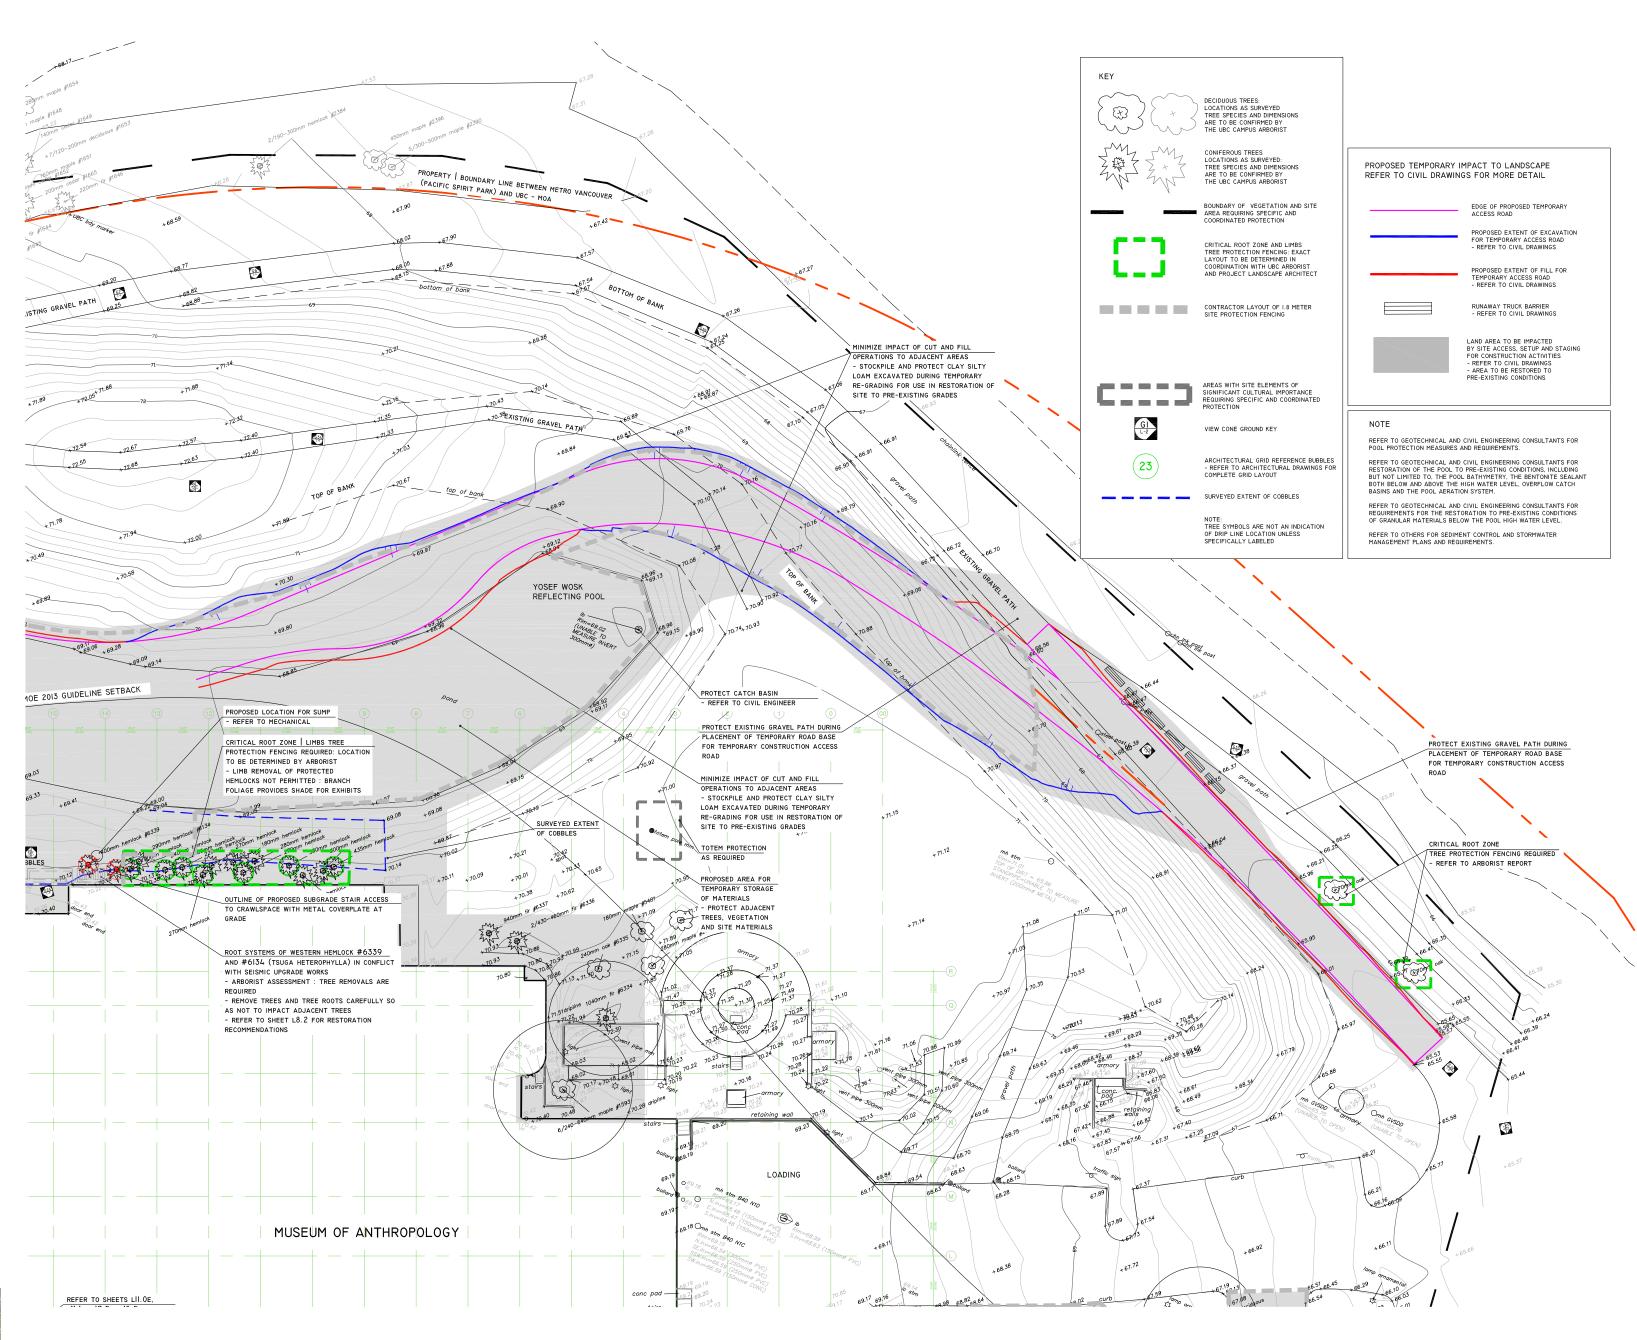
View G27 Sheet L6 (G27:L6) existing site conditions | proposed location of temporary vehicle access route | vegetation | grading | oaks require critical root zone protection fencing

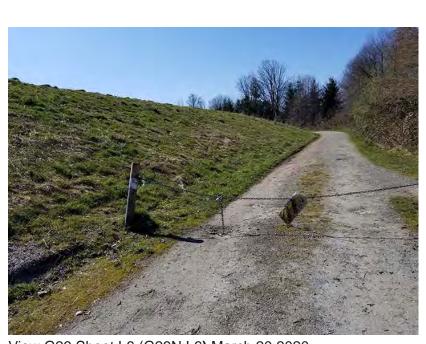
View G29 Sheet L6 (G29N:L6) March 20 2020 existing site conditions | proposed location of temporary construction vehicle access route excavation | vegetation | grading | gravel path

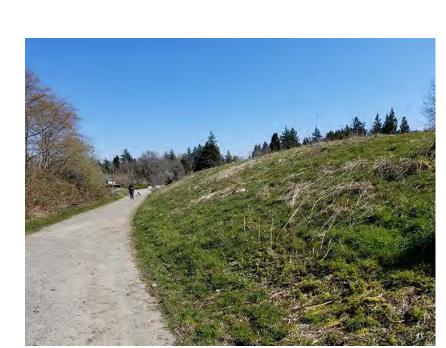
View G31N Sheet L6 (G31N:L6) March 20 2020 existing site conditions | proposed location of temporary construction vehicle access route excavation | vegetation | grading | gravel path

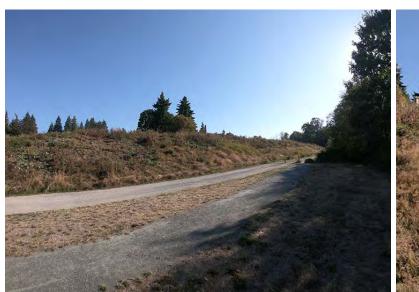
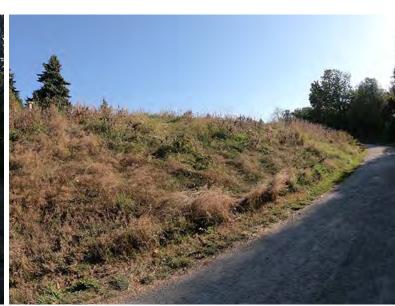
Views G33 Sheet L6 (G33:L6)

existing site conditions | mound grading | vegetation | path | views toward proposed location for temporary vehicle access route

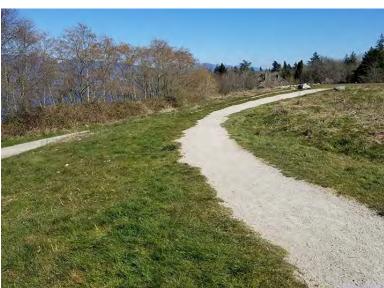
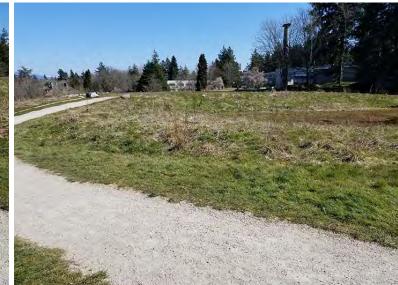
Views G34 Sheet L6 (G34:L6) March 20 2020 existing site conditions | grading | vegetation | gravel path | view toward proposed location for temporary construction vehicle access route

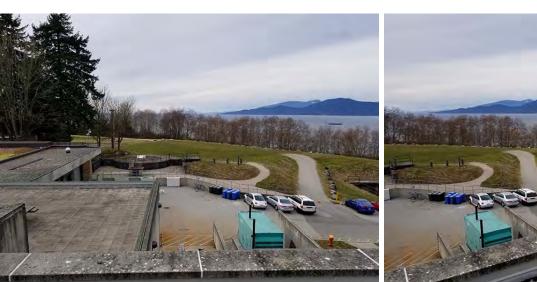
Please refer to Sheet L4 for viewcone location Views G5 Sheet L4 (G5:L4)

existing site conditions as seen from roof | grading | site vegetation | site elements | armory / gun emplacement

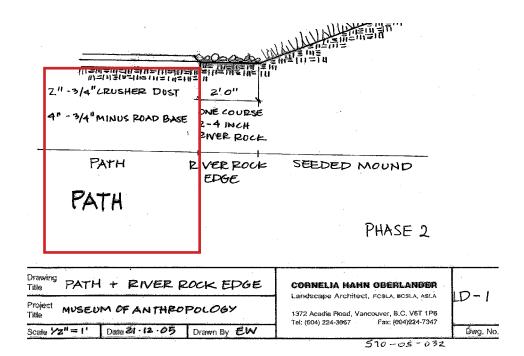
Original Gravel Path Detail for Reference reference confined to area inside red box not to scale refer to Specification Section 32 14 02 Gravel Paths

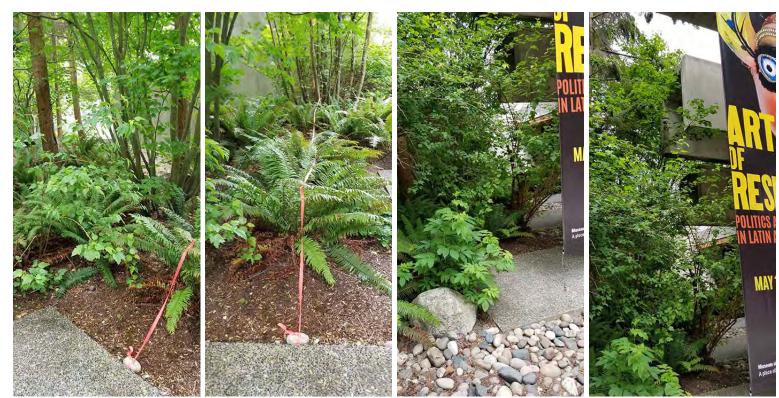
Views E1 Sheet L11 (E1:L11) existing vegetation | cobbles

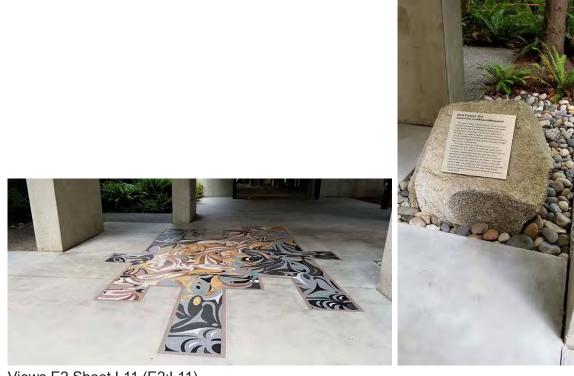
Views E2 Sheet L11 (E2:L11) existing site elements of cultural significance

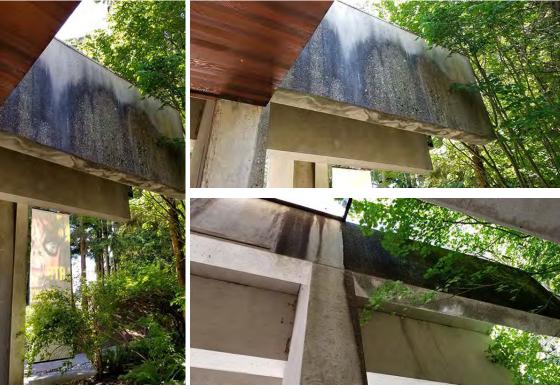
Views E3 Sheet L11 (E3:L11) tree branches adjacent to and touching concrete beams

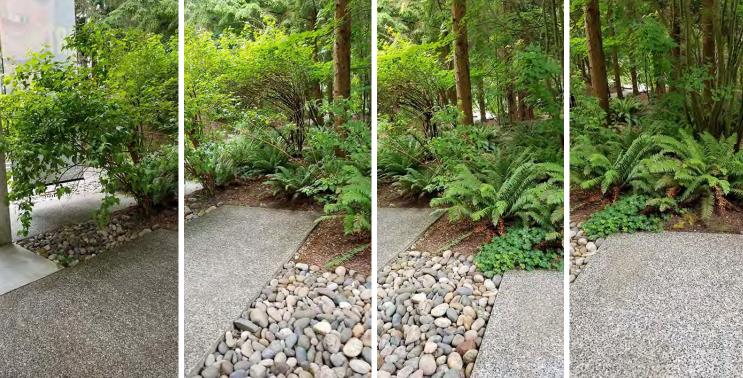
Views E3 Sheet L11 (E3:L11) existing vegetation | cobbles

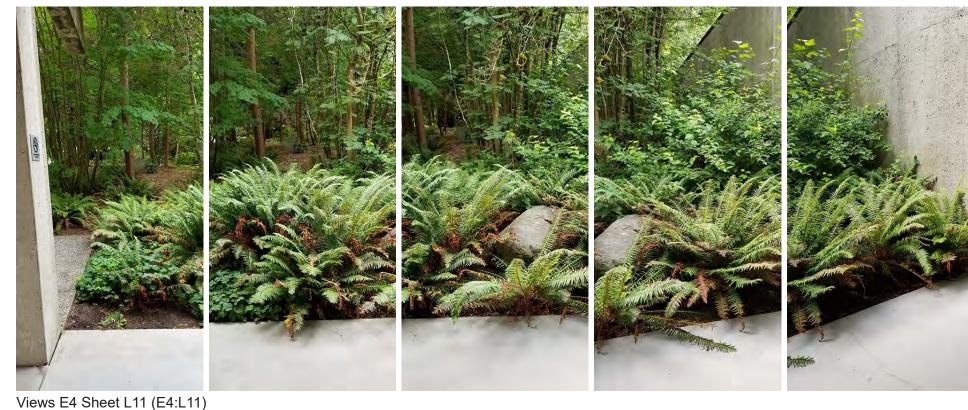
existing vegetation | branches of trees and shrubs adjacent to and touching building facade

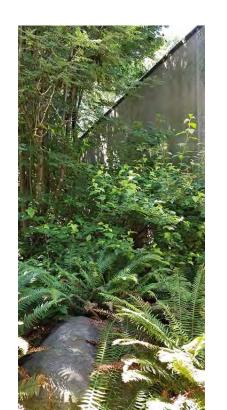
View E4 Sheet L11 (E4:L11) existing vegetation: tree branches overhanging roof

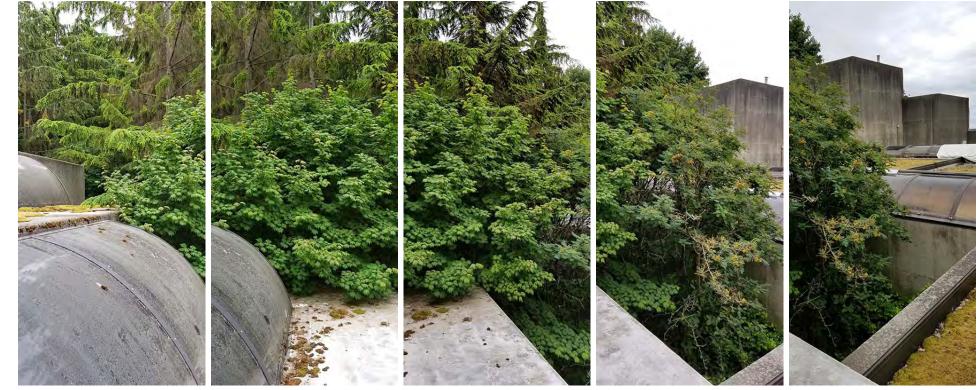
Views R1 Sheet L11 (R1:L11) tree branches overhanging and touching skylights, concrete beams and roof

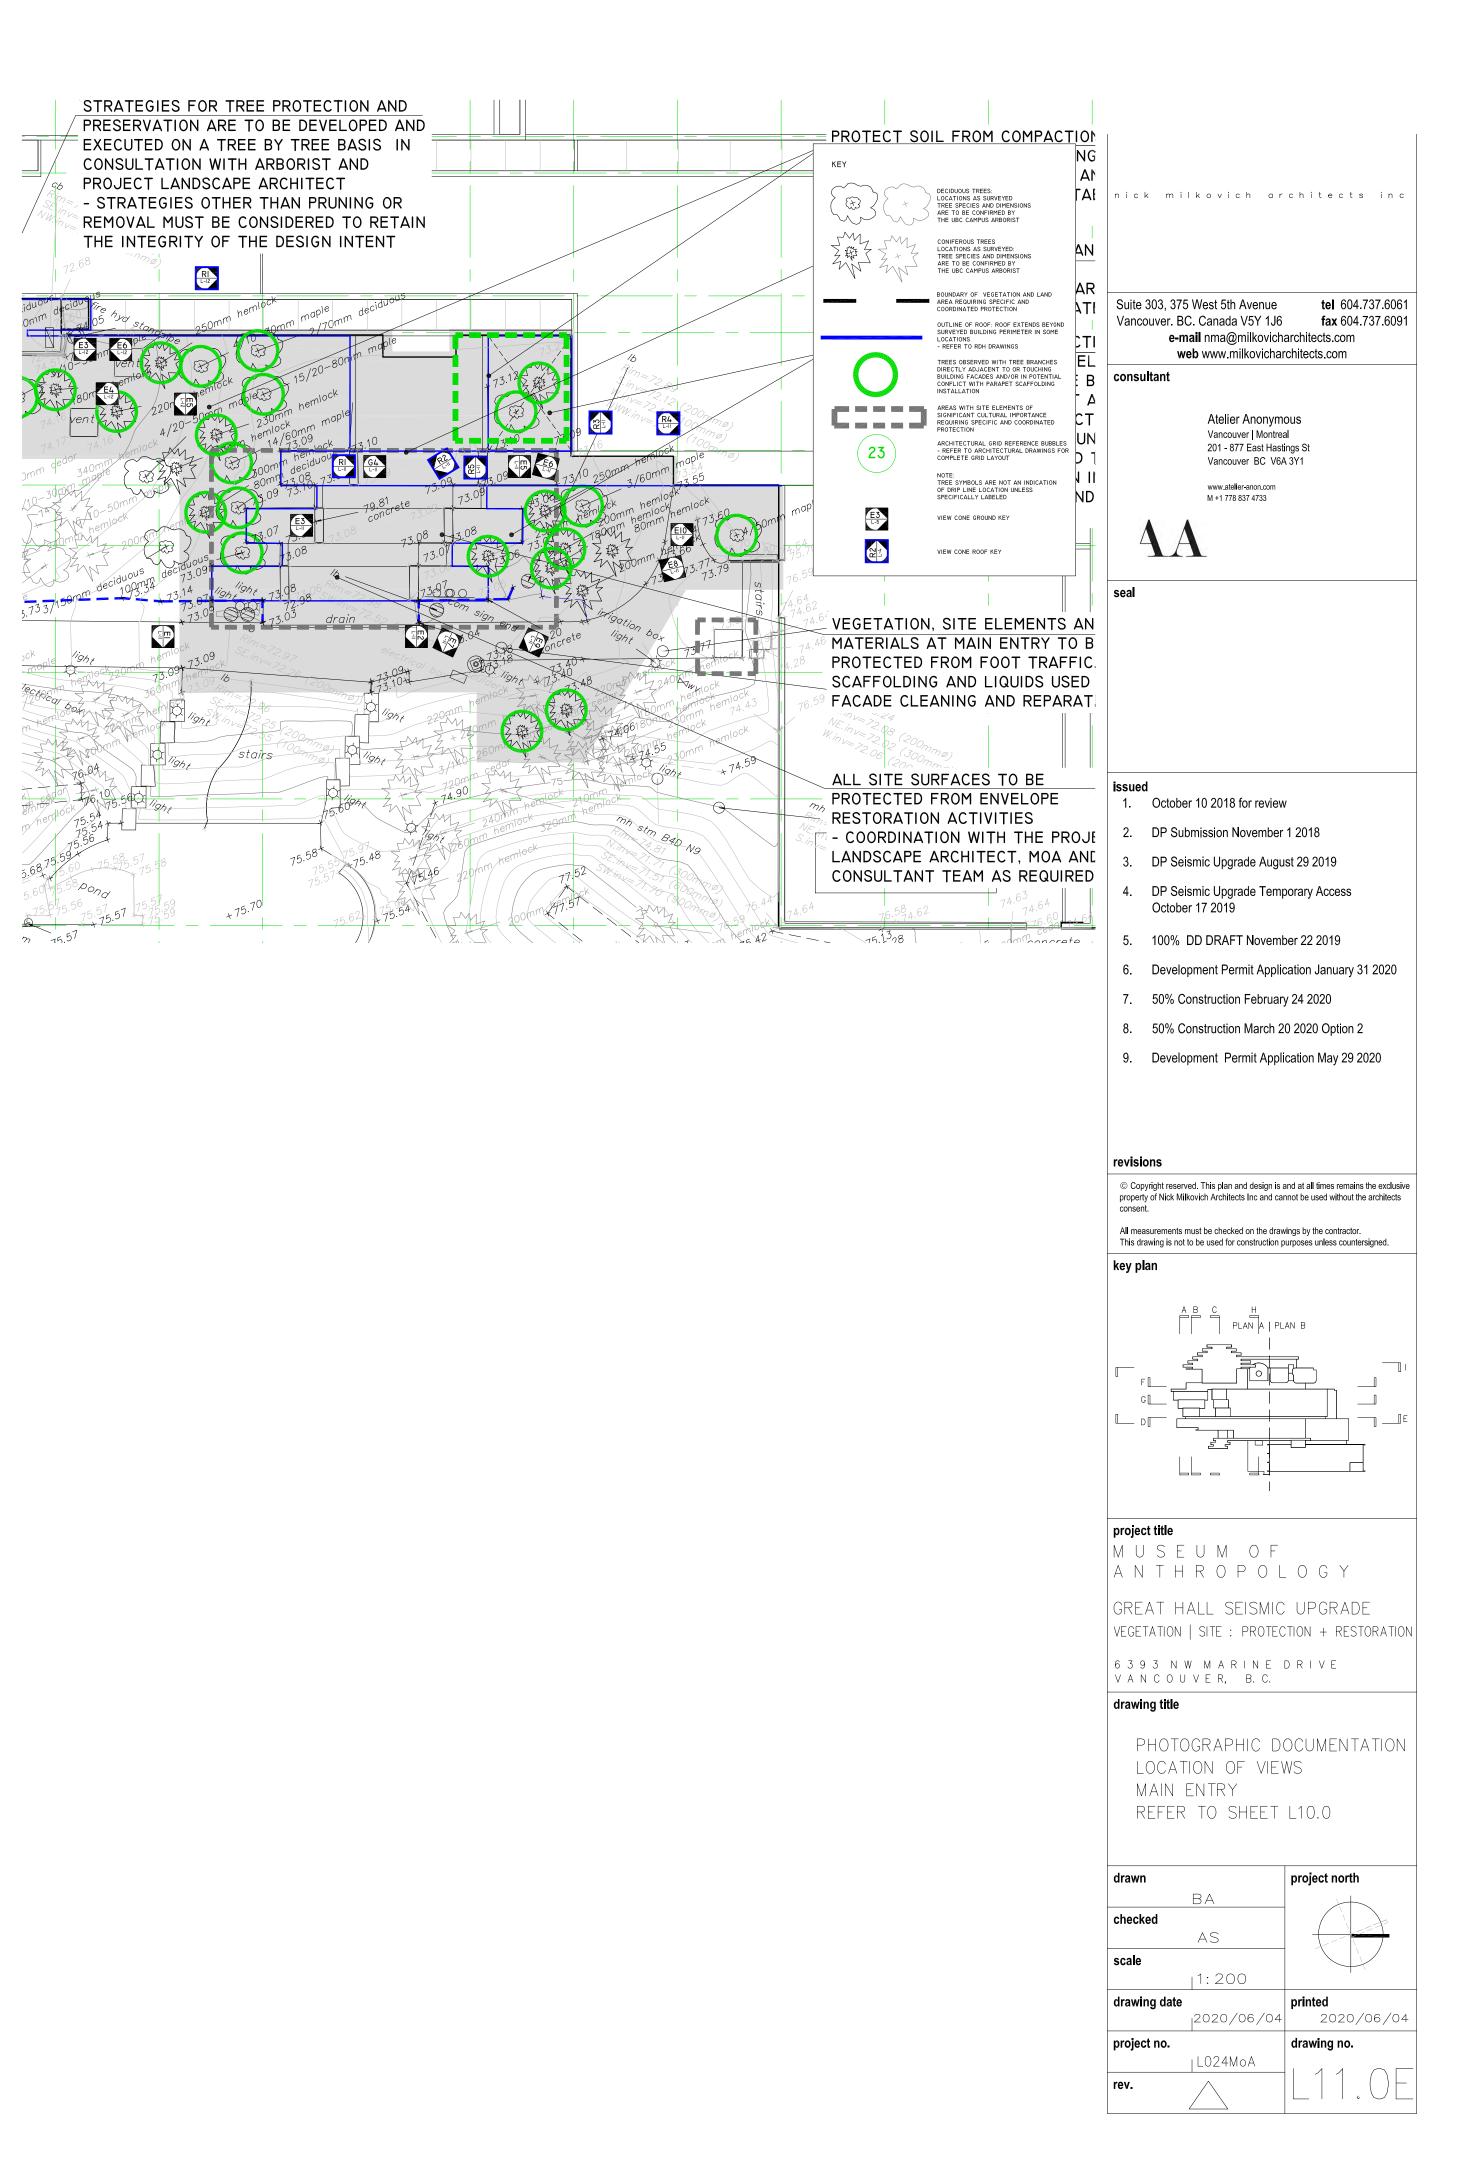
View R2 Sheet L11 (R2:L311) tree branches overhanging and touching roof

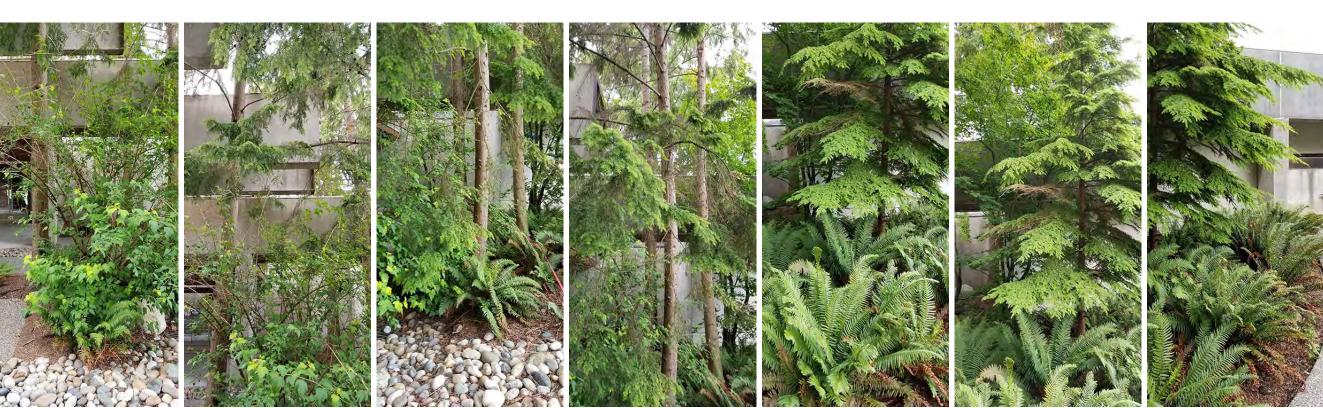
Views E8 Sheet L11 (E8:L11) tree branches adjacent to and touching building facade

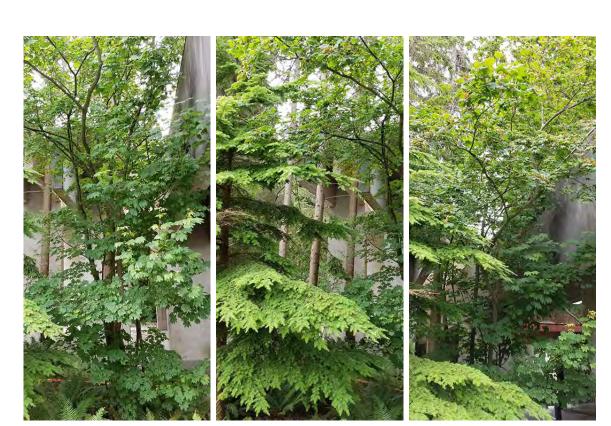
Views E6 Sheet L11 (E6:L11)

existing vegetation | site elements

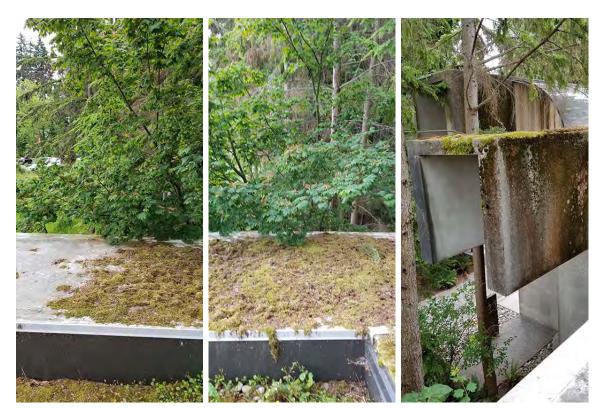
Views E10 Sheet L11 (E10:L11) existing vegetation | tree branches adjacent to and touching concrete columns | beams
