DEVELOPMENT PERMIT APPLICATION MUSEUM OF ANTHROPOLOGY at the UNIVERSITY OF BRITISH COLUMBIA

VEGETATION, SITE AND SITE ELEMENT PROTECTION, PRESERVATION, RESTORATION AND REHABILITATION GREAT HALL AND SKYLIGHT UPGRADES

GREAT HALL SEISMIC UPGRADE

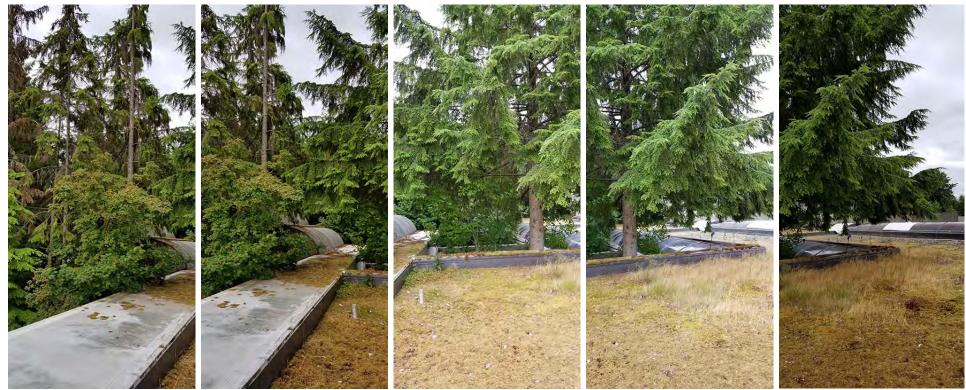
Views R3 Sheet L11 (R3:L11) tree branches overhanging and touching roof

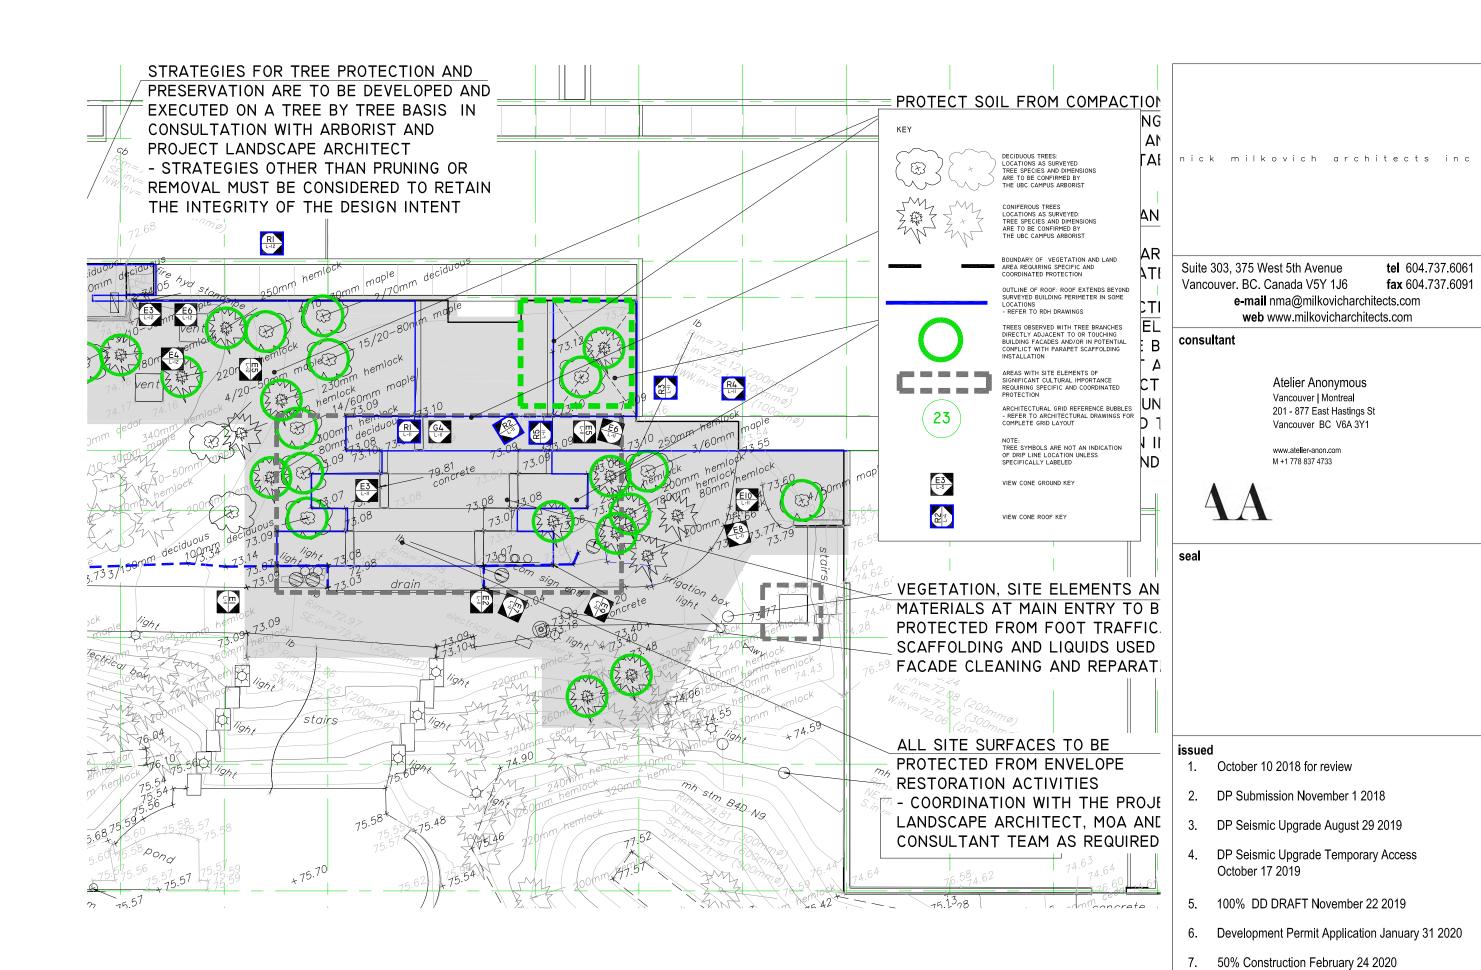
tree branches overhanging and touching skylights, concrete beams and roof

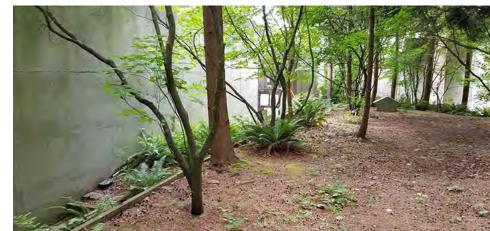
View E4 Sheet L12 (E4:L12) existing vegetation adjacent to east building facade

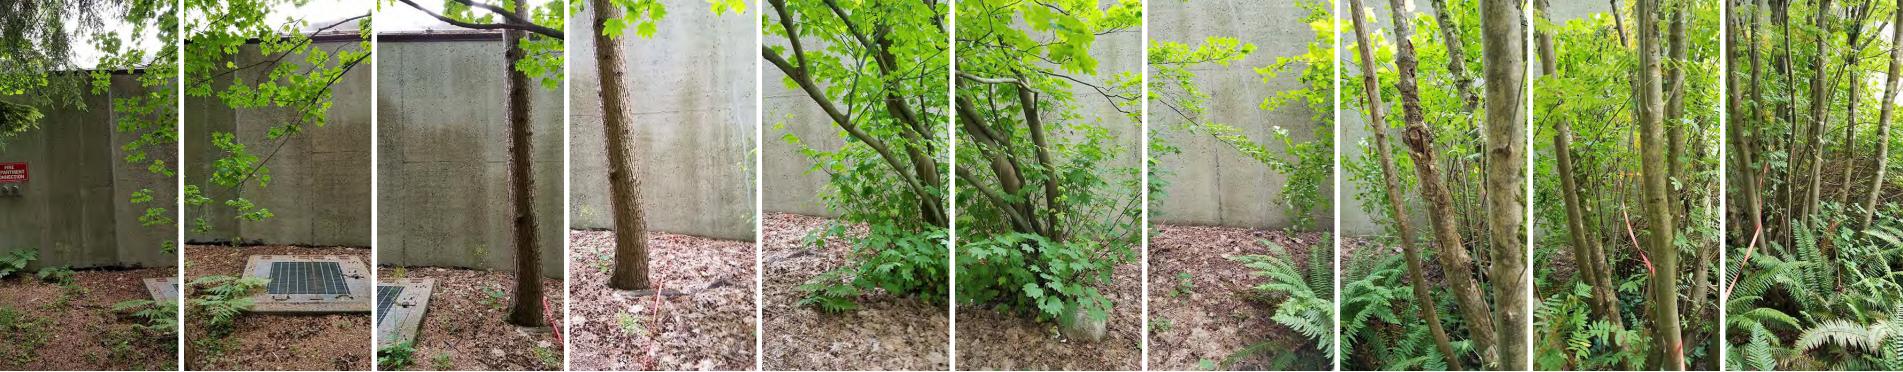
Views E5 Sheet L12 (E5:L12) existing vegetation adjacent to east building facade

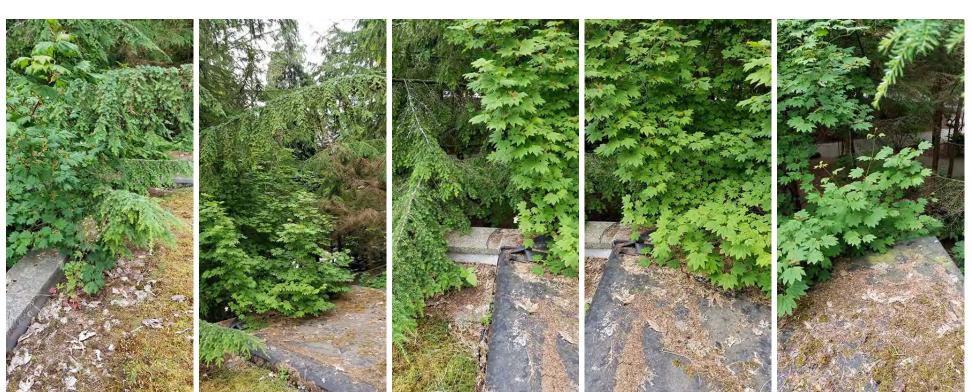
Views R2 Sheet L12 (R2:L12) tree branches overhanging roof

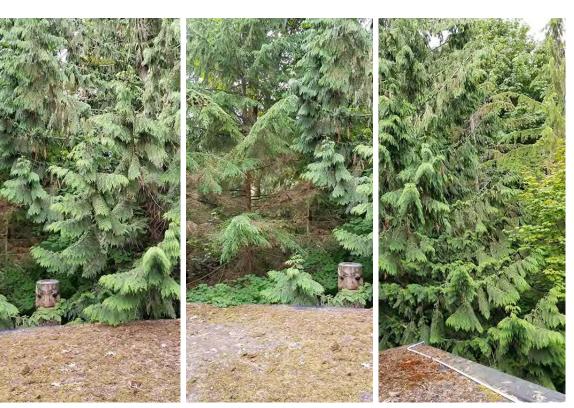
Views R3 Sheet L12 (R3:L12) tree branches overhanging roof

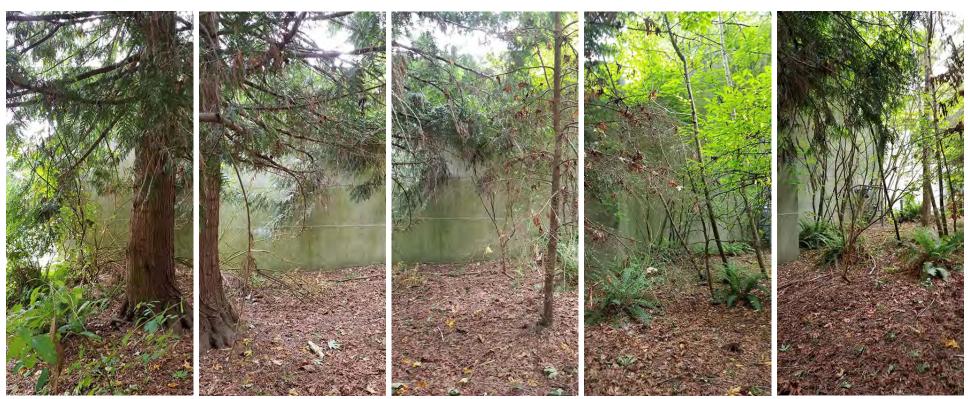
Views E2 Sheet L13 (E2:L13) existing vegetation | tree branches adjacent to and touching building facade

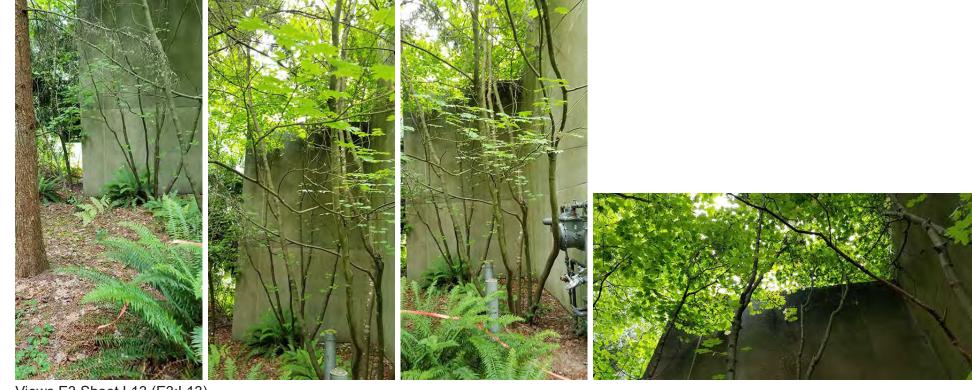
Views E3 Sheet L13 (E3:L13) existing vegetation | tree branches adjacent to and touching building facade

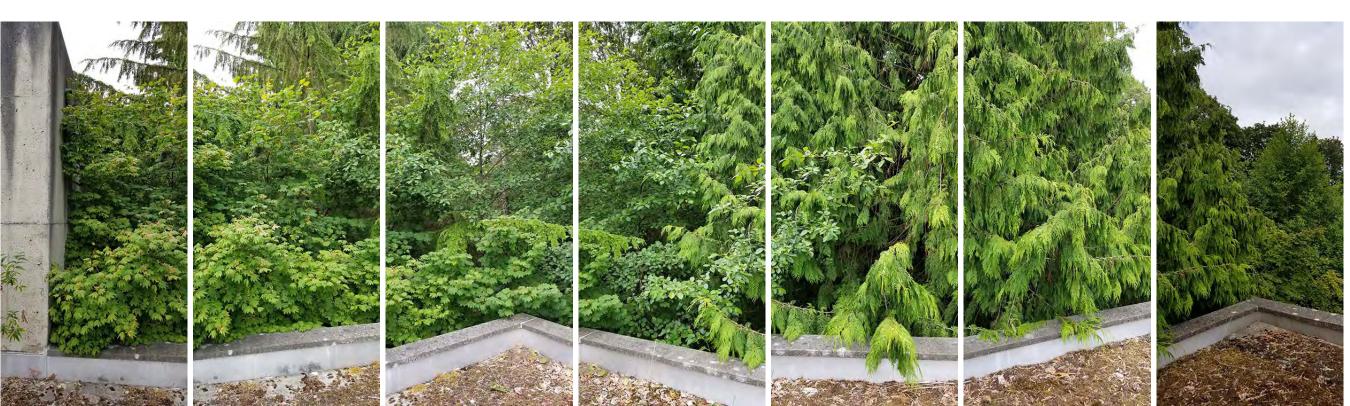
Views R1 Sheet L13 (R1:L13) tree branches touching building facade and overhanging roof

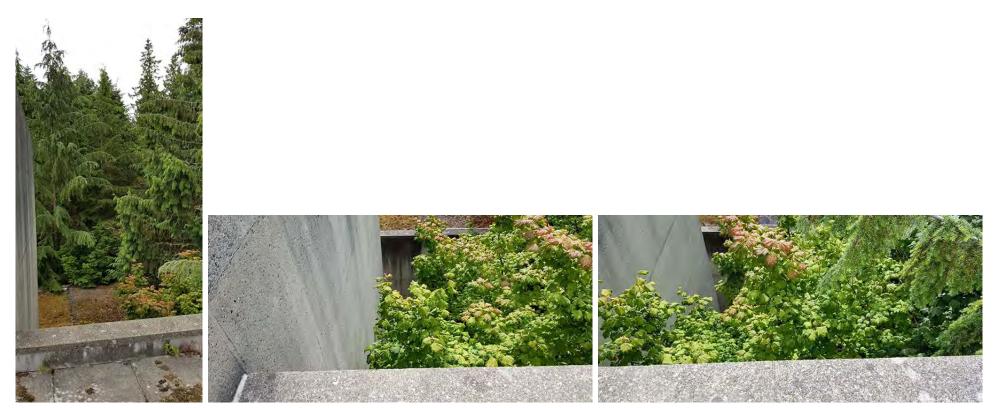
Views R2 Sheet L13 (R2:L13) tree branches adjacent to building facade and overhanging roof

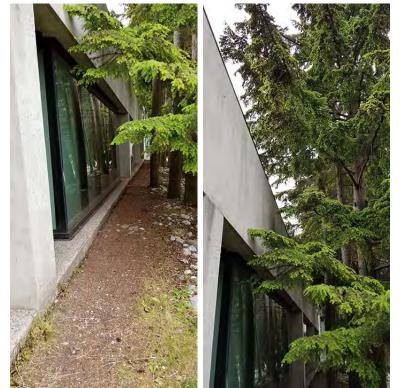
Views E3 Sheet L14 (E3:L14) tree branches adjacent to and touching building facade

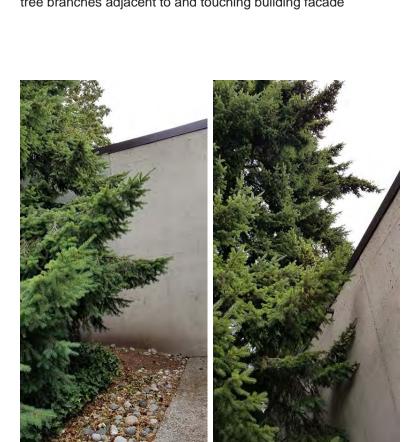
Views E4 Sheet L14 (E4:L14) tree branches adjacent to and touching building facade

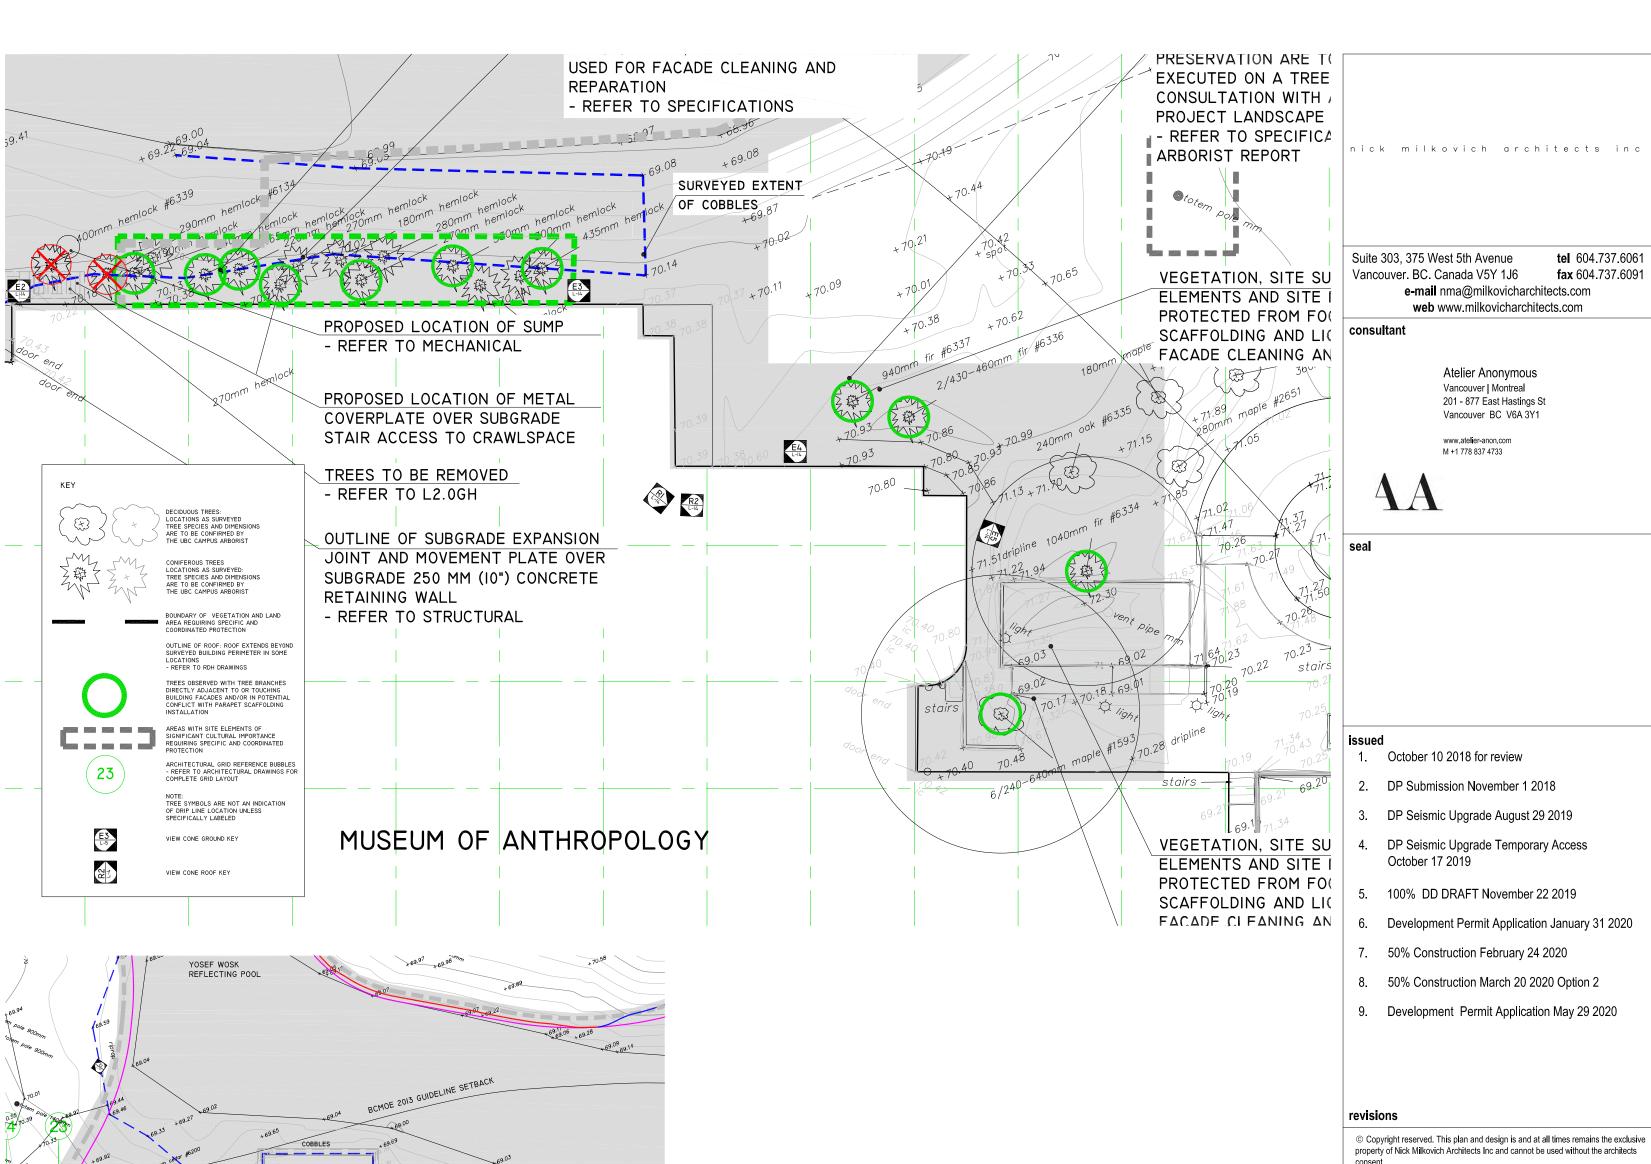
PROTECT ARMORY STRUCTURE FROM
OVERSPRAY OF FACADE CLEANING AND
REPAIRING LIQUIDS AND IMPACTS OF

Inset View Cone E1:L14 location Scale 1:400
